TECHNICIANS' GUIDE

INSPECTION AND ANALYSIS OF THE ALLISON 4000 & B 500 PRODUCT FAMILIES

INSPECTION AND ANALYSIS OF THE ALLISON 4000/B 500 PRODUCT FAMILIES

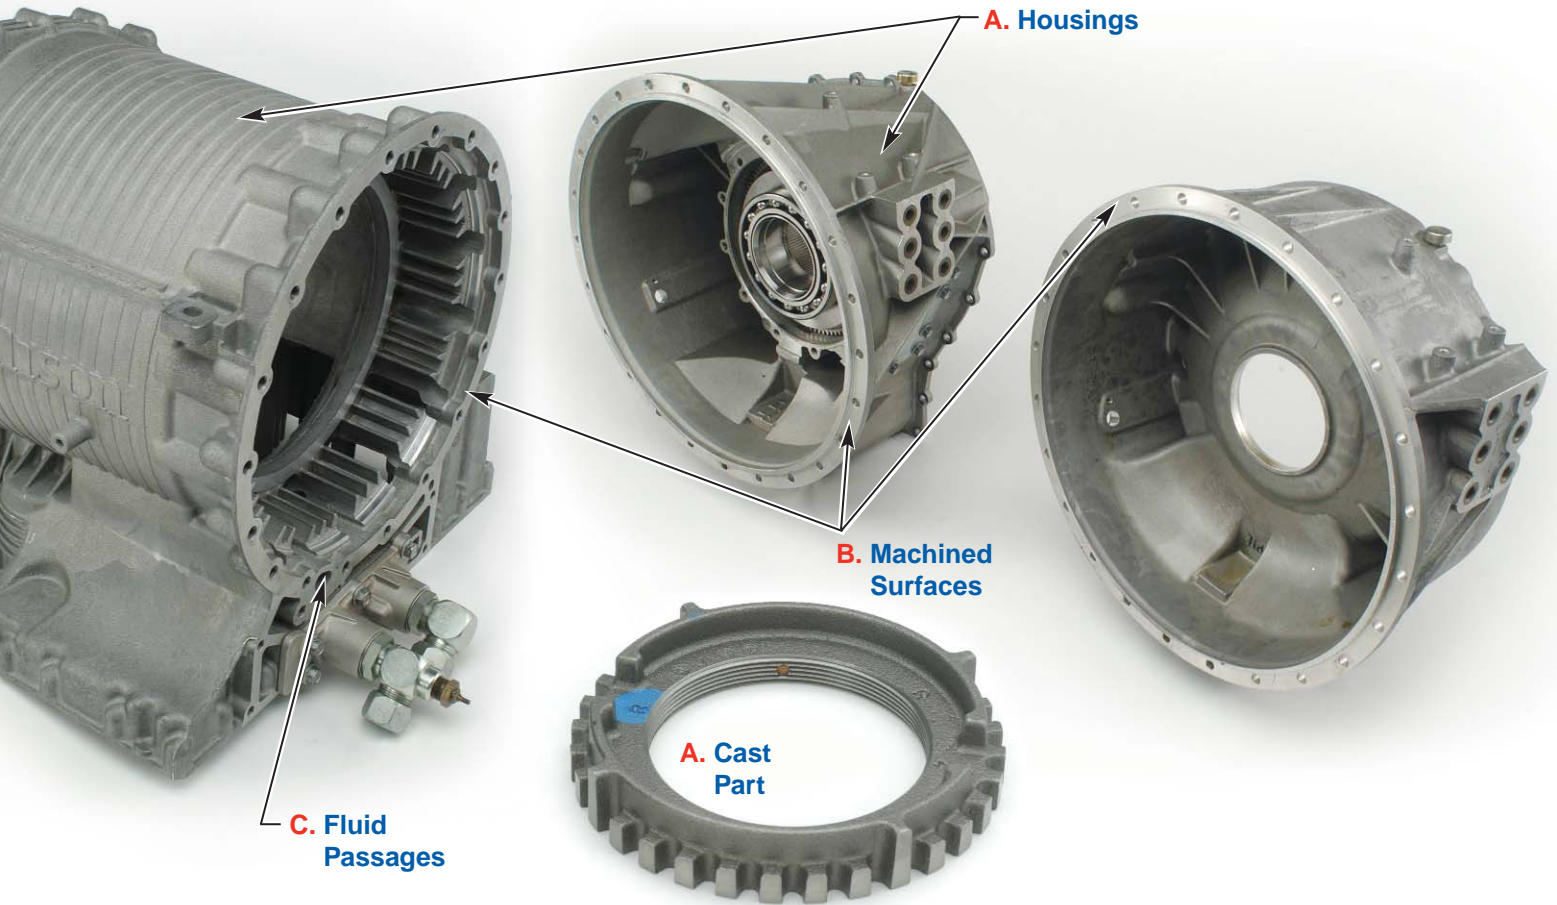
A. Replace housings or other cast parts that are cracked or broken. Inspect clutch housing sealing surfaces for imperfections that could damage the piston seals or interfere with mating parts. Inspect threaded holes for bad threads. Clean damaged threads with the correct size tap.

B. Inspect all machined surfaces for damage that could cause fluid leakage. Inspect mounting faces and bores for damage.

C. Inspect all fluid passages for obstructions, porosity, broken lands, cracks and land surface imperfections.

D. Replace housings that have splines worn beyond wear limits. Refer to the Wear Limits Table (7-1) in Service Manual SM2457EN.

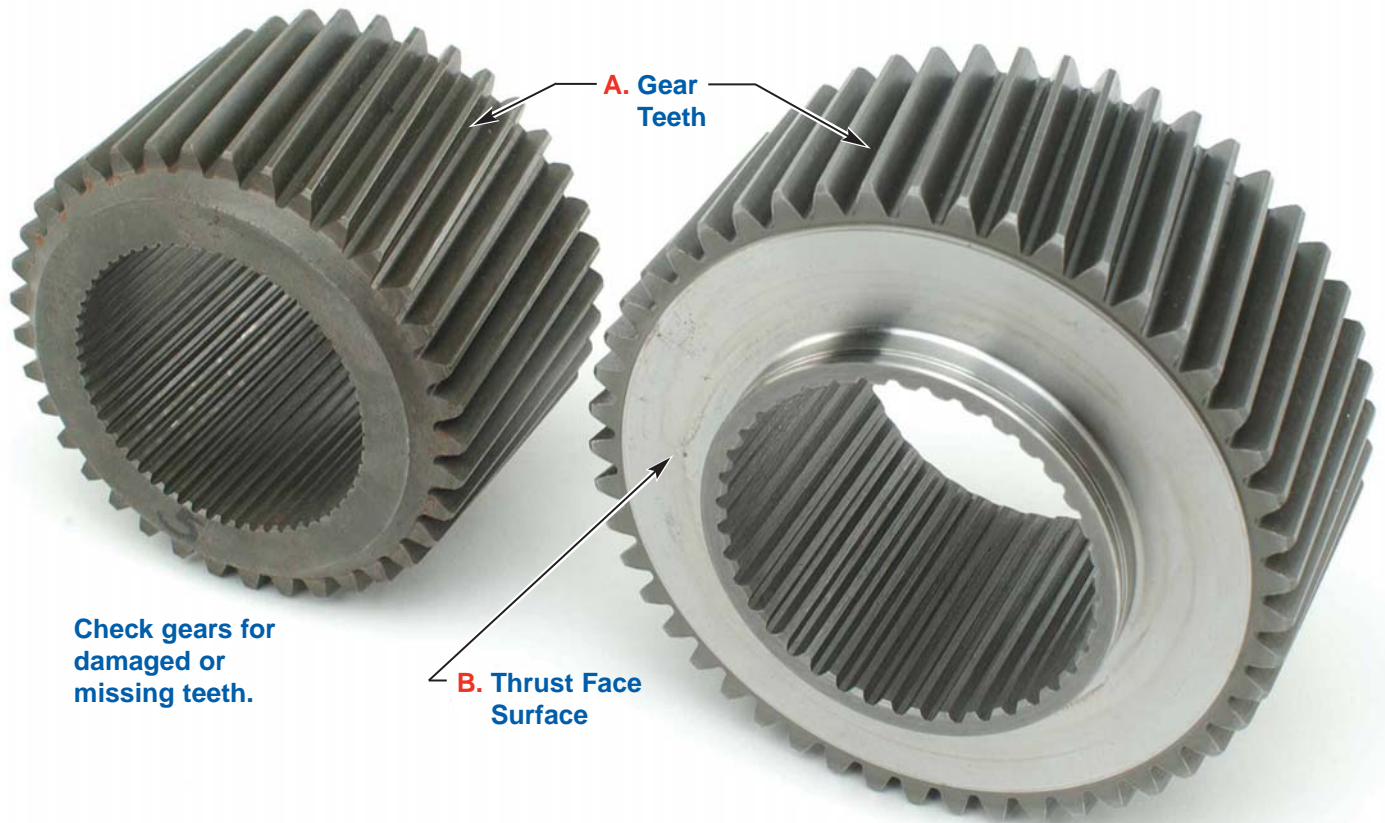
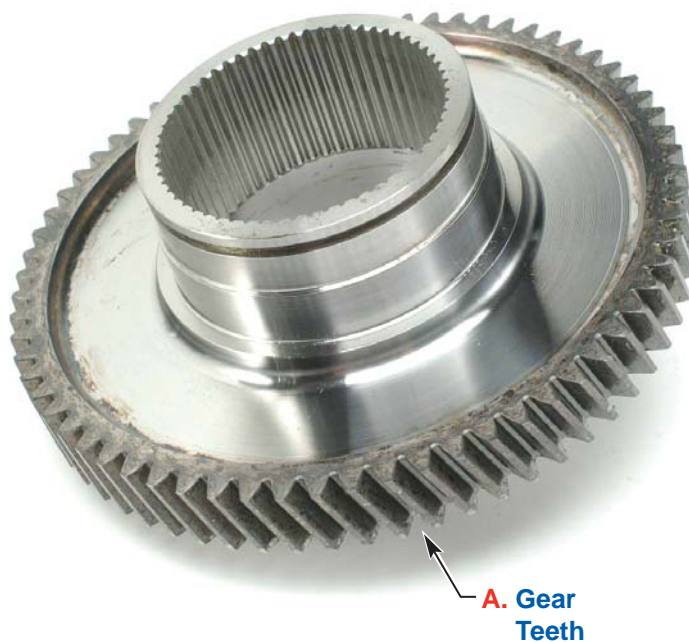
A. Inspect gears for damaged or broken teeth. Inspect gear teeth for wear that has changed the original tooth shape. If this condition is noted, replace the gear. Inspect gears for load pattern and signs of distress. Any signs of distress indicate the gear may fail during operation. Reusing distressed gears is an individual customer decision based on experience. Backlash cannot be used to establish critical gear wear. Pits, scuffs, scores or galling are typically evident long before backlash exceeds specification.

B. Inspect the thrust face of gears for damage. If these defects cannot be removed with a soft stone, replace the gear.

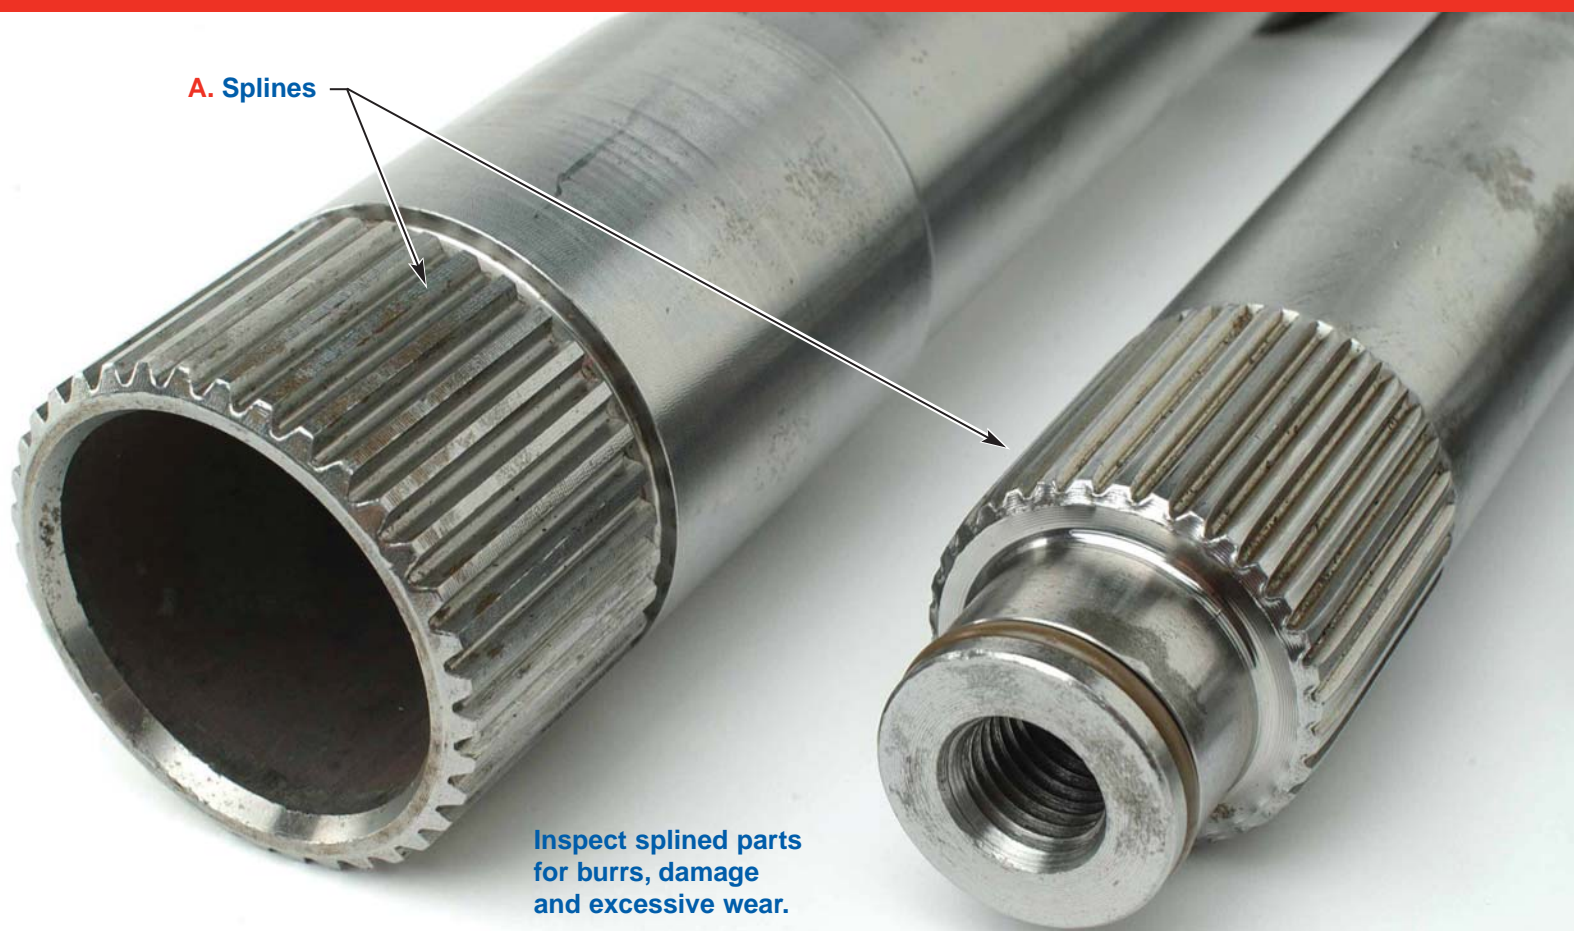
A. Splines

Inspect splined parts for burrs, damage and excessive wear.

A. Inspect splined parts for damage. Remove burrs with a soft stone. Spline wear is not considered harmful except where it affects the fit of the splined parts. Spline wear is determined by comparing feeler gauge thickness with the thickness of the worn area on the spline. Replace parts having excessive spline wear. The maximum movement allowed at the splines is

0.38 mm (0.015 inches) if not otherwise listed in Wear Limits Table 7-1 in Service Manual SM2457EN. Do not reuse a splined part that exceeds the published maximum spline wear. Backlash cannot be used to establish critical spline wear. Accurate backlash measurement requires the mating parts to be concentrically located.

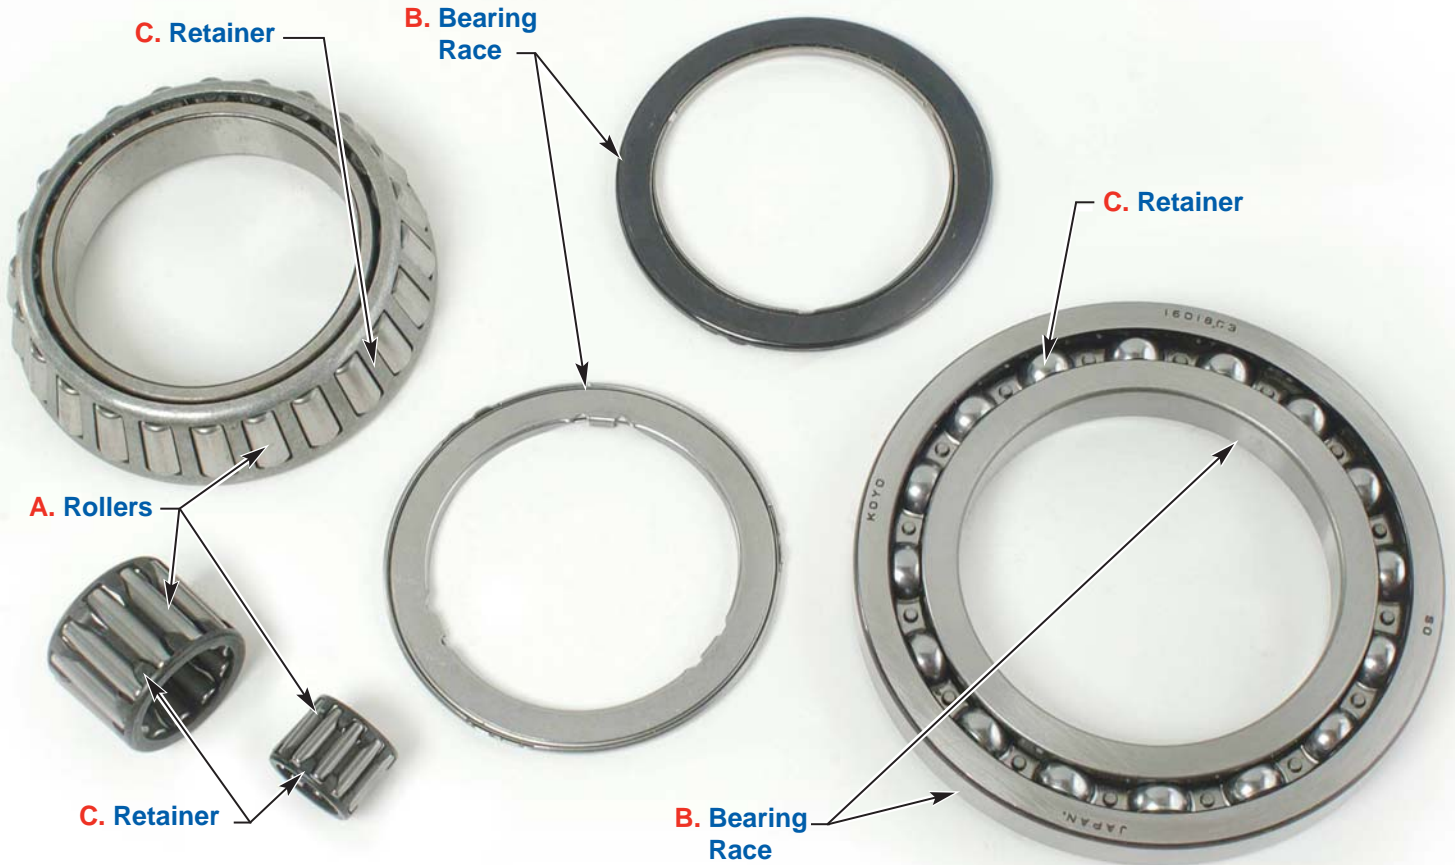
A. Replace the bearing if any rollers/balls are rusted. Replace the bearing if balls/rollers have a feeling of looseness in the retainer or race compared to a new bearing. Replace the bearing if balls/rollers are discolored from heat, lack of lubrication or debris lapping in the balls/rollers. Replace the bearing if the balls/rollers are worn, galled or abraded. Replace the bearing if it catches or feels rough after being thoroughly cleaned.

B. Replace the bearing if any races are rusted. Replace the bearing if the bearing balls/rollers have a feeling of looseness in the raceway compared to a new

bearing. Replace the bearing if races are discolored from heat, lack of lubrication or debris lapping in the race. Replace the bearing if the races are worn, galled or abraded. Replace the bearing if it catches or feels rough after being thoroughly cleaned.

C. Replace the bearing if any retainer or retainer clip is fractured, bent, dented or missing. Replace the bearing if any retainer is rusted. Replace the bearing if there is a feeling of looseness between the retainer and ball/roller compared to a new bearing. Replace the bearing if it catches or feels rough after being thoroughly cleaned.

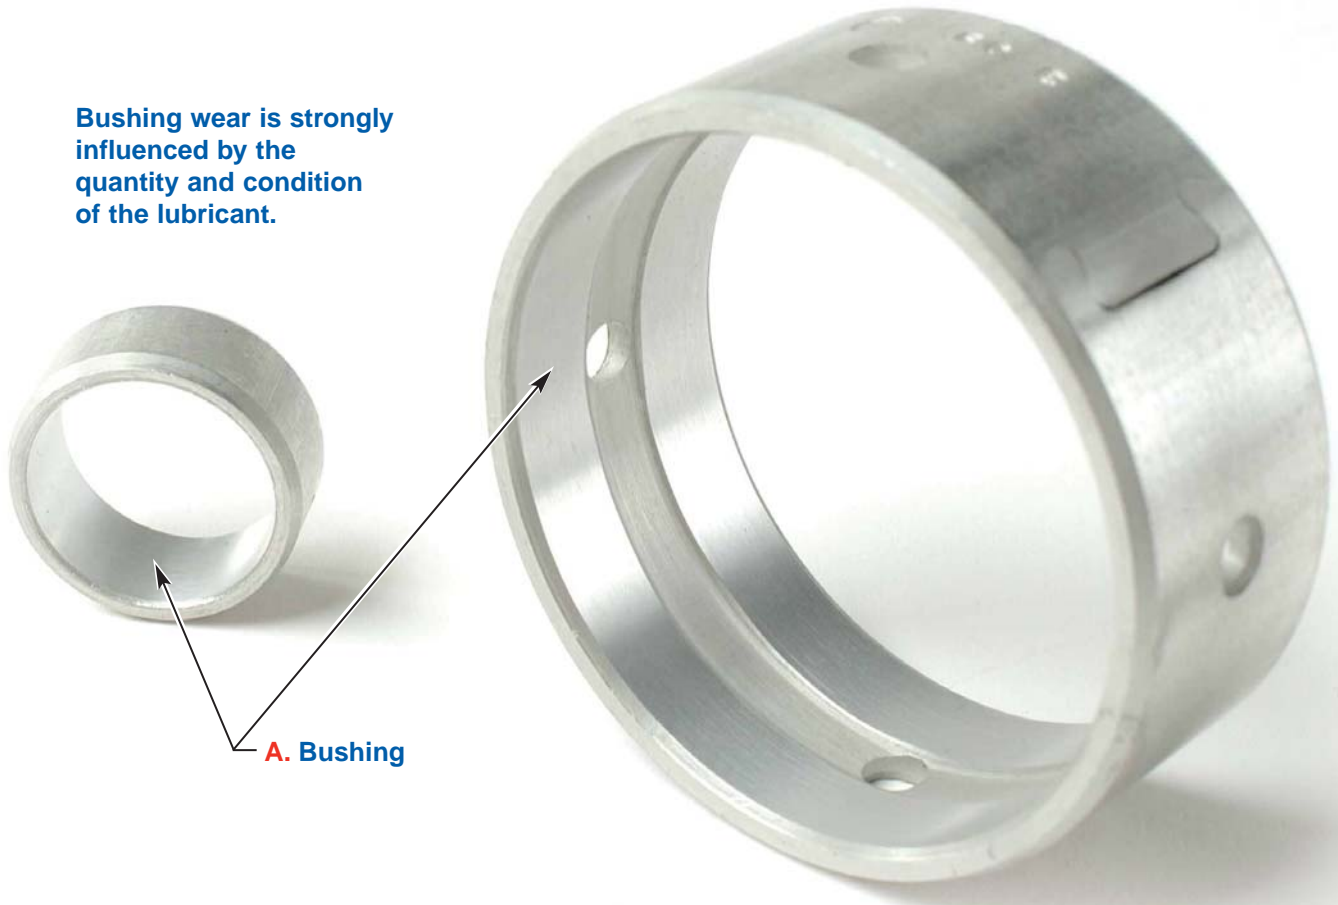
A. Bushing

Bushing wear is strongly influenced by the quantity and condition of the lubricant.

A. Inspect bushings for wear beyond service limits. Replace any bushing which is excessively worn. Inspect bushings for discoloration and surface damage due to lack of lubrication. Replace any bushing which is damaged.

Mechanically, bushings are the simplest type of journal bearing and are often referred to as “plain” bearings. A bushing is simply a sleeve of bearing material, such as bronze or aluminum, in which a component rides. Bushing wear is strongly influenced by the quantity and condition of the lubricant. Bushing bearing surfaces are sometimes grooved to better distribute lubrication across the bearing surface.

Some bushings are susceptible to material leaching. This can be caused by oxidized oil that has turned acidic combined with heat and mechanical loading. The TAN (Total Acid Number) of the transmission oil should not change by more than 3 from the baseline (new fluid) TAN. Changing transmission oil per recommended change intervals or based on a successful oil sampling program will help prevent material leaching.

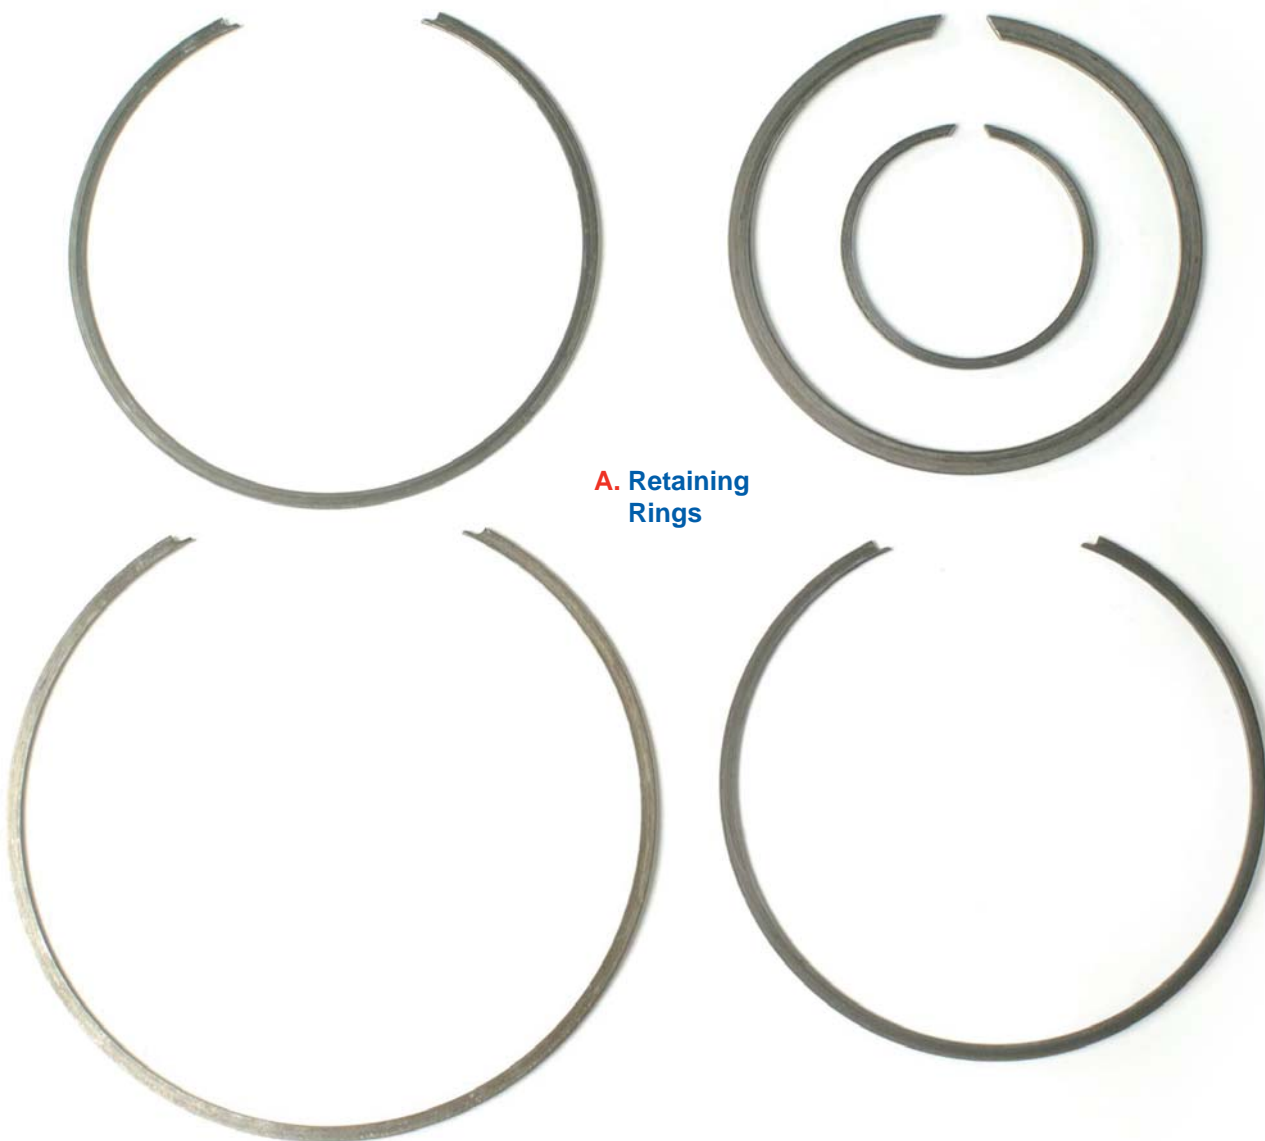
A. Retaining Rings

A. Inspect retaining rings for damage, distortion and excessive wear. Replace retaining rings if damage cannot be repaired using a soft stone or crocus cloth.

Examine retaining rings for damage, distortion or excessive wear.

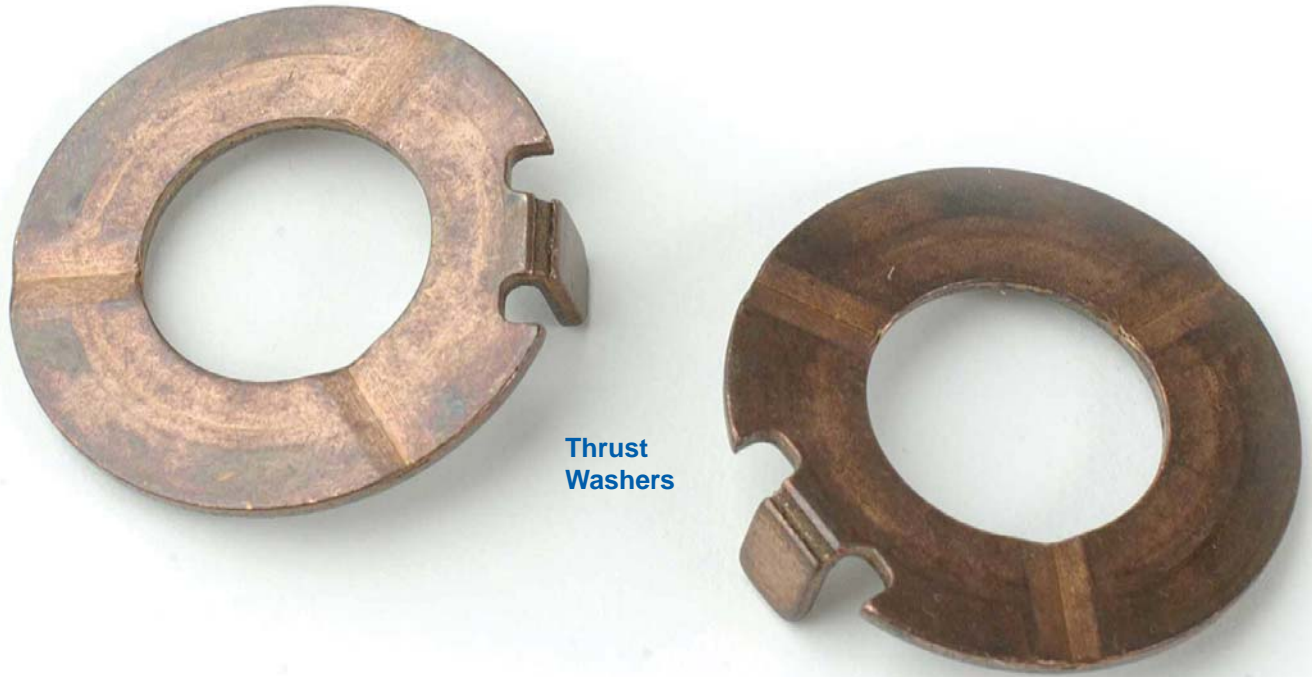
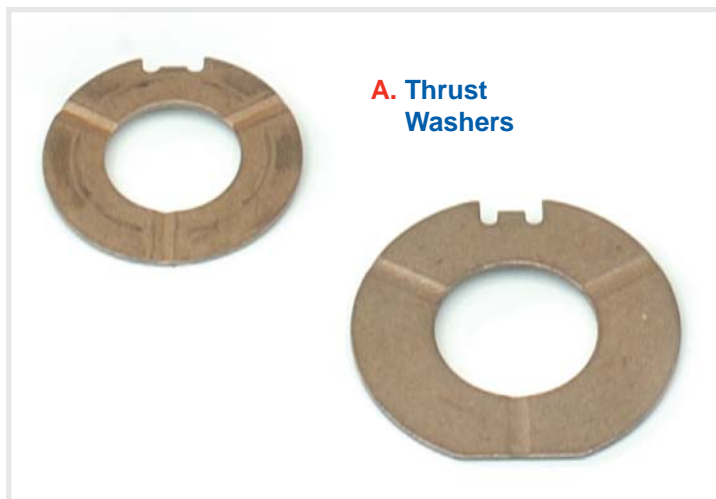
A. Replace thrust washers if they are worn beyond service limits. Replace thrust washers if they are galled, abraded or distorted. Replace thrust washers if they are damaged due to a lack of lubrication.

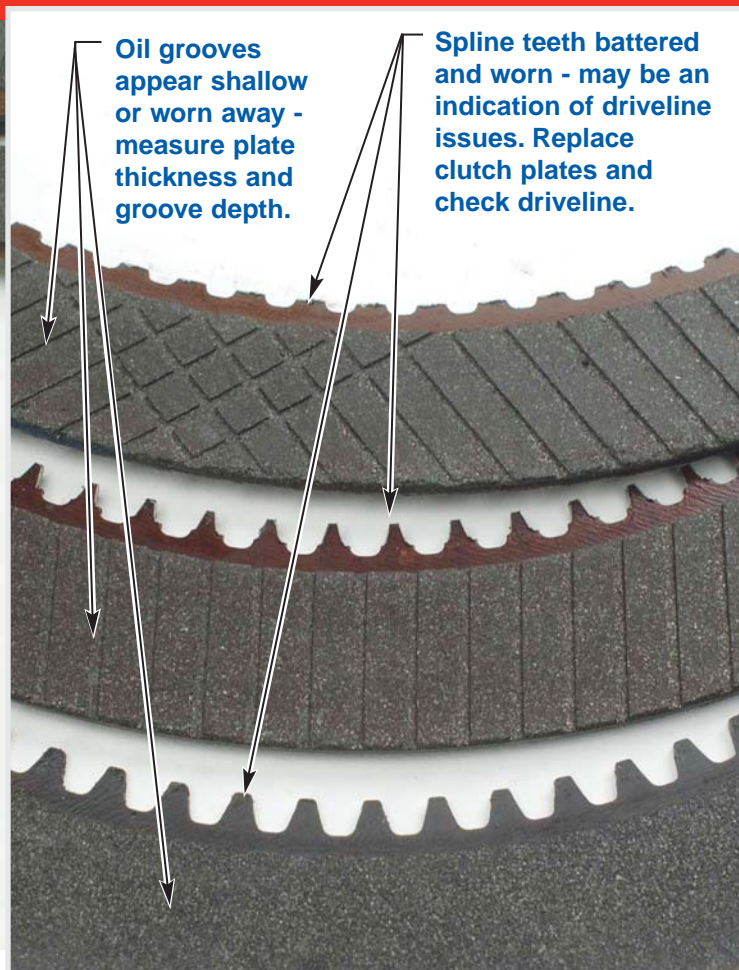
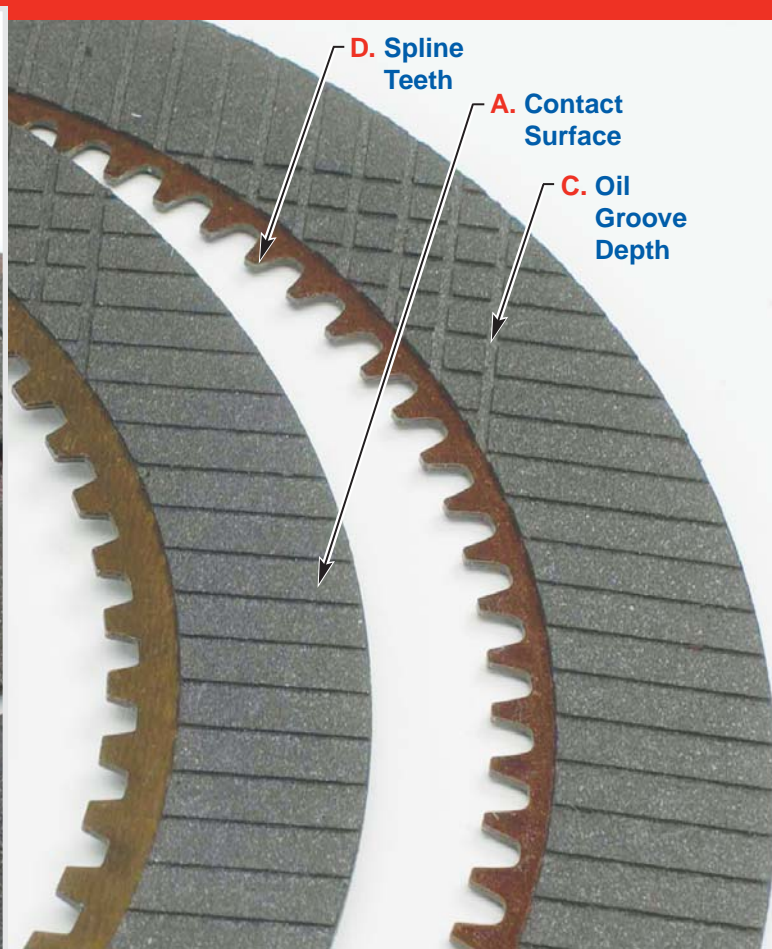
A. Inspect friction plate contact faces and splines for excessive wear, damage and coning. Inspect the plates for burrs, pitted faces, cracks, distortion and damaged spline teeth.

B. Measure friction plate thickness and coning. Reference the Service Manual for minimum thickness and maximum coning specifications. Do not reuse friction plates that do not meet published specifications. If reused plates are slightly coned (within specification), make sure each plate is stacked with the cone facing the same direction.

C. Measure friction plate oil groove depth. Replace any plates that are not within Service Manual minimum groove depth specification.

D. Inspect spline teeth for excessive wear and battering. Replace the clutch plate if damage cannot be repaired using a soft

stone or crocus cloth. Replace the clutch plate if spline teeth are broken or missing.

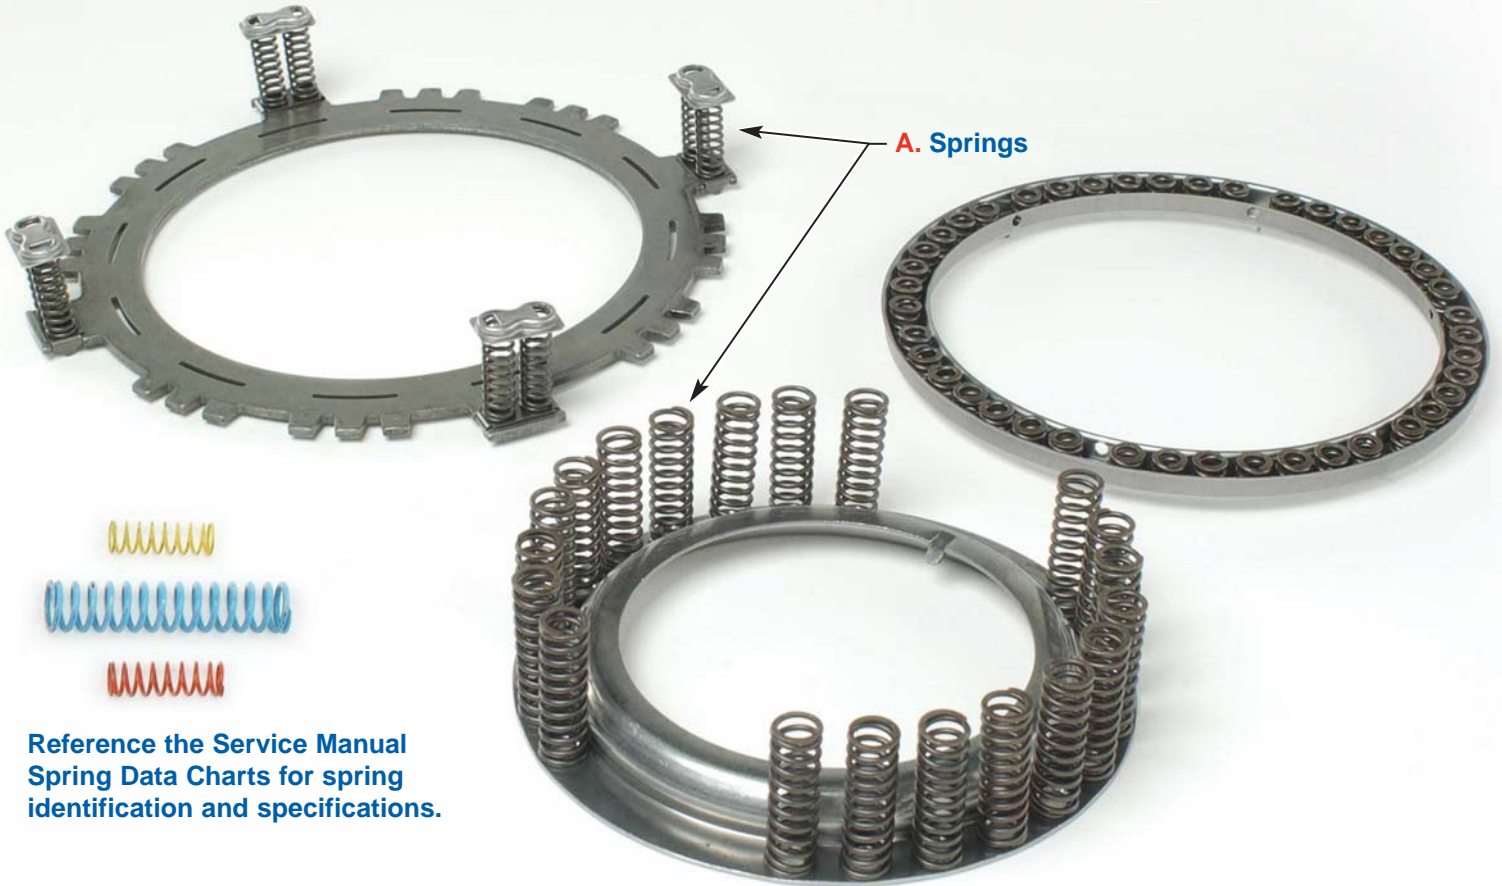
Reference the Service Manual Spring Data Charts for spring identification and specifications.

A. Inspect springs for permanent set and wear due to rubbing adjacent parts. Replace the spring if any of these defects are identified or if the spring fails to meet published service limits. Reference the Spring Data Charts in Service Manual SM2457EN for spring identification and service limit specifications.

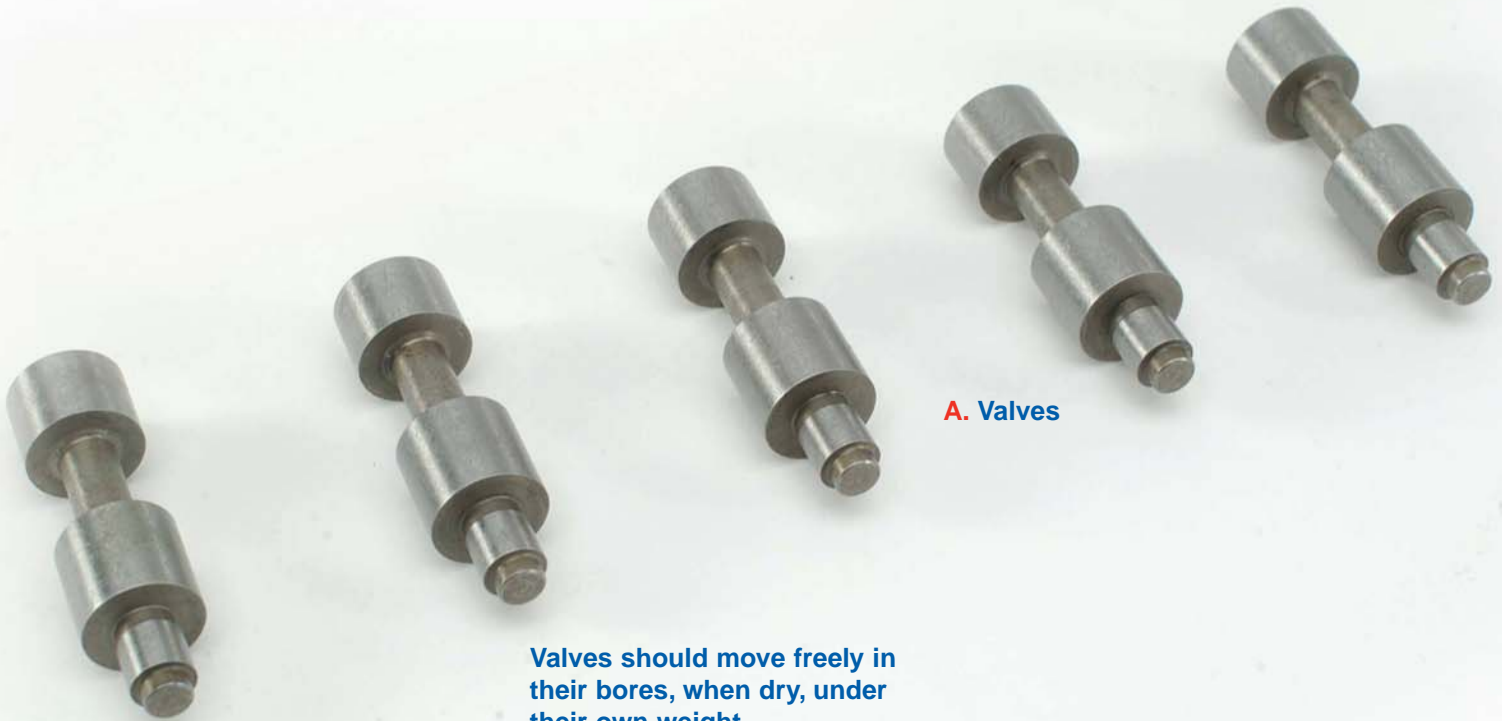
Valves should move freely in their bores, when dry, under their own weight.

A. Valves must be free of nicks, burrs and scoring and operate smoothly in their bores without sticking. Dry valves must move freely in their bores by their own weight. Replace damaged valves. A soft stone or crocus cloth can be used in an attempt to repair slight irregularities.

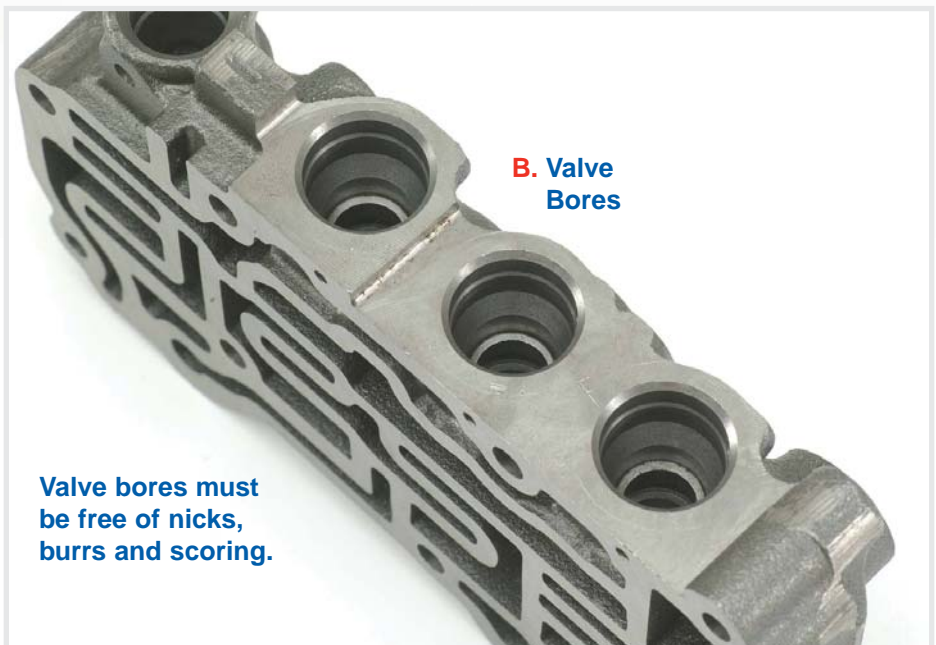
B. Valve Bores

B. Valve bores must be free of nicks, burrs and scoring. No honing of any kind is allowed. A soft stone or crocus cloth can be used in an attempt to repair slight irregularities.

Valve bores must be free of nicks, burrs and scoring.

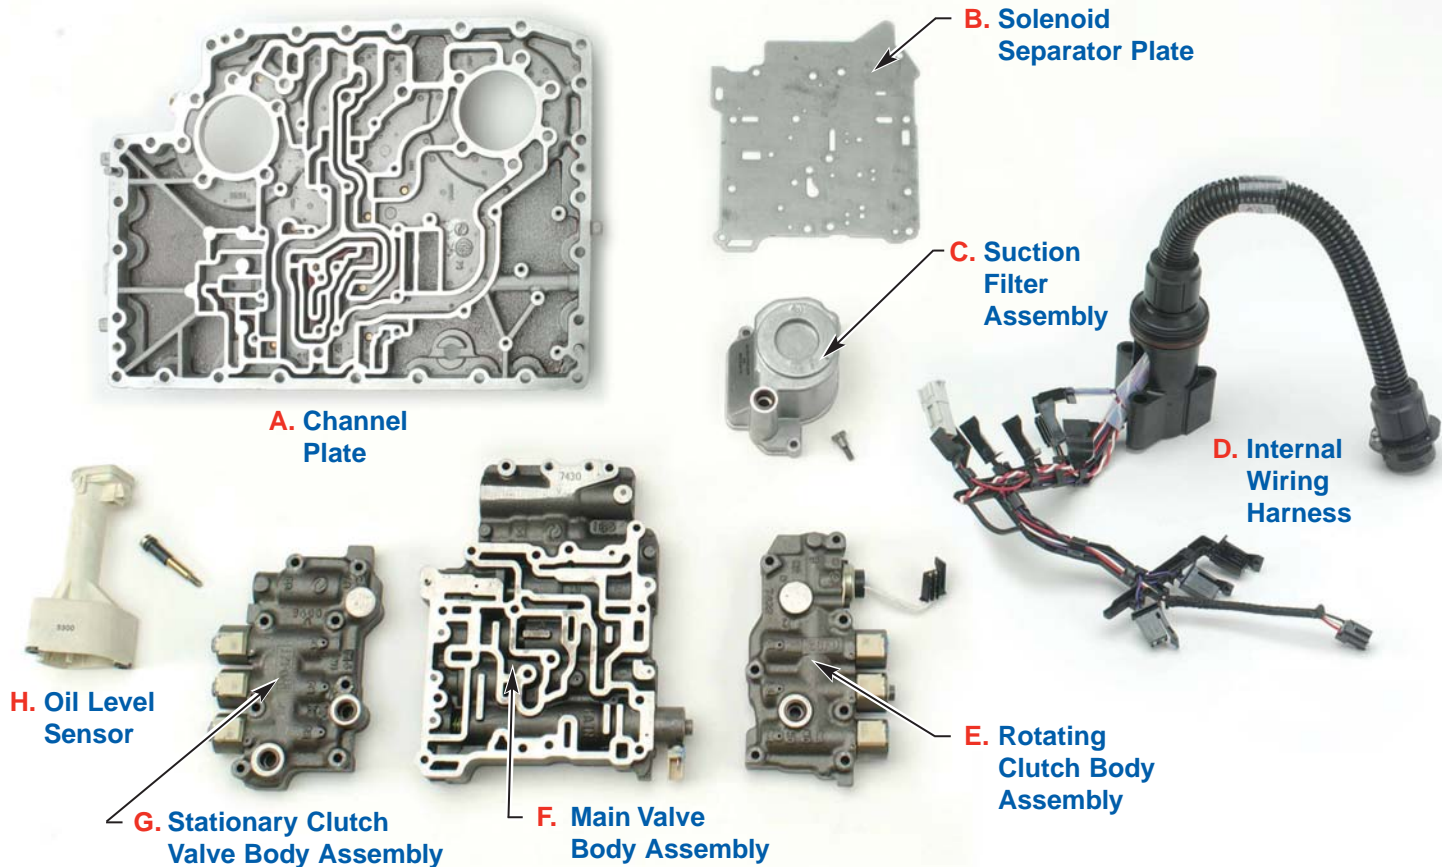
A. Inspect the channel plate for damage. All passages must be clear of debris. Inspect all machined surfaces for burrs, nicks or scoring. Light stoning and crocus cloth may be used to eliminate minor high spots. If a channel plate cannot be repaired so that all machined surfaces can seal correctly to their mating parts, or if thread damage cannot be repaired, replace the channel plate.

B. Inspect both separator plates for dents, nicks, burrs and other damage or distortion. Replace the plate if it has damage which cannot be repaired using a soft stone or crocus cloth. All passages must be clean and debris free.
(continued)

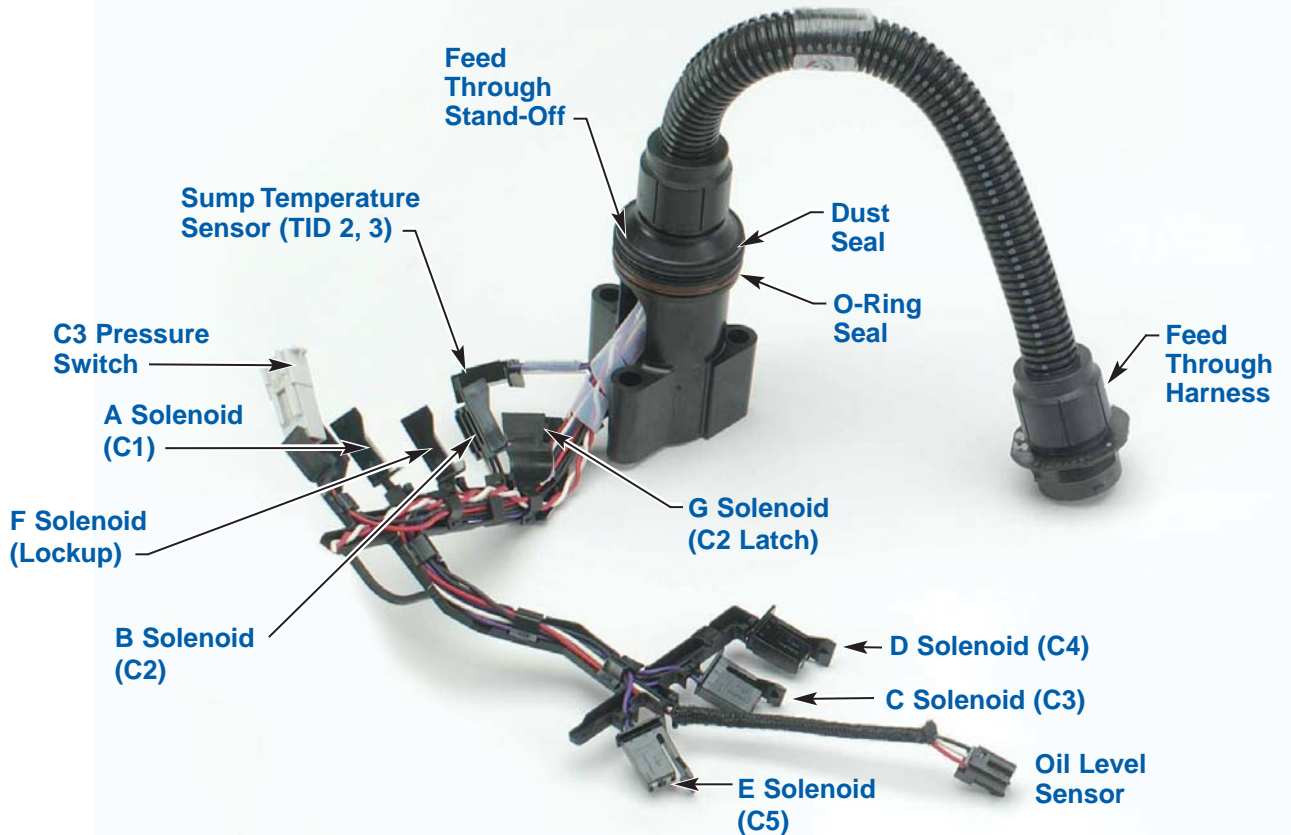
Identification Detail: Internal Wiring Harness

D. Replace or repair the control module wiring harness if the wires, terminals or connectors are visibly damaged. Inspect the molded harness channel for cracks or breaks. Replace the harness if the molded channel is damaged. Check sump temperature resistance following the guidelines and specifications listed in the Service Manual and Troubleshooting Manual.

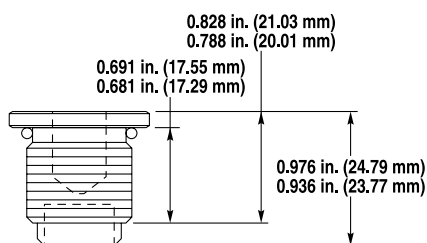
CURRENT OIL DRAIN PLUG ASSEMBLY - 29534362

Current plug is backward compatible with all control modules.

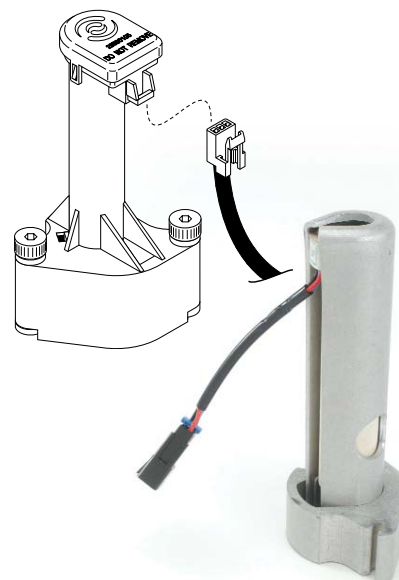
Oil Level Sensor Redesign - SIL 19-WT-99

Kit must be used when replacing former sensor with current sensor.

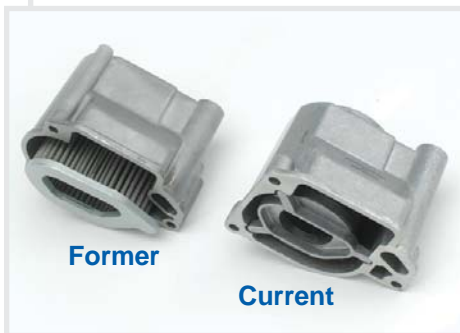
Suction Filter Redesign - SIL 1-WT-00

Former

Current

C. Replace the suction filter assembly during overhaul.

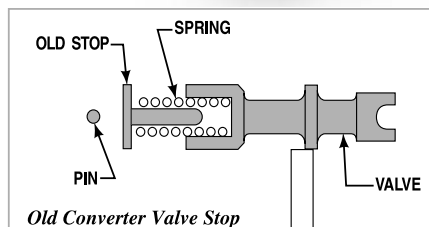
Converter Regulator Valve Stop Redesign - SIL 12-WT-99

Former Stop

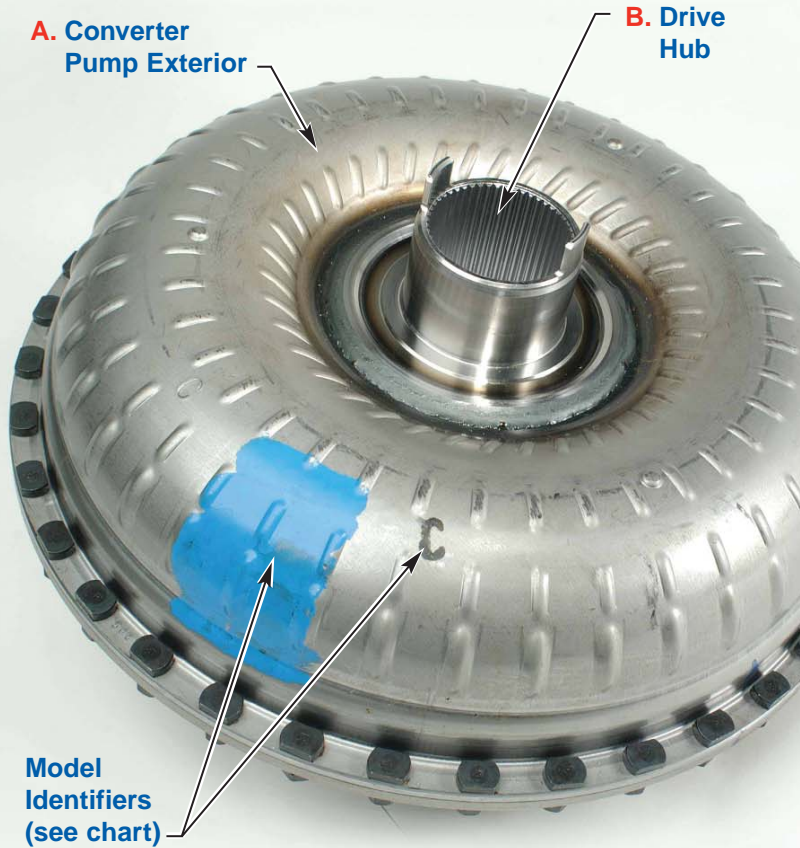
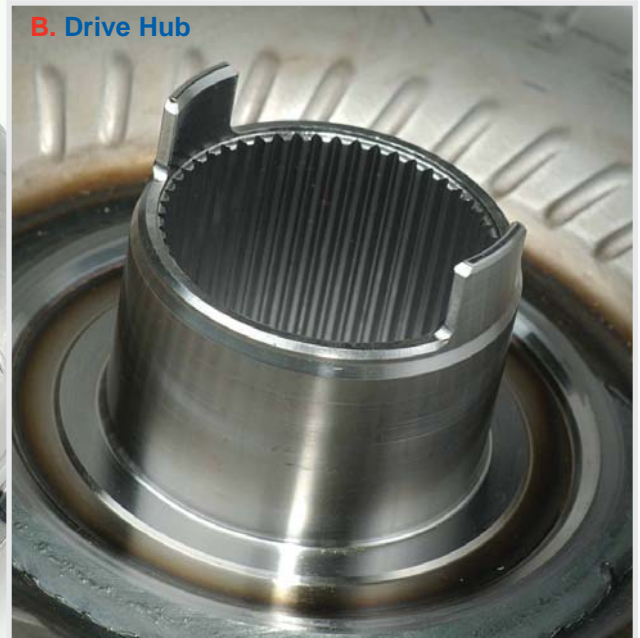
Inspect the pump hub tangs for cracks, impact damage and broken tangs.

A. Inspect the converter pump exterior for dents and sealing surface damage. Replace the converter pump if damage cannot be removed with a soft stone or crocus cloth.

B. Inspect the converter pump hub for damage and excessive wear. Minimum pump hub diameter is 88.99 mm (3.504 inch). Inspect the pump hub tangs for cracks, impact damage or broken tangs. Maximum allowable tang step wear is 0.31 mm (0.012 inch). On PTO-equipped models, check the splines inside the hub for wear and damage. Maximum spline wear is 0.38 mm (0.015 inch).

NOTE: Do not use crocus cloth on the converter pump hub. Polishing the hub with crocus cloth can cause improper input seal performance resulting in fluid leakage.

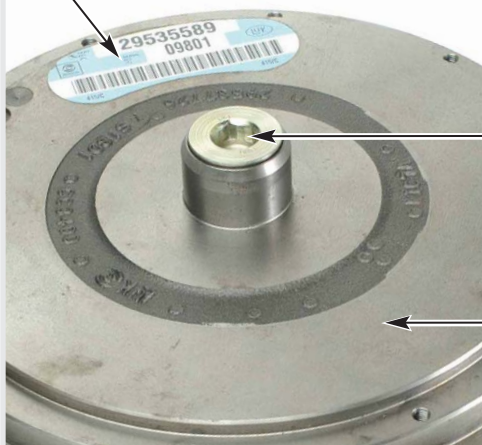
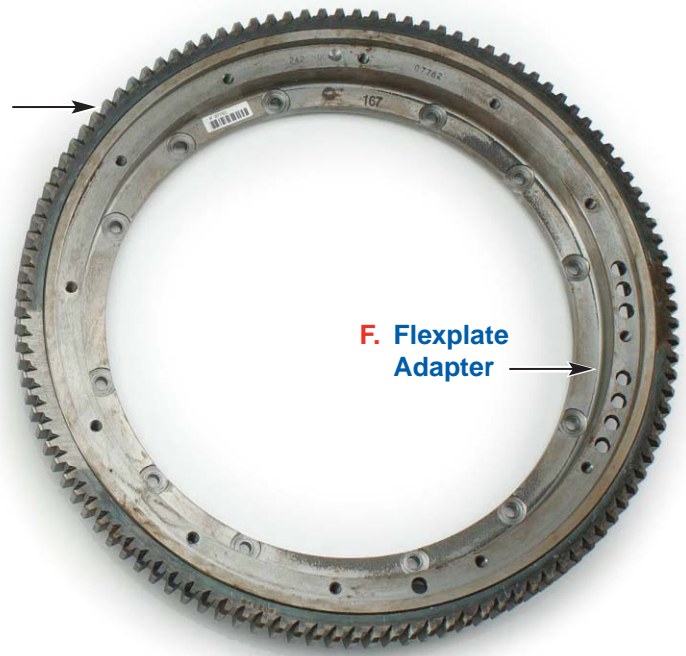
D. Pilot

C. Front Cover Mounting Face

E. Ring Gear

F. Flexplate Adapter

C. Inspect the torque converter front cover mounting faces for damage. Inspect the flexplate adapter bolt holes for stripped or damaged threads.

D. Inspect the front cover pilot for damage and wear. Maximum pilot diameter is 61.77 mm (2.432 inches). Inspect the torque converter end plug and the retaining bolt for stripped or damaged threads. Verify that the correct turbine shaft selective shim is installed following the Service Manual procedures.

E. Inspect the engine starter ring gear for chipped, worn or broken teeth.

F. Inspect the flexplate adapter mounting faces for surface damage. Replace the adapter if damage cannot be repaired using a soft stone or crocus cloth. Inspect the flexplate adapter bolt holes for stripped or damaged threads. Clean damaged threads using the correct size tap. Replace the adapter if damage cannot be repaired.

NOTE: The flexplate adapter bolt holes use Spiralock® threads. A Spiralock® tap must be used when repairing damaged threads. Using a standard tap will destroy the locking feature. If this occurs, the torque converter front cover must be replaced.
