TECHNICIANS' GUIDE

INSPECTION AND ANALYSIS OF THE ALLISON 4000 & B 500 PRODUCT FAMILIES

INSPECTION AND ANALYSIS OF THE ALLISON 4000/B 500 PRODUCT FAMILIES

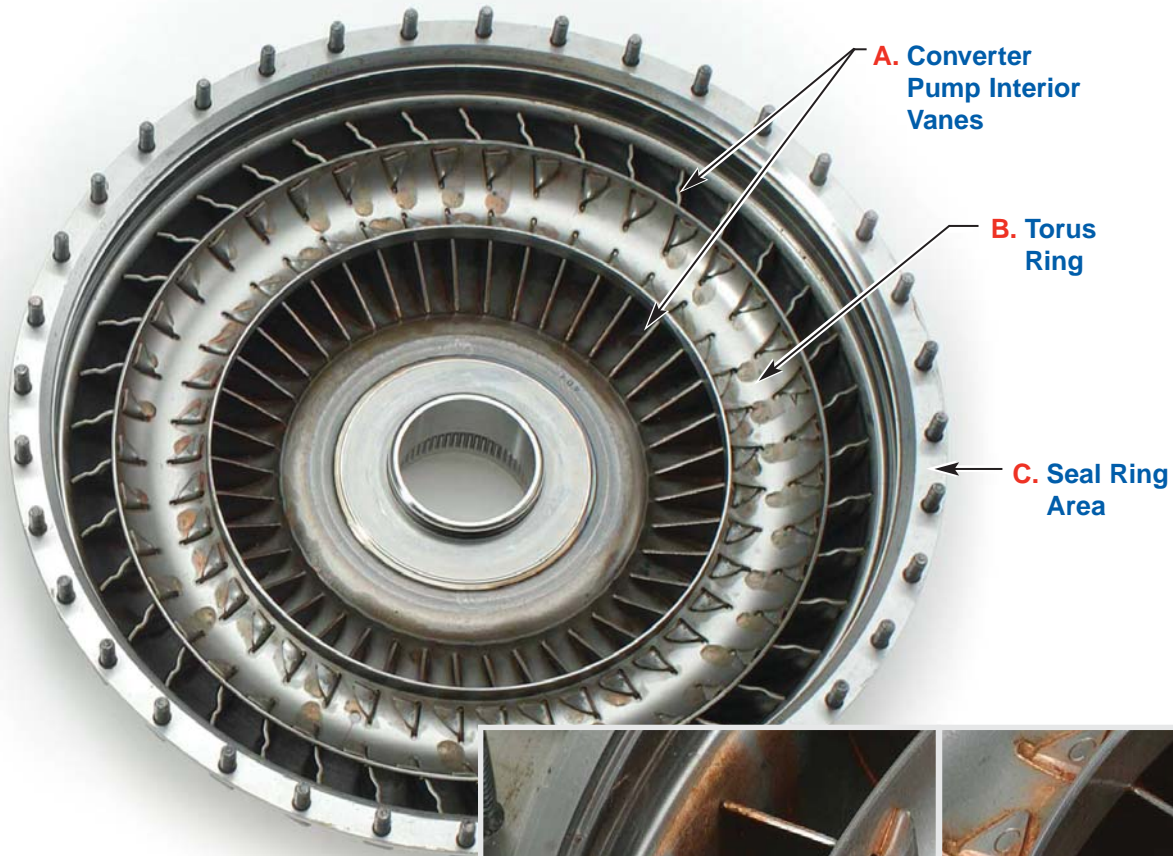
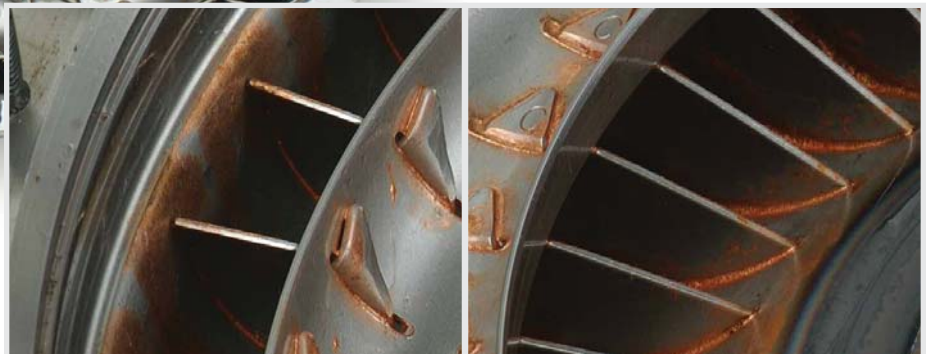
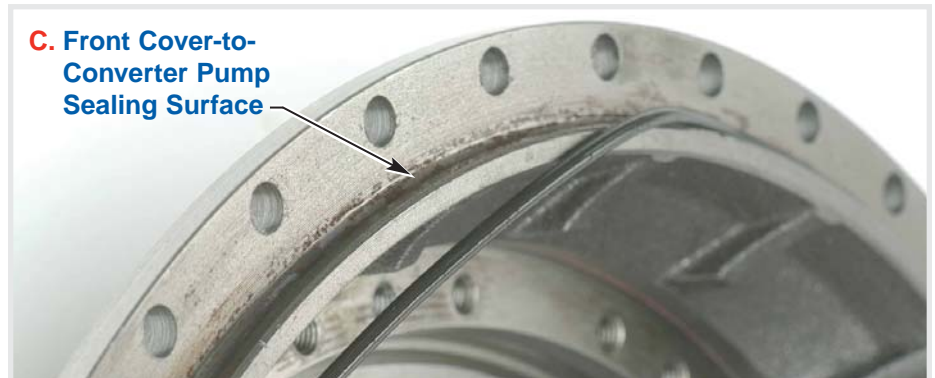
A. Inspect the converter pump interior. Replace the assembly if the vanes are damaged, cracked or loose.

B. Replace the converter pump assembly if the torus ring is loose or cracked.

C. Inspect the seal surface between the converter pump assembly and the front cover. Light stoning is permitted to remove slight irregularities.

Replace the assembly if the vanes are damaged, cracked or loose.

C. Front Cover-to-Converter Pump Sealing Surface

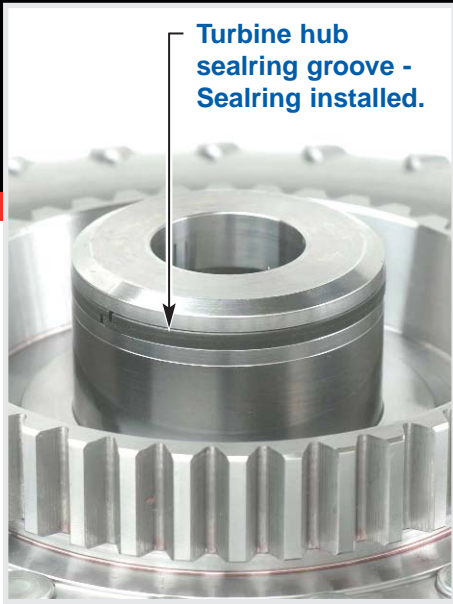
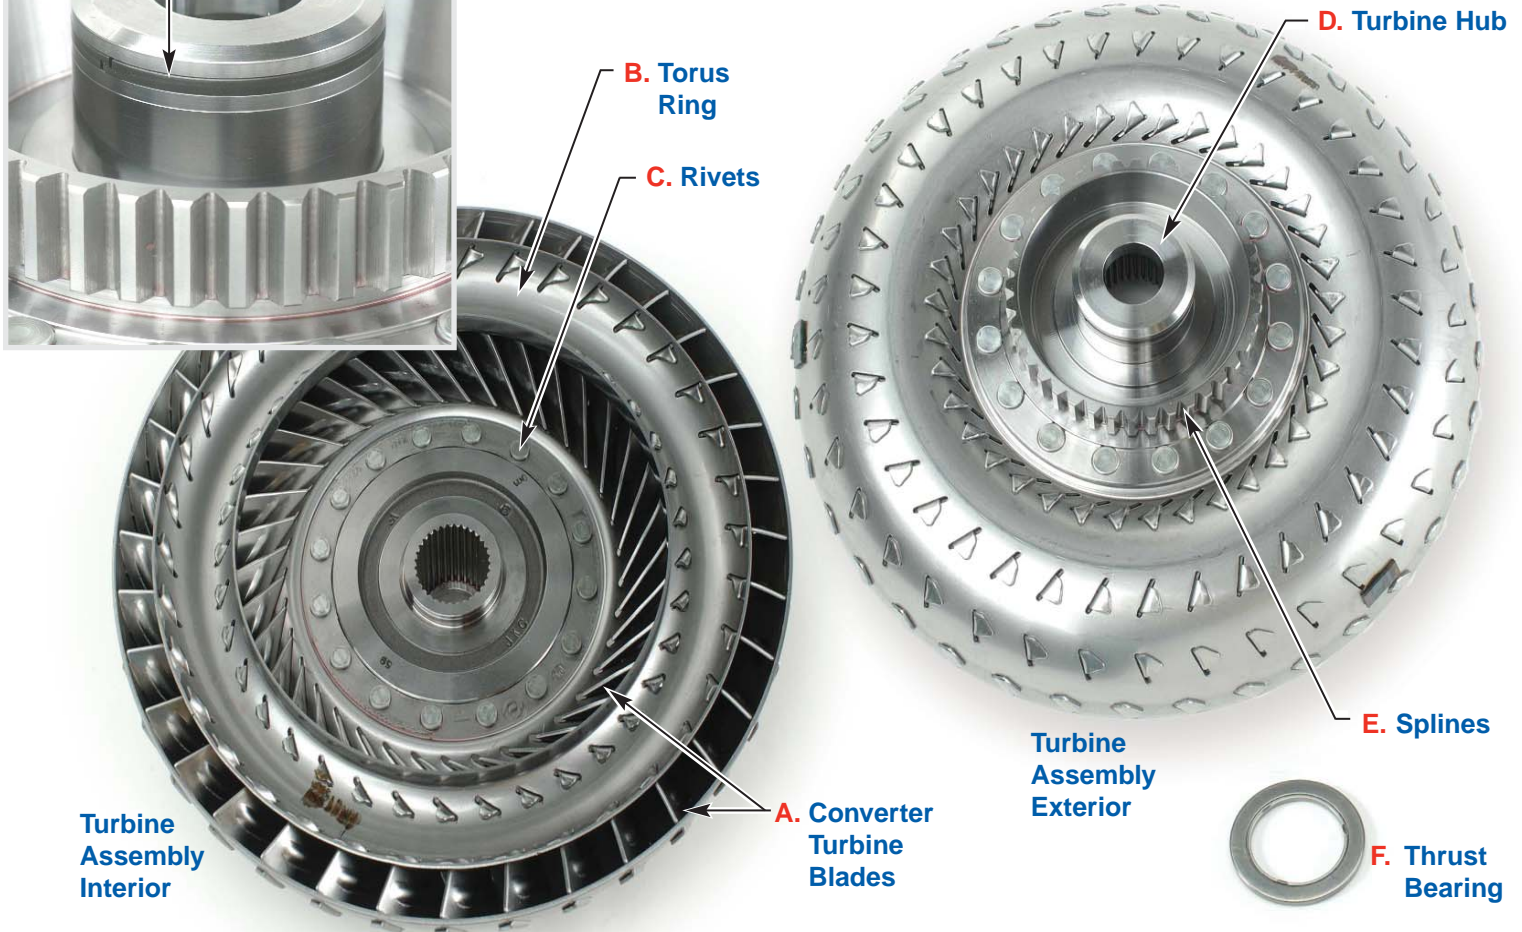
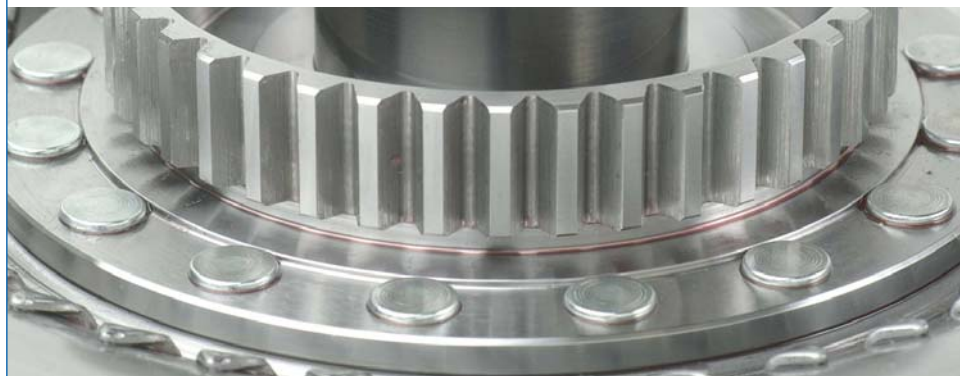
A. Inspect the converter turbine assembly. Replace the assembly if the blades are cracked, broken or loose.

B. Inspect the torus ring. Replace the turbine assembly if the torus ring is loose or cracked.

C. Inspect the rivets. Replace the turbine assembly if the rivets are loose or cracked.

D. Inspect the converter turbine hub. Replace the converter turbine assembly if the hub is worn beyond limits. Minimum allowable hub diameter is 66.69 mm (2.626 inches). Inspect the sealring groove for damage.

E. Inspect the hub splines for damage and wear. Spline movement between the lockup damper and turbine hub cannot exceed 0.38 mm (0.015 inch). Replace the turbine assembly if splines are excessively worn.

F. Inspect the thrust bearing following the “General Inspection Guidelines for Bearings” section of this manual. Replace any thrust bearing failing these inspection procedures.

Inspect the hub splines and rivets for damage and wear.

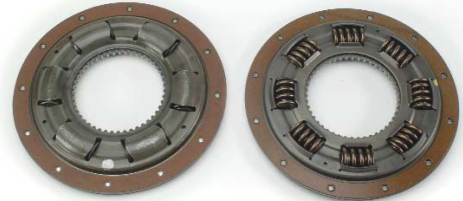
Lockup Clutch Damper Assembly
Update SIL-4-WT-00, Rev. B

Current damper is backward compatible with all torque converter assemblies. ECU recalibration is not necessary.

D. Backplate

A. Torque converter lockup clutch components fit inside the front cover. Install a new turbine sealing in the converter cover bore then measure the sealing inside diameter. Replace the cover assembly if diameter exceeds 61.77 mm (2.432 inch).

B. Inspect the converter cover bushing for damage. Replace the bushing if damage cannot be removed with crocus cloth. Maximum allowable bushing inside diameter is 66.91 mm (2.634 inch).

C. Inspect the lockup clutch piston for damage. Minimum allowable piston thickness is 6.53 mm (0.257 inch).

D. Inspect the lockup clutch backplate for damage, scoring and overheating. Minimum allowable plate thickness is 11.79 mm (0.464 inch).

NOTE: If the backplate is within thickness limits but has surface damage due to metal transfer between the backplate and lockup damper, the plate may be reused by turning it over so that the lockup damper has a new contact surface.

E. Replace the lockup clutch damper if the friction surfaces are worn beyond service limits. Minimum allowable friction surface thickness is 8.51 mm (0.335 inch). Maximum allowable damper distortion is 0.51 mm (0.020 inch). Maximum allowable movement between the damper and converter turbine splines is 0.38 mm (0.015 inch). Replace the damper if any of these measurements are beyond allowable limits.

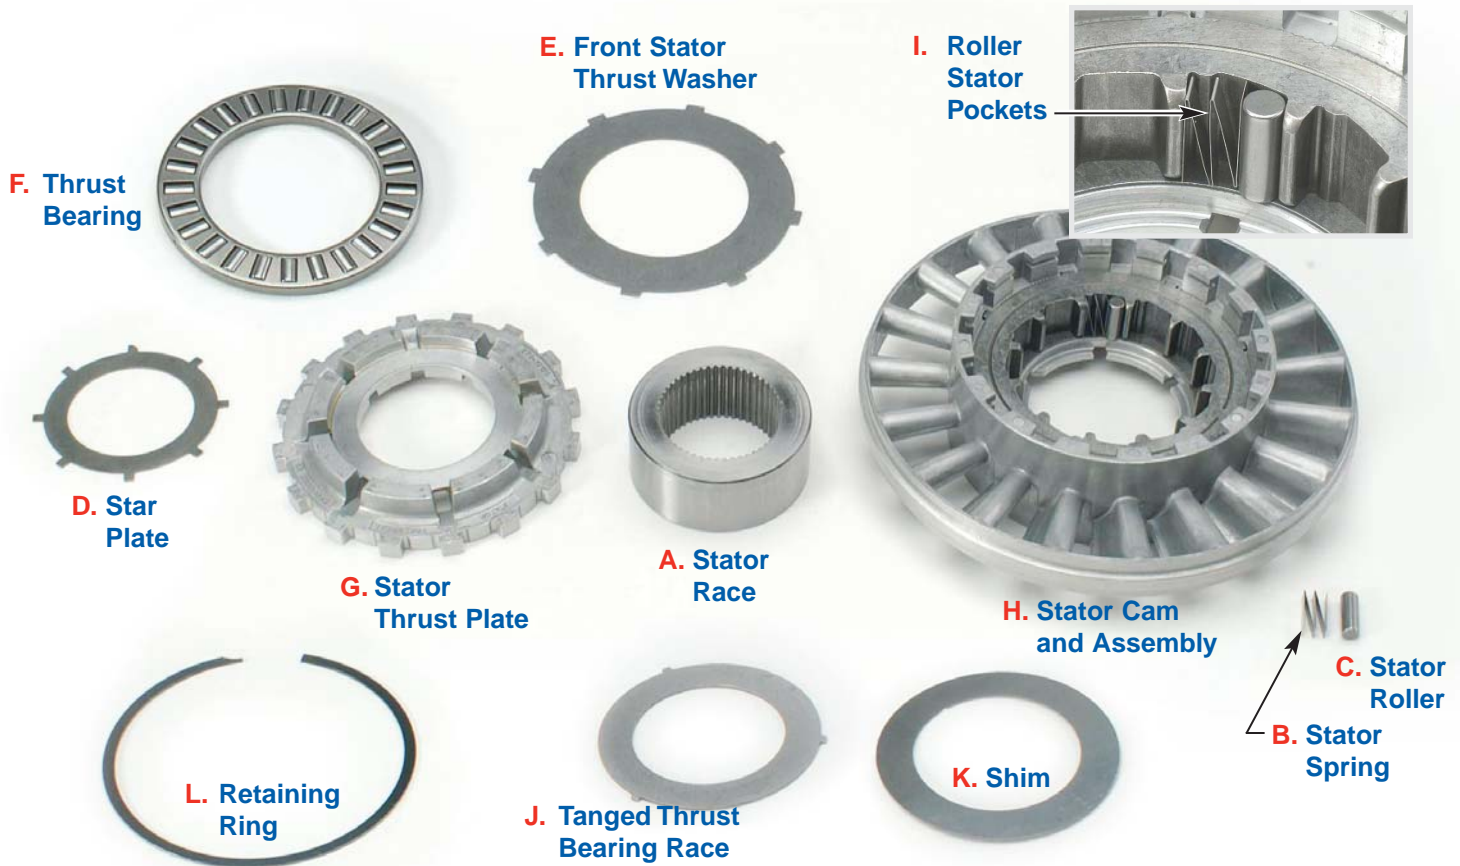
A. Inspect the stator race for damage. Replace the race if damage cannot be repaired using a soft stone or crocus cloth.

B. Inspect the stator springs for correct spring height following per the Service Manual. Replace any spring which has a free length below 17.8 mm (0.700 inch).

C. Inspect the stator rollers for damage. Rollers should be smooth, round and defect-free. Replace damage or worn rollers.

D. Inspect the star plate for excessive wear. Replace the star plate if damage cannot be repaired using a soft stone or crocus cloth.

E. Inspect the front stator thrust washer for wear beyond service limits. Replace the stator thrust washer if it is worn 0.40 mm (0.010

inch) or more. If it is within service limits, the thrust washer can be turned over and the un-worn surface can be used.

F. Inspect the thrust bearings following the “General Inspection Guidelines for Bearings” section of this manual. Replace any thrust bearings failing these inspection procedures.

G. Inspect the stator thrust plate for damage and wear. Replace the plate if damage cannot be removed using a soft stone or crocus cloth. Minimum allowable plate thickness is 9.45 mm (0.372 inch).

H. Inspect the stator and cam assembly for damage. Replace the stator and cam assembly if damaged.

I. Inspect the stator roller pockets for wear and damage. Verify correct spring-to-roller orientation. Inspect the bottom of the cam pocket for wear. Replace the stator and cam assembly if it is worn 0.40 mm (0.010 inch) or more in the bottom of the pocket.

J. Inspect tanged thrust bearing race for damage. Replace any damaged race.

K. Inspect shim for damage. Replace any damaged shims. Use procedure for shim selection in 4000 Series Service Manual.

L. Inspect the retaining ring for damage and distortion. Replace any distorted or damaged retaining rings.

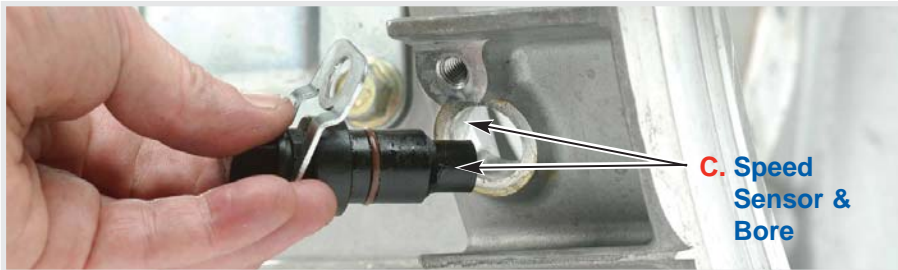
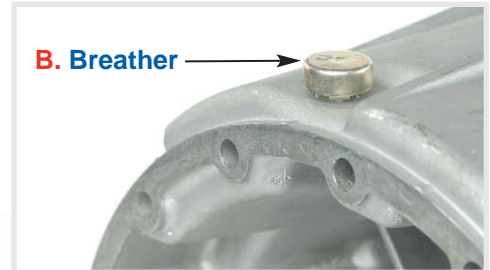
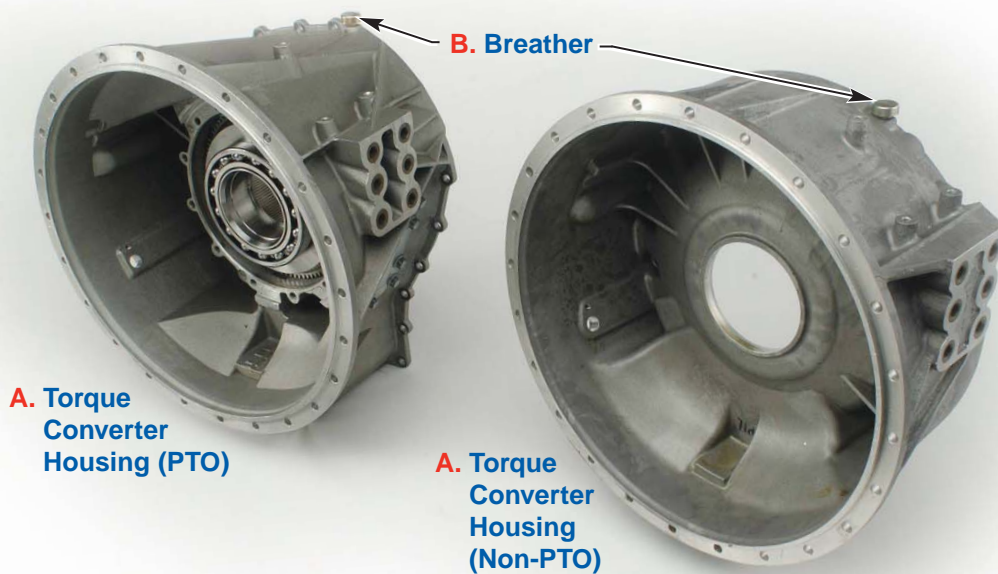
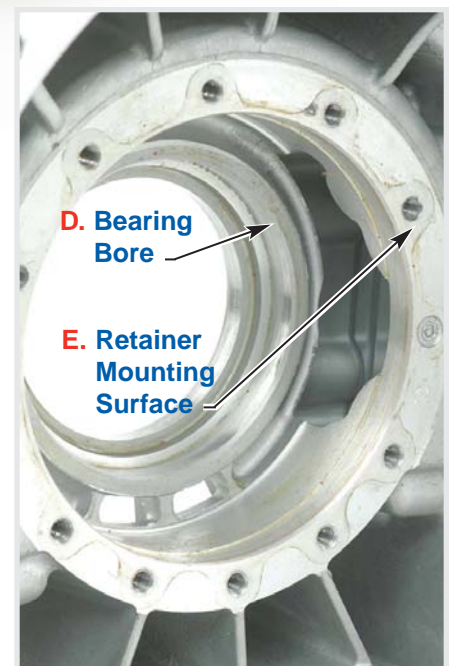
A. Inspect for torque converter housing damage. High spots may be removed with crocus cloth or a soft stone. Inspect threaded holes for debris and thread damage. Replace the torque converter housing if it is cracked, if it leaks from a damaged machined surface, or if it has thread damage which cannot be repaired.

B. Inspect the breather for damage and obstructions. Replace the breather if it is damaged. Clean the breather if it is blocked with debris.

C. Replace the input speed sensor if the sensor body or electrical terminals are damaged. Speed sensor resistance is 300 ohms (plus or minus 30 ohms). Replace the

D. On PTO-equipped models, inspect the converter housing bearing bore for wear. Maximum allowable bearing bore inside diameter is 180.05 mm (7.088 inches). Replace the housing if damage cannot be repaired using a soft stone or crocus cloth.

E. Inspect the PTO bearing retainer mounting face surface and threads for damage. Replace the housing if surface damage cannot be repaired using a soft stone or crocus cloth. Replace the housing if thread damage cannot be repaired.

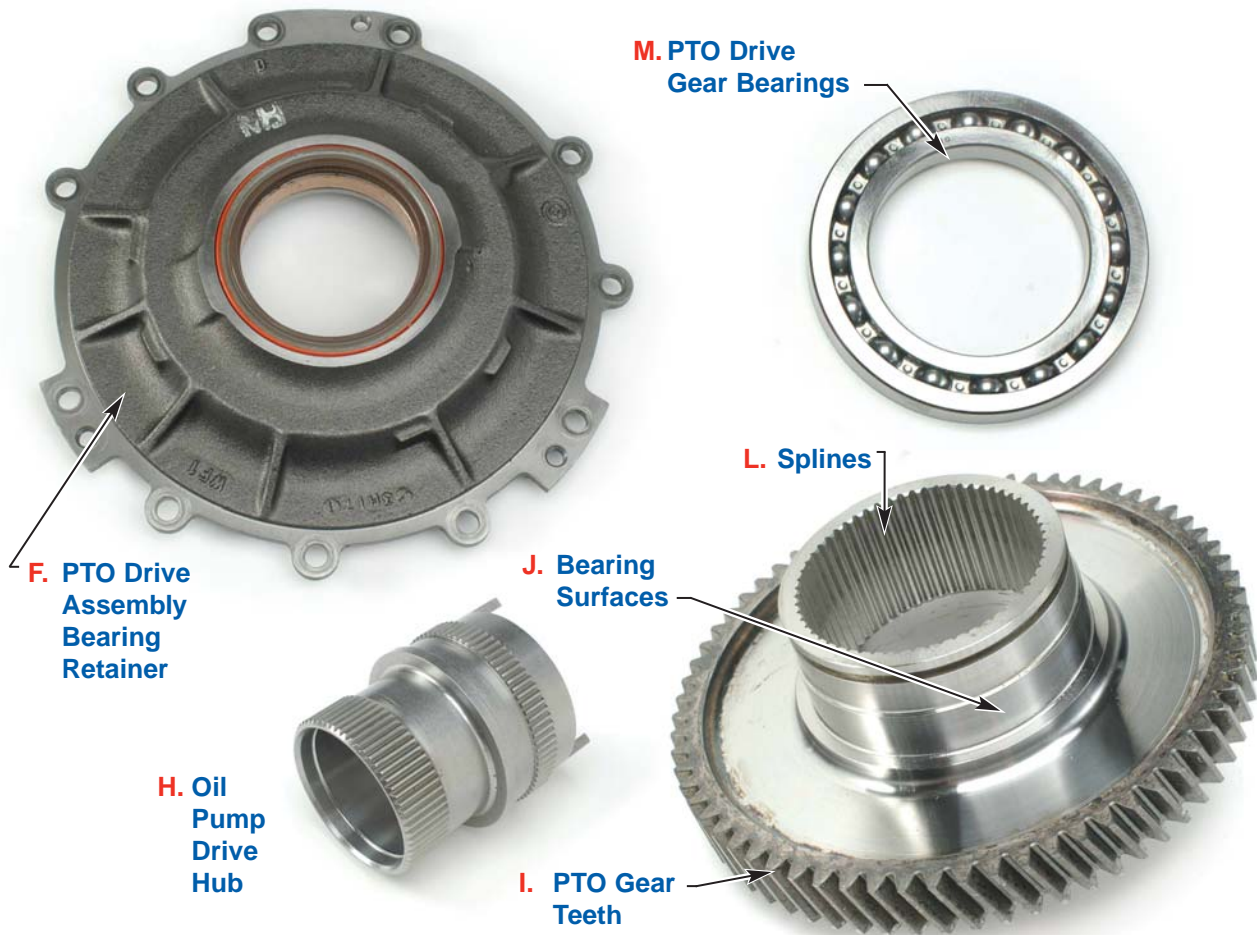
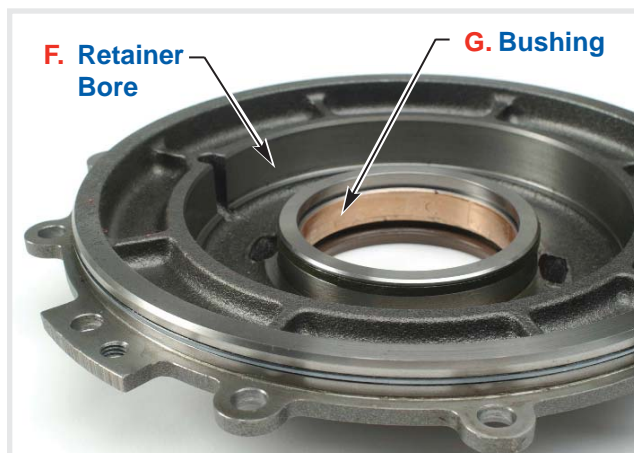
F. On PTO-equipped models, inspect the PTO drive bearing retainer housing bore for damage. Replace the retainer if damage cannot be repaired using a soft stone or crocus cloth. Replace the retainer housing if the bushing has spun in the bushing bore.

G. Inspect the retainer housing bushing for damage and wear. Replace the bushing if damaged. Maximum allowable bushing inside diameter is 89.19 mm (3.511 inches). Replace the bushing if it is worn beyond service limits.

I. Inspect the PTO drive gear teeth for chips, pitting and excessive wear. Replace the gear if damage cannot be repaired using a soft stone or crocus cloth.

NOTE: Some axial movement of the gear is normal, but movement should not exceed 3.175 mm (0.125 inch). Replace the PTO bearings if axial movement exceeds service limit.

NOTE: Normal operating backlash after PTO is installed is 0.1 mm to 0.66 mm (0.004 to 0.026 inch).

H. Inspect the oil pump drive hub. Replace the drive hub if damage cannot be repaired using a soft stone or crocus cloth.

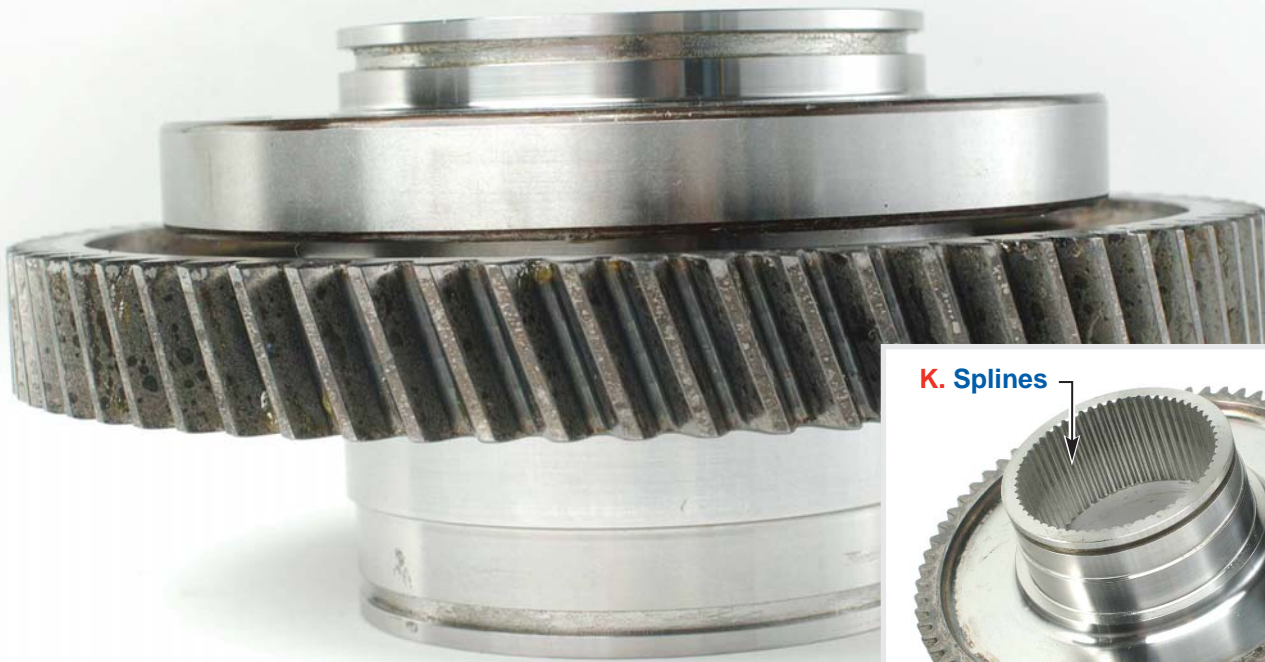
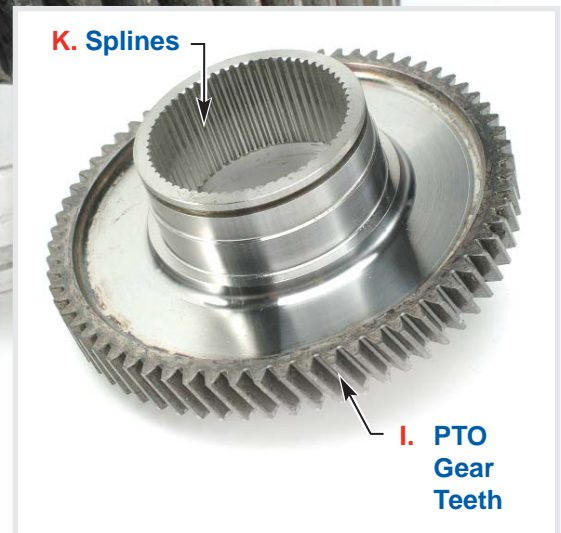
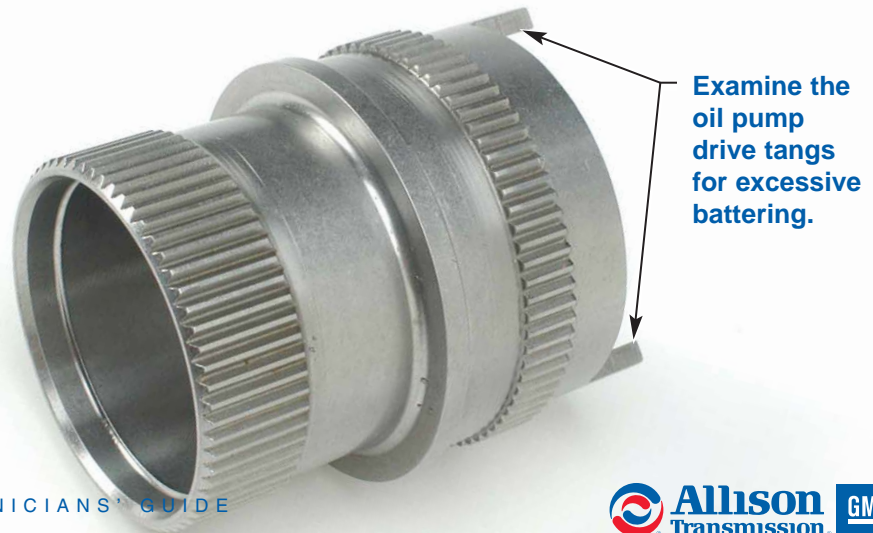
J. Inspect the PTO drive hub tangs for step wear, deformation and cracks. Replace the drive hub if tang step wear exceeds 0.38 mm (0.015 inch) or if either tang is deformed or cracked.

NOTE: Drive hub tang breakage or deformity accompanied by charging pump bushing failure and ground sleeve wear is often caused by poor transmission fluid condition due to improper maintenance intervals. Observation of proper fluid change intervals is key to optimum transmission life.

K. Inspect the drive hub splines for wear. Replace the drive hub if spline wear exceeds 0.38 mm (0.015 inch).

L. Inspect the PTO drive gear bearings following the “General Inspection Guidelines for Bearings” section of this manual. Replace either bearing as needed.

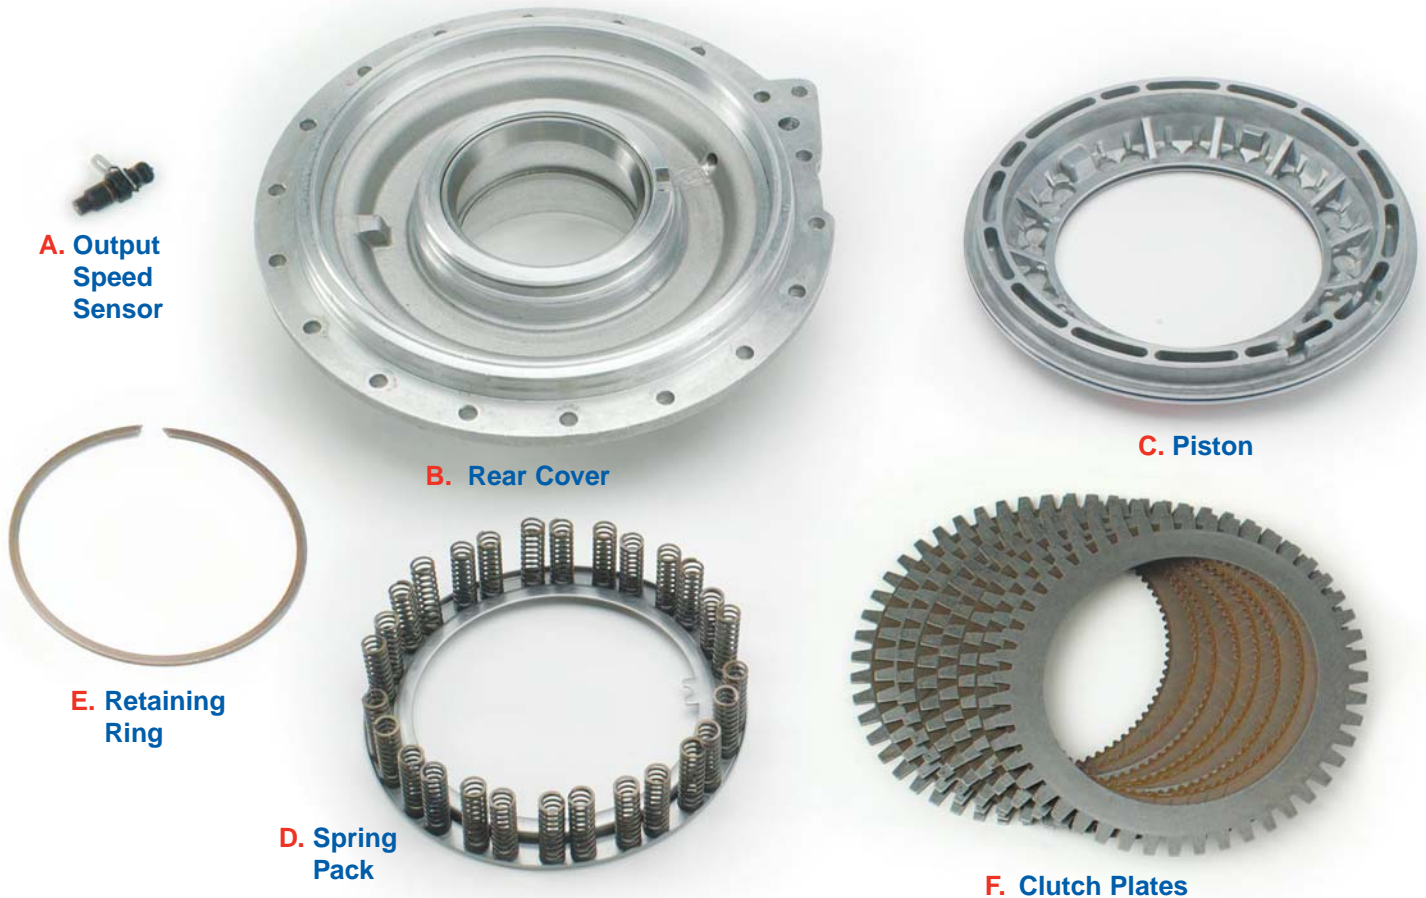
A. Inspect the output speed sensor for damage. Replace any sensor that has body, terminal or connector seat damage. Allowable output speed sensor resistance is 300 ohms plus or minus 30 ohms.

B. Inspect the rear cover following the “General Inspection Guidelines for Cast Parts and Machined Surfaces” section of this manual. High spots on machined surfaces can be removed using a soft stone or crocus cloth. Inspect the slot on the back side of the housing where the C5 piston tang indexes. Replace the rear cover if

damage to any machined surface cannot be repaired using a soft stone or crocus cloth. Replace the rear cover if it is cracked.

C. Inspect the C5 clutch piston following the “General Inspection Guidelines for Cast Parts and Machined Surfaces” section of this manual. Replace the piston if it fails to meet the inspection guidelines. Inspect the C5 piston tang for excessive wear.

D. Inspect the C5 clutch spring pack for damage due to rubbing adjacent parts and cracked or broken pieces. Check springs for wear, breakage and damage. Reference the Spring Data Charts in the Service Manual SM2457EN for spring specifications and identification.

E. Replace the C5 retaining ring if it is bent or distorted.

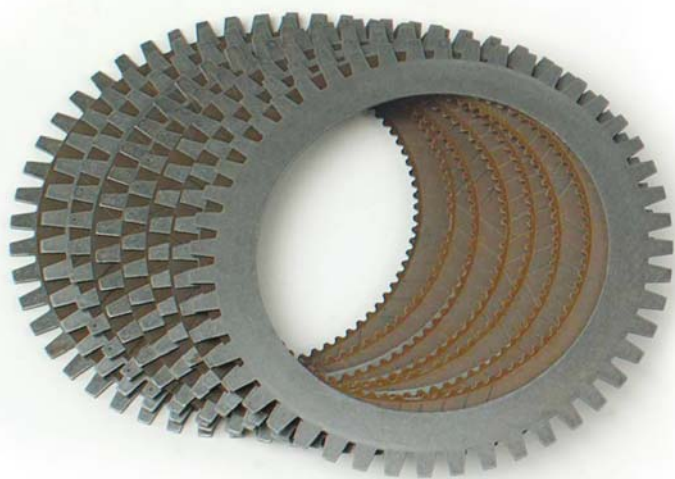
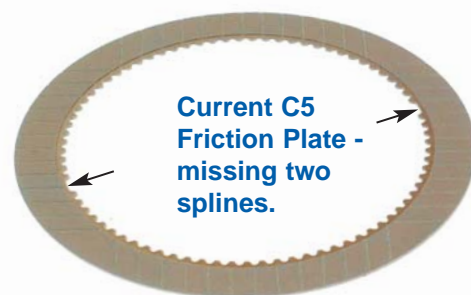
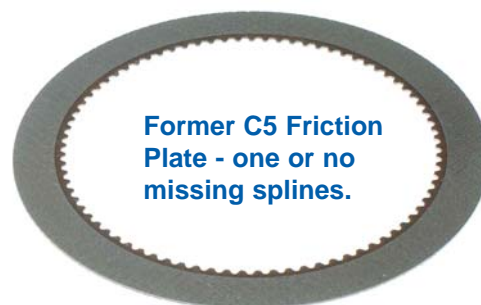
**C5 Friction Plate Update -
SIL 4-WT-00, Rev. B and SIL 12-WT-03**

F. Clutch Plates

**Clutch plate identification is made by
counting the number of missing teeth.**

F. Inspect the C5 friction clutch plates following the “General Inspection Guidelines for Friction Plates” section of this manual. Discard any plates that do not meet the guidelines. Minimum allowable thickness for reuse is 3.48 mm (0.137 inch). Minimum oil groove depth for reuse is 0.20 mm (0.0008 inch). Maximum cone for reuse is 0.25 mm (0.010 inch).

NOTE: Battered and worn spline teeth may be an indicator of driveline issues. Replace the clutch plates and check the driveline.

NOTE: The current clutch friction plates were implemented April of 2000 starting with s/n 6610062126. Current clutch friction plates will have two or more missing splines. Former friction plates will either have one spline missing or none

missing. Any 4000/B 500 model transmission may be updated from former C5 friction plates to current C5 frictions without recalibrating the transmission ECU. The rest of the clutches in the main housing (C1 through C4) must be updated with current friction plates if any other individual clutch besides C5 is updated from former to current friction plates. Any update from former frictions to current frictions in C1 through C4 for a 4000 Series or B500 with a WTEC II ECU will require a new ECU calibration from Allison Transmission. Any update

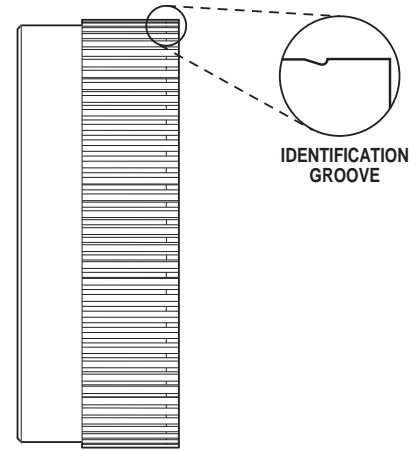
**FORMER (NON-HARDENED)
P3 RING GEAR**

**Use C5 friction
plate missing
3 internal teeth.**

The P3 ring gear changed to a harder ring gear on s/n 6610027070. The current P3 ring gear identifier is a groove machined around the outer diameter of the gear. The P3 ring gear with a groove identifier requires the C5 friction with two missing splines if updating from former C5 frictions. If any

4000/B500 series model without the harder ring gear (no groove on O.D.) is being updated with current C5 frictions, then it will require the C5 friction that has three missing internal splines. The C5 friction plate missing three splines will exhibit spline wear if used with the current P3 ring gear with a groove identifier on the O.D. The former P3 ring gear (no groove on O.D.) will exhibit premature wear if used with the current C5 friction with two missing internal splines. No ECU calibration is necessary for updating C5 clutch plates.

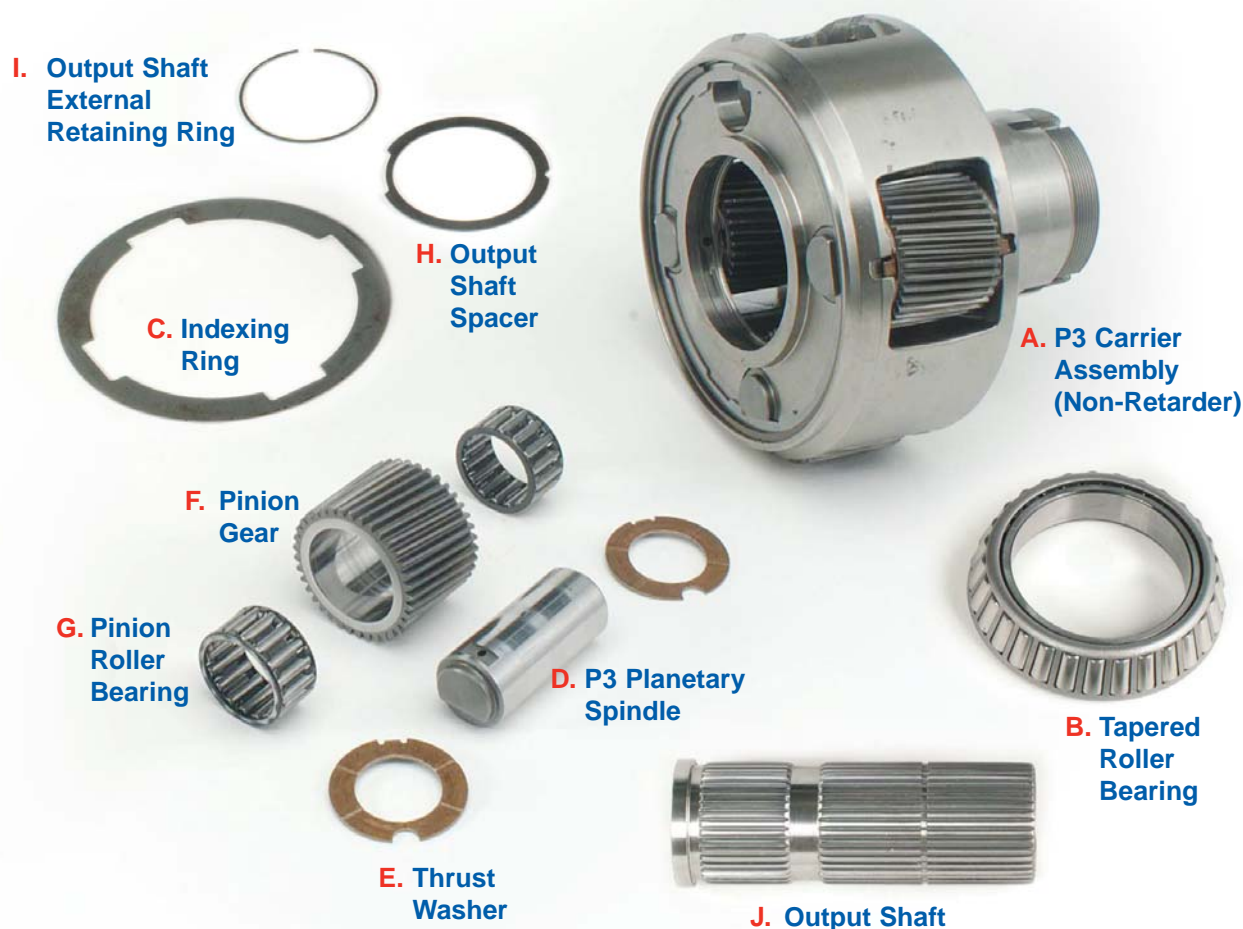
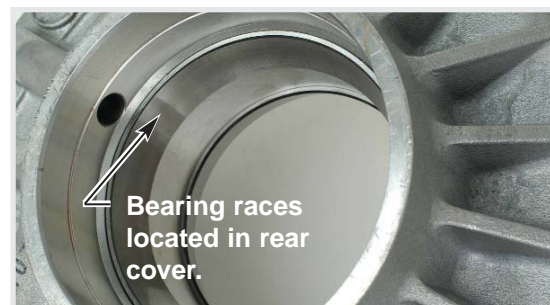
A. Verify a proper press fit between the P3 carrier and rear cover or retarder housing by inverting the carrier over a table or workbench. If the P3 carrier falls out of the rear cover or retarder housing without using a press or mallet, the press fit between the tapered bearings and P3 carrier no longer exists and the carrier must be replaced.

Inspect the P3 carrier for spline wear. Replace the carrier if spline wear exceeds 0.38 mm (0.015 inch). Inspect the pinion spindle bores in the carrier and the pinion thrust surfaces for excessive wear and damage. Replace the P3 carrier if a

spindle has more than 0.051 mm (0.002 inch) clearance in the bore. Inspect for thread damage on the carrier hub. Replace the carrier if threads are damaged.

B. Inspect the tapered roller bearings and races following the “General Inspection Guidelines for Bearings” section of this manual. Replace any bearings failing to meet the inspection guidelines. Bearing races are located in the rear cover housing and should also be inspected for wear and damage.

C. Inspect the P3 indexing ring for step wear in the area where it contacts the spindle. Replace the

indexing ring if it is broken or if it has excess step wear or damage which cannot be repaired using a soft stone or crocus cloth. Indexing rings with acceptable wear can be flipped during reassembly so that a new contact surface is used.

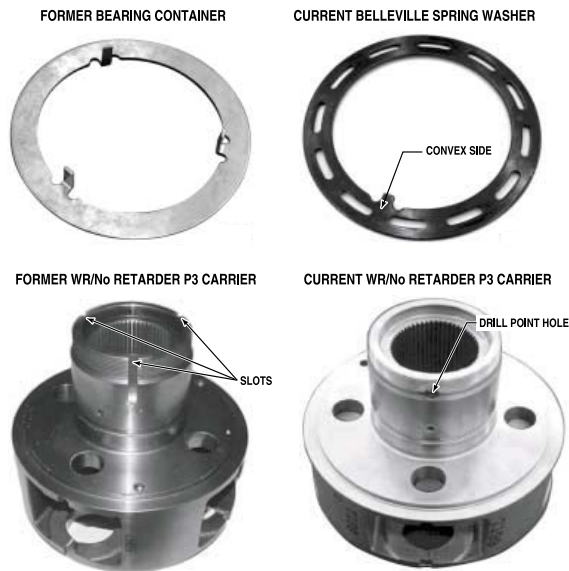
P3 Carrier Update - SIL 25-WT-01

Current P3 carriers use a drill point hole and a Belleville spring washer.

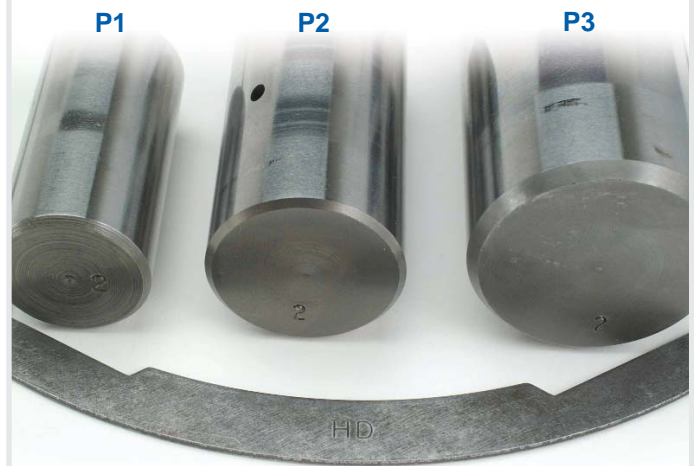
Planetary Spindle and Indexing Ring Updates - SIL 10-WT-00

Planetary spindles and indexing rings are backward compatible. Current spindles are stamped with the number "2." Indexing rings are stamped with the identifier "HD5."

D. Inspect planetary spindles for wear and damage. Discoloration is only a concern if spindle surface damage exists.

E. Inspect the pinion gear thrust washers for damage, distortion and signs of excessive wear. Minimum allowable thrust washer thickness is 1.39 mm (0.054 inch). Replace damaged or worn thrust washers.

F. Inspect the pinion gears following the "General Inspection Guidelines for Gears" section of this manual. Replace any gears which fail these inspection procedures or if the damage cannot be repaired using a soft stone.

G. Inspect the pinion roller bearings following the "General Inspection Guidelines for Bearings" section of this manual. Replace any bearings which fail these inspection procedures.

H. Replace the output shaft spacer if it is bent, cracked or if it is distorted in any way. An attempt can be made to repair some minor damage using a soft stone.

I. Inspect the output shaft external retaining ring. Replace the retaining ring if it is distorted or fits loosely on the shaft.

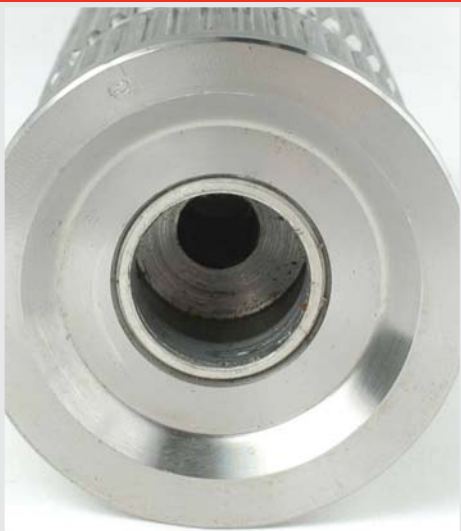
J. Inspect the output shaft bushing for damage.

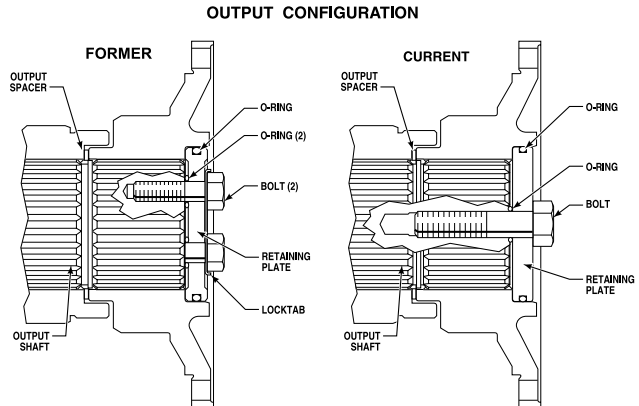
Flange / Yoke Retaining Bolt Update - Reference SIL 1-WT-99

Single Bolt design increases clamp load.

Output spacers are not interchangeable between the former and current designs.

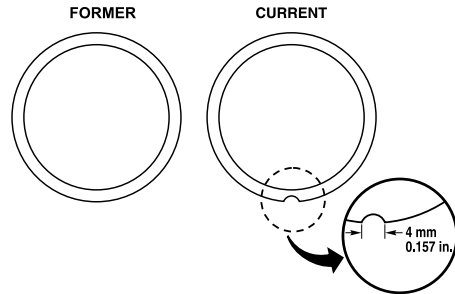
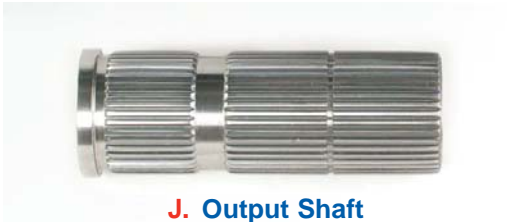
J. Output Shaft

J. Inspect the output shaft following the “General Inspection Guidelines for Cast Parts and Machined Surfaces” and the “General Inspection Guidelines for Splines” sections of this manual. Replace the output shaft if it fails these inspection procedures.

Inspect the output shaft bushing following the “General Inspection Guidelines for Bushings” section of this manual. Replace the bushing if it fails these inspection procedures. Maximum allowable bushing inside diameter is 36.14 mm (1.423 inch).

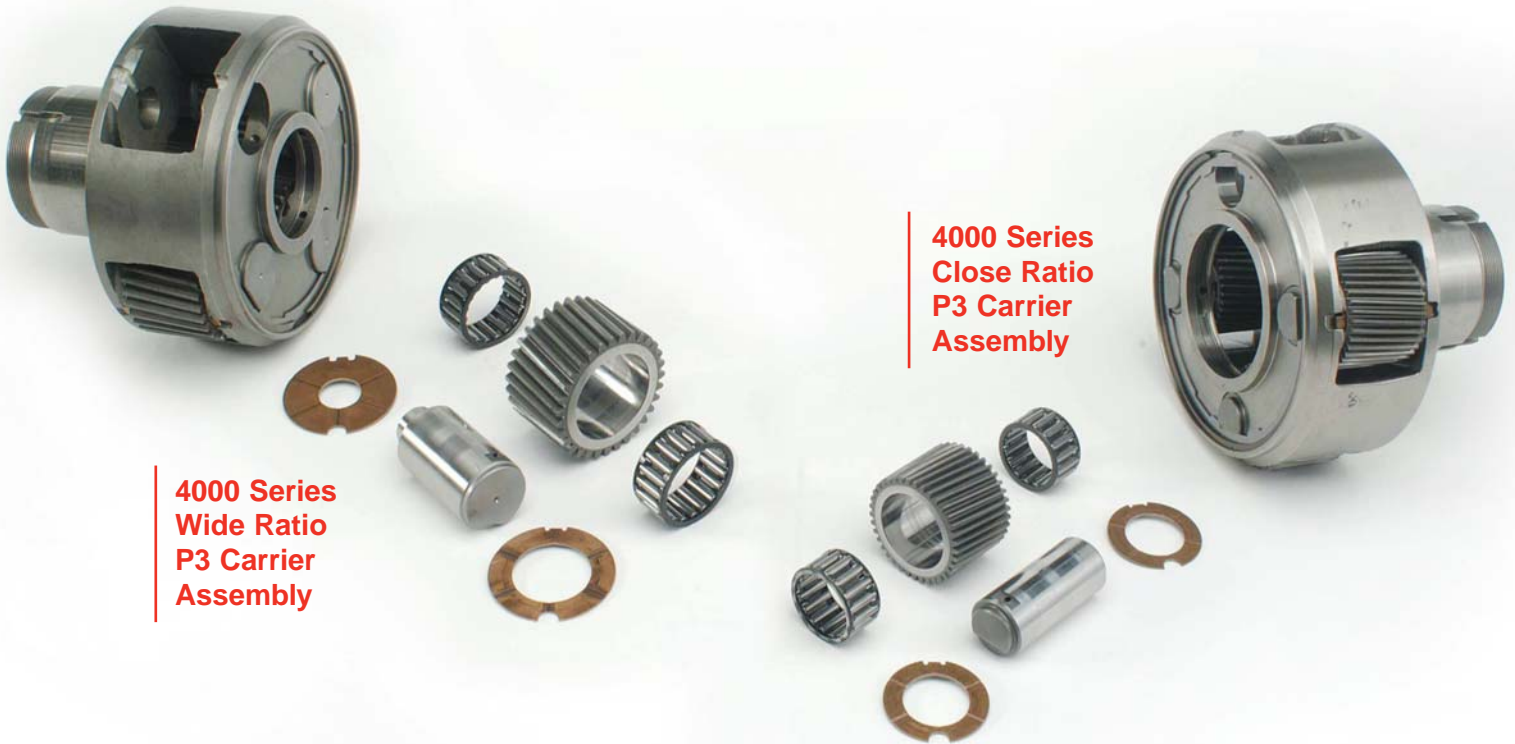
**4000 Series
Wide Ratio
P3 Carrier
Assembly**

**4000 Series
Close Ratio
P3 Carrier
Assembly**

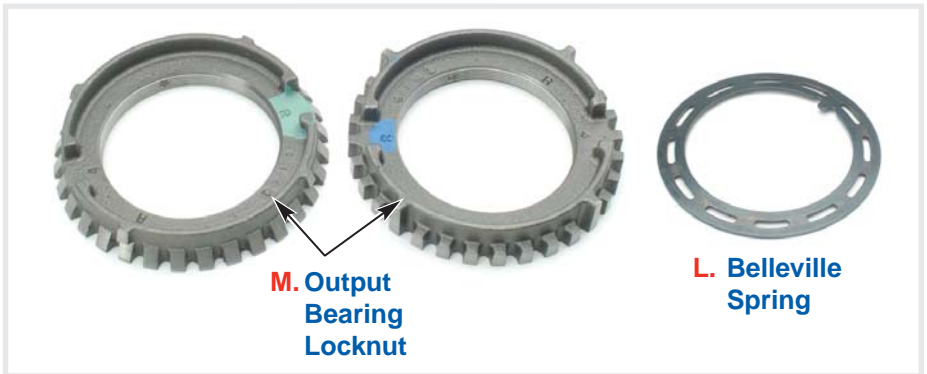
K. Replace the output bearing locknut retainer whenever the locknut is removed.

L. Inspect the Belleville spring washer for damage. Replace the washer if it is distorted or the tang is worn.

M. Replace the output bearing locknut if it is cracked, distorted, has damaged threads. The current locknuts have three buttons in the threaded area. This nut should be replaced if it does not have a minimum of 10 N·m (7.5 ft. lb.) of running torque when threading the nut.

**M. Output
Bearing
Locknut**

**L. Belleville
Spring**

**K. Locknut
Retainer**

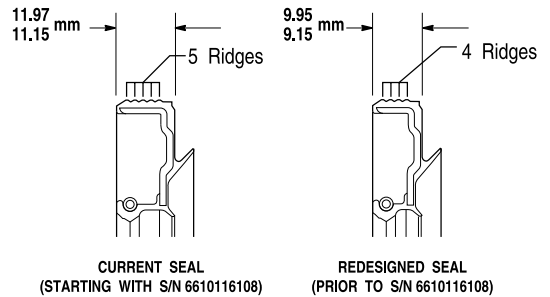
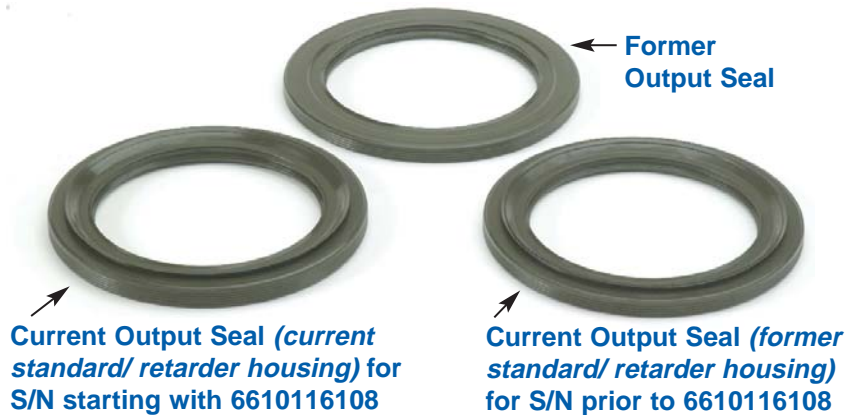
Output Seal Update - Reference SIL 4-WT-03

Two seals are currently available - to fit former and current rear covers. They are **NOT** interchangeable.

Current rear cover has interior cut relief to accommodate 5-ridge output seal. Former rear cover has interior cut relief to accommodate 4-ridge output seal (reference *Output Seal Update Supersession Information*).

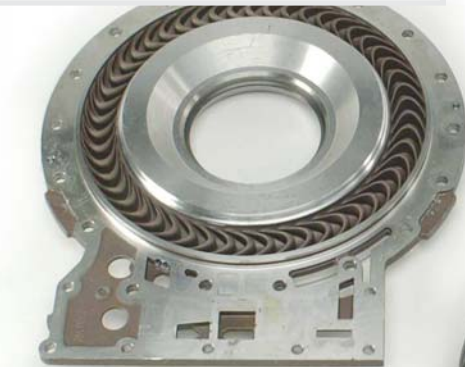
B. Retarder Stator Housing

F. Retarder Temp Sensor Assembly

G. Output Speed Sensor

B. Inspect the stator housing following the “General Inspection Guidelines for Cast Parts and Machined Surfaces” section of this manual. Some light housing imperfections can be removed using a soft stone. Discard and replace the housing if damage is excessive.

F. Inspect the retarder temperature sensor exterior for defects. Replace the temperature sensor if it is damaged. There are two temperature sensor types - TID

G. Inspect the output speed sensor for damage. Replace the sensor if it has body, terminal or connector seat damage. Allowable output speed sensor resistance is 300 ohms plus or minus 30 ohms.

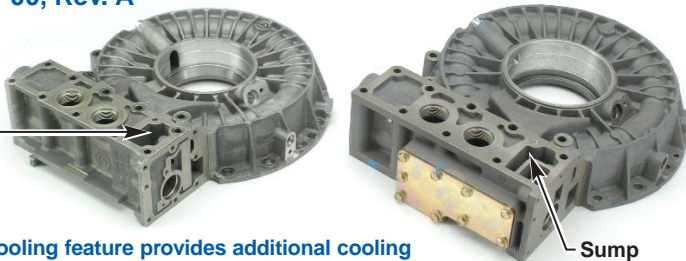
No Sump
Cooling
Feature

The sump cooling feature provides additional cooling when the retarder is active through either an additional auxiliary cooler or the direct mount cooler for retarder transmissions. The direct mount cooler for retarder transmissions works as both the main cooler and auxiliary cooler.

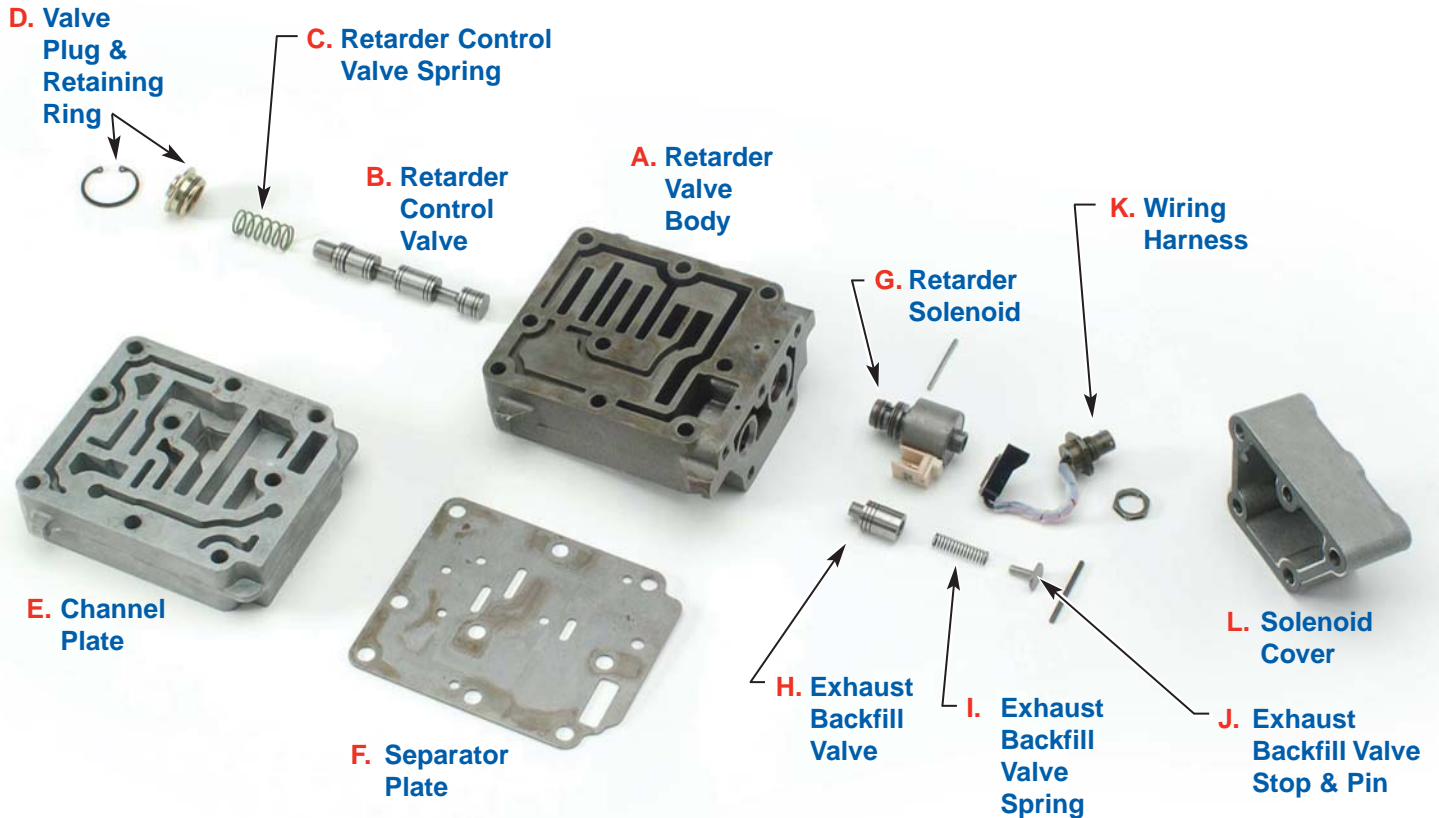
A. Inspect the retarder control valve body following the “General Inspection Guidelines for Cast Parts and Machined Surfaces” section of this manual. All passages must be clean and debris free. Valve bores must be free of nicks, burrs and scoring. Crocus cloth or a soft stone can be used to attempt removal of slight irregularities, however no honing of any kind is permitted.

B & H. Inspect the retarder control valve and exhaust backfill valve for nicks, burrs, scoring and other damage. A soft stone or crocus cloth can be used to attempt

C & I. Replace the retarder control valve spring or exhaust backfill spring for damage or permanent set. Reference the Spring Data Charts in the Service Manual for spring specifications and identification.

D. Inspect the valve plug for damage. Replace the plug if damage cannot be repaired using a soft stone or crocus cloth.

E. Inspect the channel plate following the “General Inspection Guidelines for Cast Parts and Machined Surfaces” section of this manual. Replace the channel plate if it fails any of these inspection procedures or if it has damage which cannot be repaired using a soft stone or crocus cloth. All passages must be clean and debris free.
