TECHNICIANS' GUIDE

INSPECTION AND ANALYSIS OF THE ALLISON 4000 & B 500 PRODUCT FAMILIES

INSPECTION AND ANALYSIS OF THE ALLISON 4000/B 500 PRODUCT FAMILIES

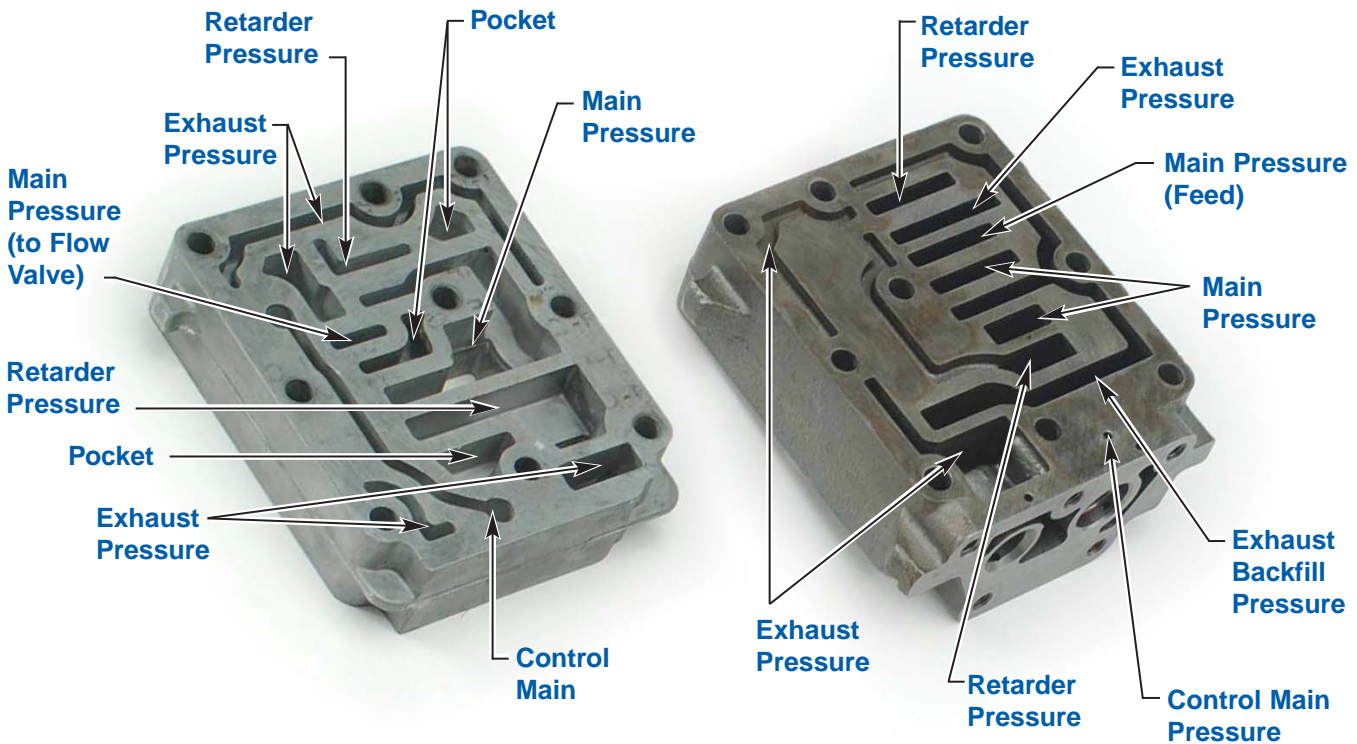
F. Inspect the separator plate for nicks, burrs, scoring and distortion (flatness). Replace the plate if damage cannot be repaired using a soft stone or crocus cloth.

G. Replace the retarder solenoid if the body, connector or terminals show visible signs of damage. Solenoid resistance should be 3 to 4 ohms measured between the two solenoid terminals. Check resistance between each solenoid terminal and the solenoid body. Replace the solenoid if either reading is less than 100k ohms resistance.

J. Inspect the exhaust backfill valve stop for damage. Replace the stop if damage cannot be repaired using a soft stone or crocus cloth. Inspect the exhaust backfill valve pin for damage. Replace the pin if it is bent or has damage.

K. Replace or repair the wiring harness if the wires, terminals or connectors are visibly damaged. Check the installed harness for tight bends or crimps which might damage harness wires.

L. Inspect the solenoid cover following the “General Inspection Guidelines for Cast Parts and Machined Surfaces” section of this manual. Replace the housing if it fails any of these inspection procedures.

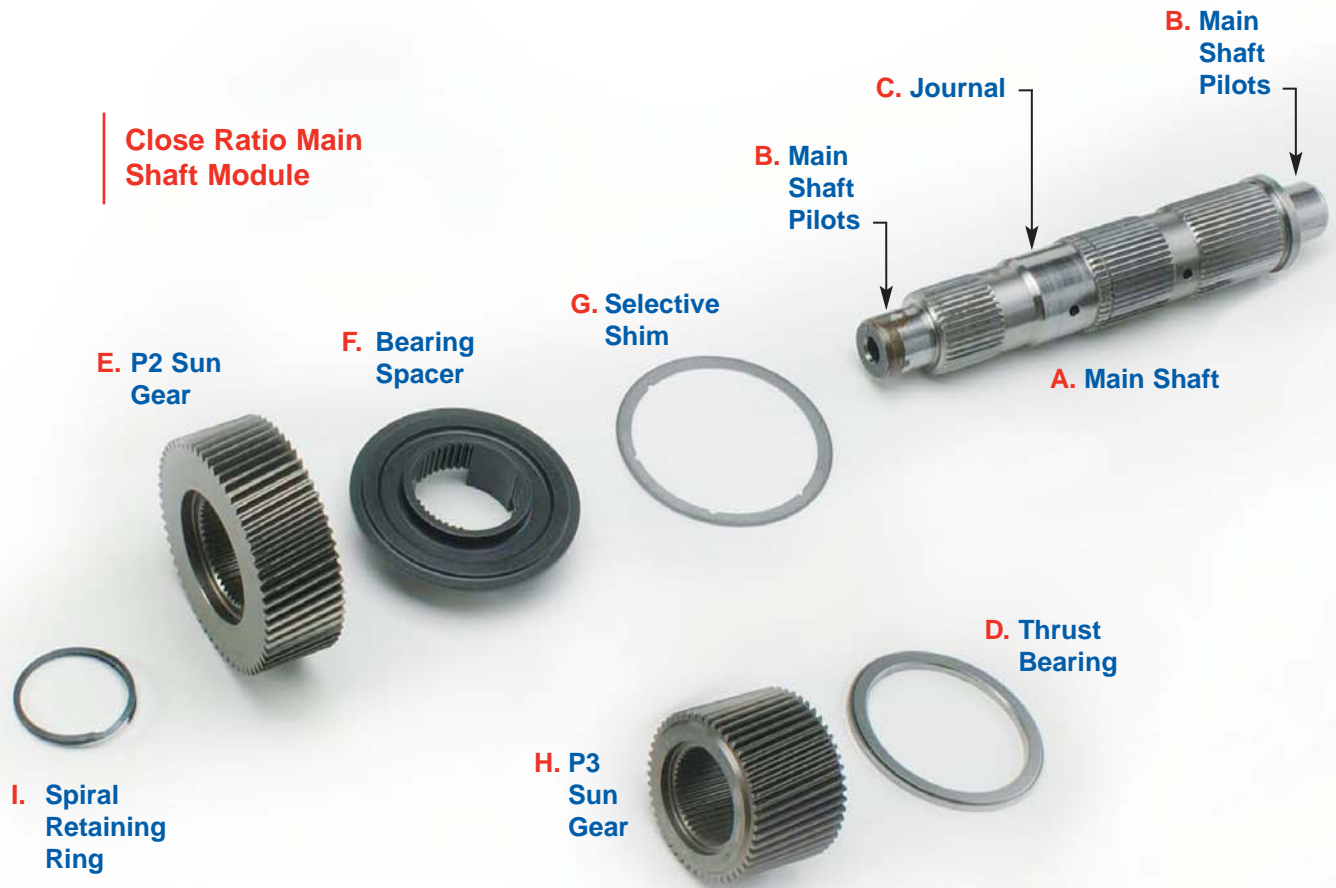
Close Ratio Main Shaft Module

A. Inspect the main shaft following the “General Inspection Guidelines for Gears” and “General Inspection Guidelines for Splines” sections of this manual. Replace the main shaft if it fails any of these inspection procedures.

B. Inspect the front and rear main shaft pilots for damage. The front main shaft pilot fits inside the turbine shaft. The rear main shaft pilot fits inside the output shaft. Replace the main shaft if pilot outside diameter is less than 35.92 mm (1.414 inch).

D. Inspect the thrust bearings following the “General Inspection Guidelines for Bearings” section of this manual. Replace any bearing that fails any of these inspection procedures.

E. Inspect the P2 sun gear following the “General Inspection Guidelines for Gears” and “General Inspection Guidelines for Splines” sections of this manual. Replace the gear if it fails any of these inspection procedures.

G. Inspect the selective shim for damage. Replace the shim if it is distorted or if damage cannot be removed by light stoning.

H. Inspect the P3 sun gear following the “General Inspection Guidelines for Gears” and “General Inspection Guidelines for Splines” sections of this manual. Replace the gear if it fails any of these inspection procedures.

I. Replace the spiral retaining ring if it is removed.

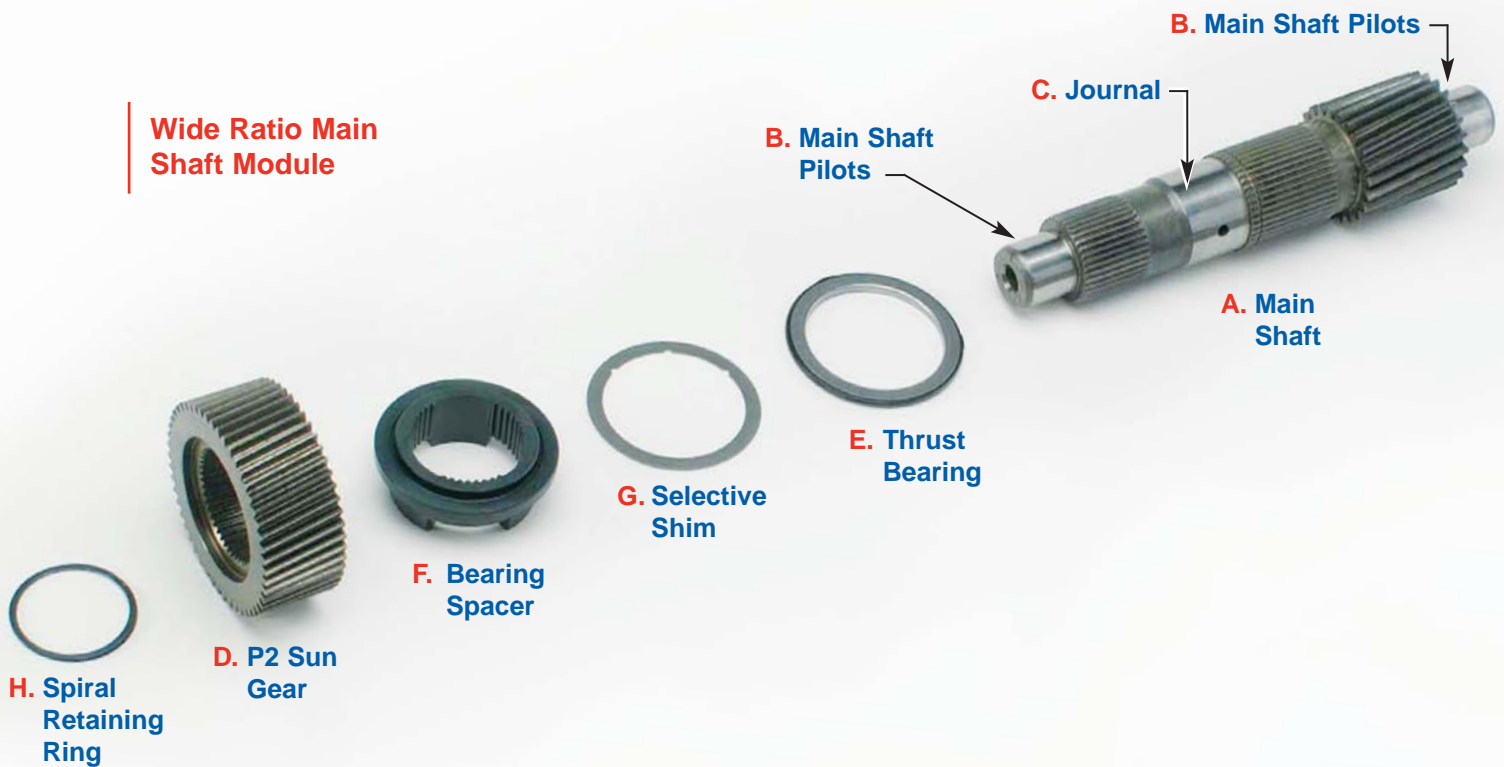
WIDE RATIO MAIN SHAFT MODULE

A. Inspect the main shaft following the “General Inspection Guidelines for Gears” and “General Inspection Guidelines for Splines” sections of this manual. Replace the main shaft if it fails any of these inspection procedures.

B. Inspect the front and rear main shaft pilots for damage. The front main shaft pilot fits inside the turbine shaft. The rear main shaft pilot fits inside the output shaft. Replace the main shaft if pilot outside diameter is less than 35.92 mm (1.414 inch).

C. “Inspect the P2 bushing journal for damage. Replace the main shaft if P2 planetary bushing journal diameter is less than 52.98 mm (2.085 inch).

D. Inspect the P2 sun gear following the “General Inspection Guidelines for Gears” and “General Inspection Guidelines for Splines” sections of this manual. Replace the gear if it fails any of these inspection procedures.

E. Inspect the thrust bearings following the “General Inspection Guidelines for Bearings” section of this manual. Replace any bearing that fails any of these inspection procedures.

F. Inspect the main shaft bearing spacer following the “General Inspection Guidelines for Cast Parts and Machined Surfaces” “General Inspection Guidelines for Splines” sections of this manual. Replace the spacer if it fails any of these inspection procedures.

G. Inspect the selective shim for damage. Replace the shim if it is distorted or if damage cannot be removed by light stoning.

H. Replace the spiral retaining ring if it is removed.

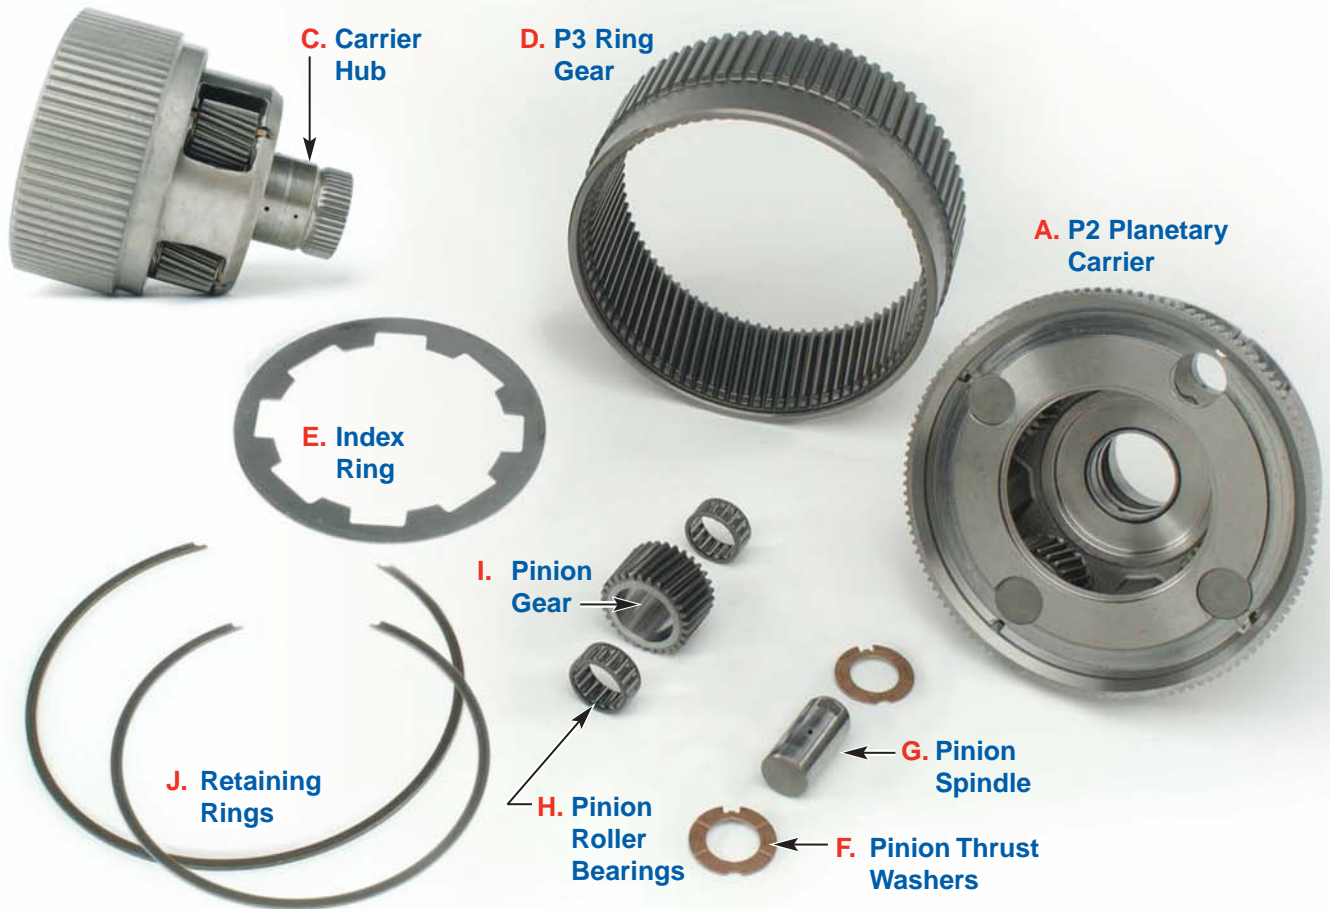
A. Inspect the P2 carrier following the “General Inspection Guidelines for Cast Parts and Machined Surfaces” and the “General Inspection Guidelines for Splines” sections of this manual. Replace the carrier if any spindle has more than 0.051 mm (0.002 inch) clearance in its bore.

B. Inspect the P2 carrier bushing for damage. Replace the bushing if damaged. Replace the bushing if inside diameter exceeds 53.23 mm (2.096 inches).

C. Inspect the carrier hub for damage. Replace the carrier if damage cannot be repaired using a soft stone or crocus cloth.

D. Inspect the P3 ring gear following the “General Inspection Guidelines for Gears” and “General Inspection Guidelines for Splines” sections of this manual. Replace the ring gear if it fails any of these inspection procedures.

E. Inspect the P2 indexing ring for step wear in the area where it contacts the spindle. Replace the indexing ring if it is broken or if it has excessive step wear or damage. Indexing rings with acceptable wear can be flipped during reassembly so that a new contact surface is used.

F. Replace the pinion gear thrust washers if they are damaged, distorted, galled or showing signs of

excessive wear. Minimum allowable thrust washer thickness is 1.40 mm (0.055 inch). Maximum allowable thrust washer step wear is 0.12 mm (0.005 inch).

G. Replace planetary spindles if they are worn or damaged. Discoloration is only a concern if spindle surface damage exists.

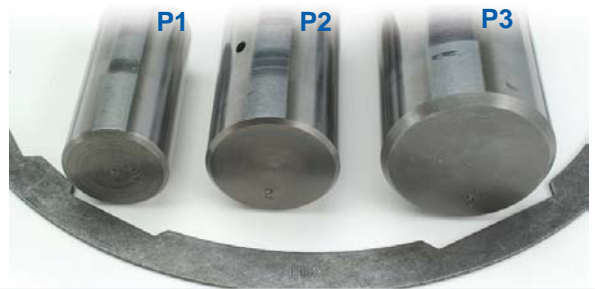
Planetary Spindle and Indexing Ring Updates - Reference SIL 10-WT-00

Planetary spindles and indexing rings are backward compatible. Current spindles are stamped with the number "2." Indexing rings are stamped with the identifier "HD5."

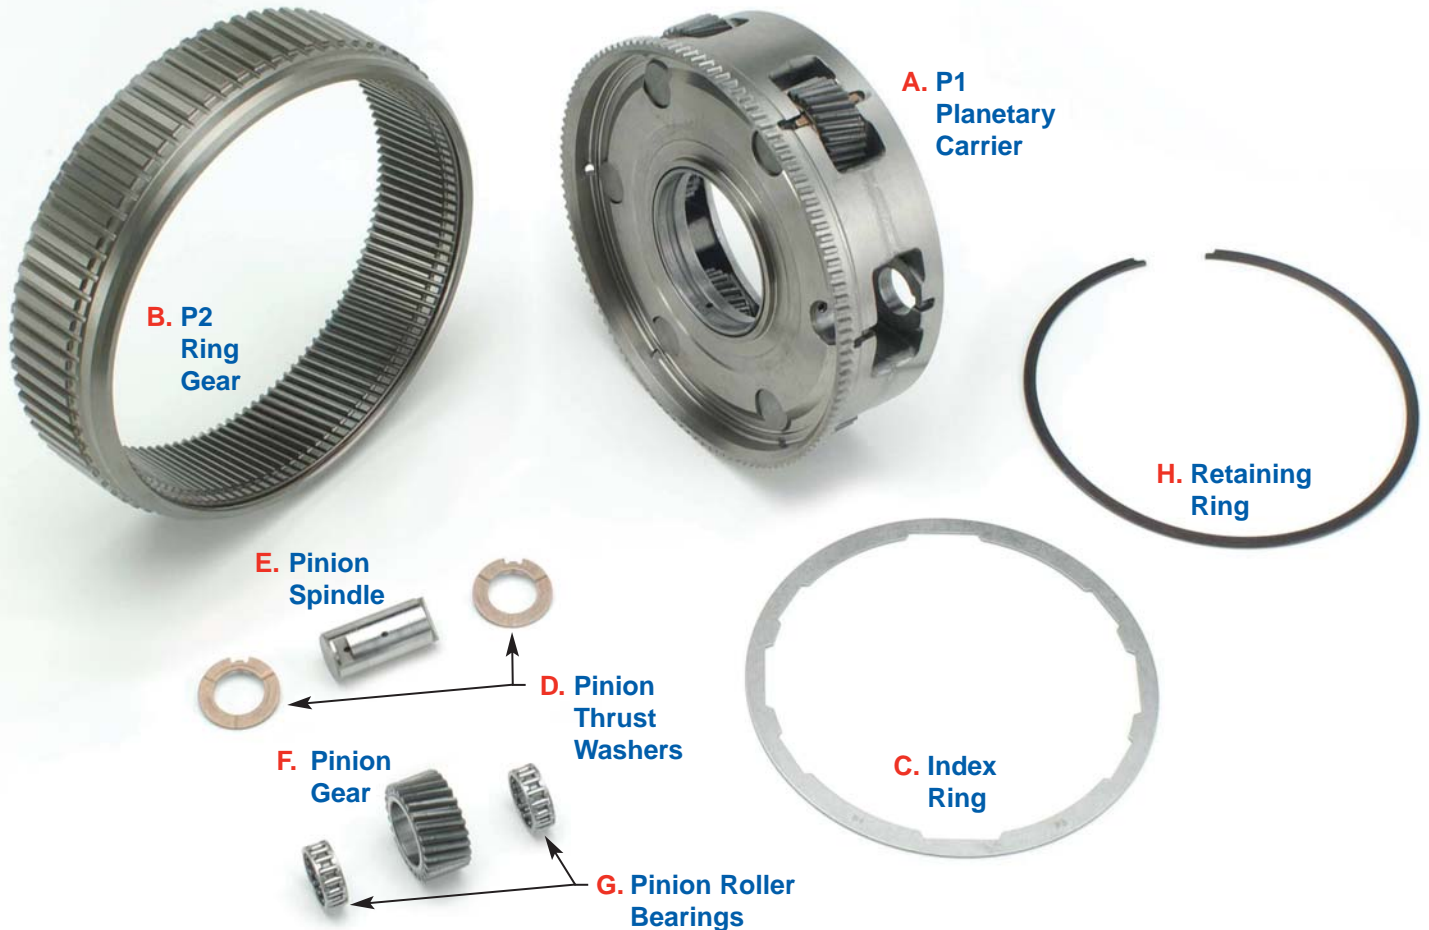
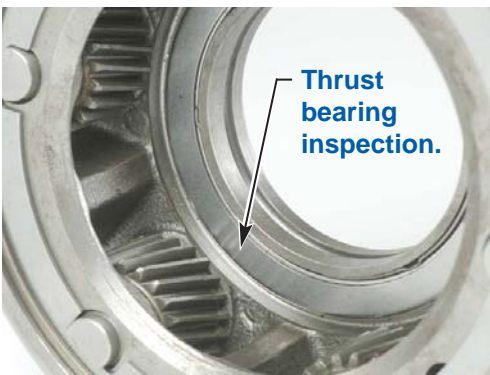
A. Inspect the P1 carrier following the “General Inspection Guidelines for Cast Parts and Machined Surfaces” and the “General Inspection Guidelines for Splines” sections of this manual. Replace the carrier if any spindle has more than 0.051 mm (0.002 inch) clearance in its bore.

Thrust bearings fit on both sides of the P1 carrier. Inspect the thrust bearings following the “General Inspection Guidelines for Bearings” section of this manual. Replace any bearing that fails any of these inspection procedures.

B. Inspect the P2 ring gear following the “General Inspection Guidelines for Gears” and the “General Inspection Guidelines for Splines” sections of this manual. Replace the ring gear if it fails any of these inspection procedures.

C. Inspect the P1 indexing ring for step wear in the area where it contacts the spindle. Replace the indexing ring if it is broken or if it has excessive step wear or damage. Indexing rings with acceptable wear can be flipped during reassembly so that a new contact surface is used.

D. Replace the pinion gear thrust washers if they are damaged, distorted, galled or showing signs of excessive wear. Minimum allowable thrust washer thickness is 1.39 mm (0.054 inch).

E. Replace planetary spindles if they are worn or damaged. Discoloration is only a concern if spindle surface damage exists.

F. Inspect the P1 pinion gears following the “General Inspection Guidelines for Gears” section of this manual. Replace any gear that fails these inspection procedures or if damage cannot be removed using a soft stone.

H. Inspect the P1 carrier retaining rings for damage or distortion. Replace any retaining rings with damage that cannot be removed using a soft stone.

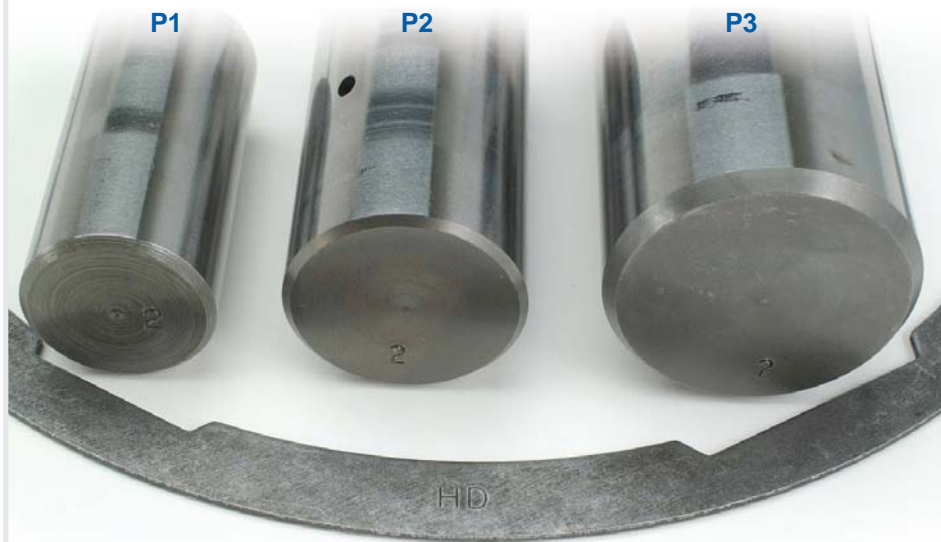
Planetary Spindle and Indexing Ring Updates - SIL 10-WT-00

Planetary spindles and indexing rings are backward compatible. Current spindles are stamped with the number “2.” Indexing rings are stamped with the identifier “HD5.”

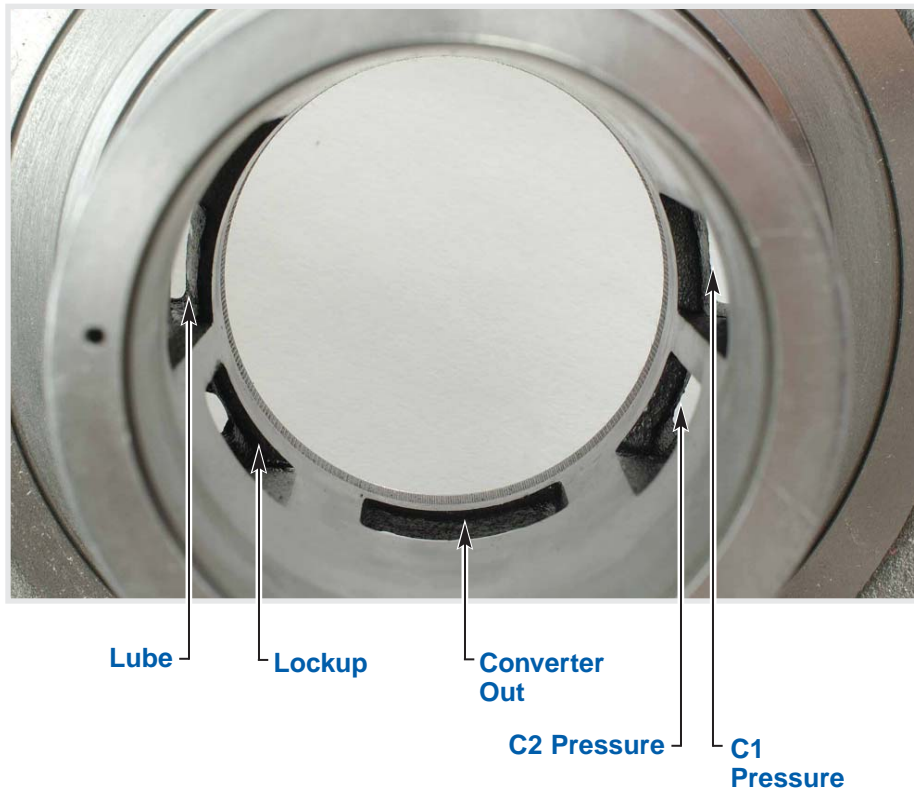
Oil passage detail -
inside hub.

F. Inspect the charging pump housing following the “General Inspection Guidelines for Cast Parts and Machined Parts” section of this manual. Replace the housing if it fails any of these inspection procedures. Replace the charging pump housing if gear cavity depth exceeds 19.04 mm (0.750 inches). Replace the charging pump housing if gear cavity diameter exceeds 150.25 mm (5.915 inches).

G. Replace the main pressure relief ball if it is damaged. Inspect the main pressure relief spring following the “General Inspection Guidelines for Springs” section of this manual. Replace the spring if it is bent, broken, distorted or shows signs of wear from rubbing adjacent parts. Reference the Spring Data Charts in the Service Manual for spring identification and specifications.

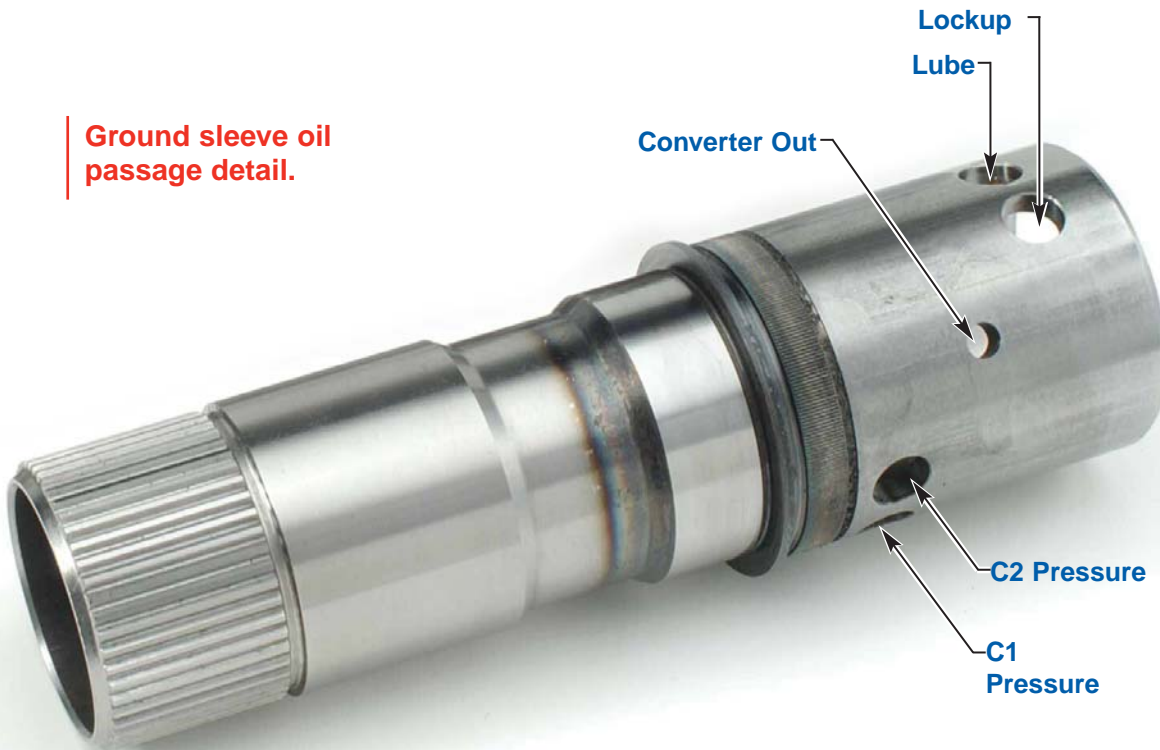
Ground sleeve oil passage detail.

I. Replace the charging pump gear set if the sides, faces or gear teeth are damaged. Replace the gear set if the inside gear shows damage or battering at the point where the torque converter drive tangs (or the PTO drive hub tangs) index into the gear. Replace the gear set if the bushing inside diameter exceeds 57.30 mm (2.256 inch). Minimum allowable outside diameter of the outer gear is 149.94 mm (5.903 inch).

J. Replace the wear plate if it is galled or moderately scored. Pay particular attention to the area where the charging pump gear set rides. Minimum allowable wear plate thickness is 4.70 mm (0.0185 inch). Replace the wear plate if it is worn past service limits or if it has damage that cannot be repaired using a soft stone or crocus cloth.

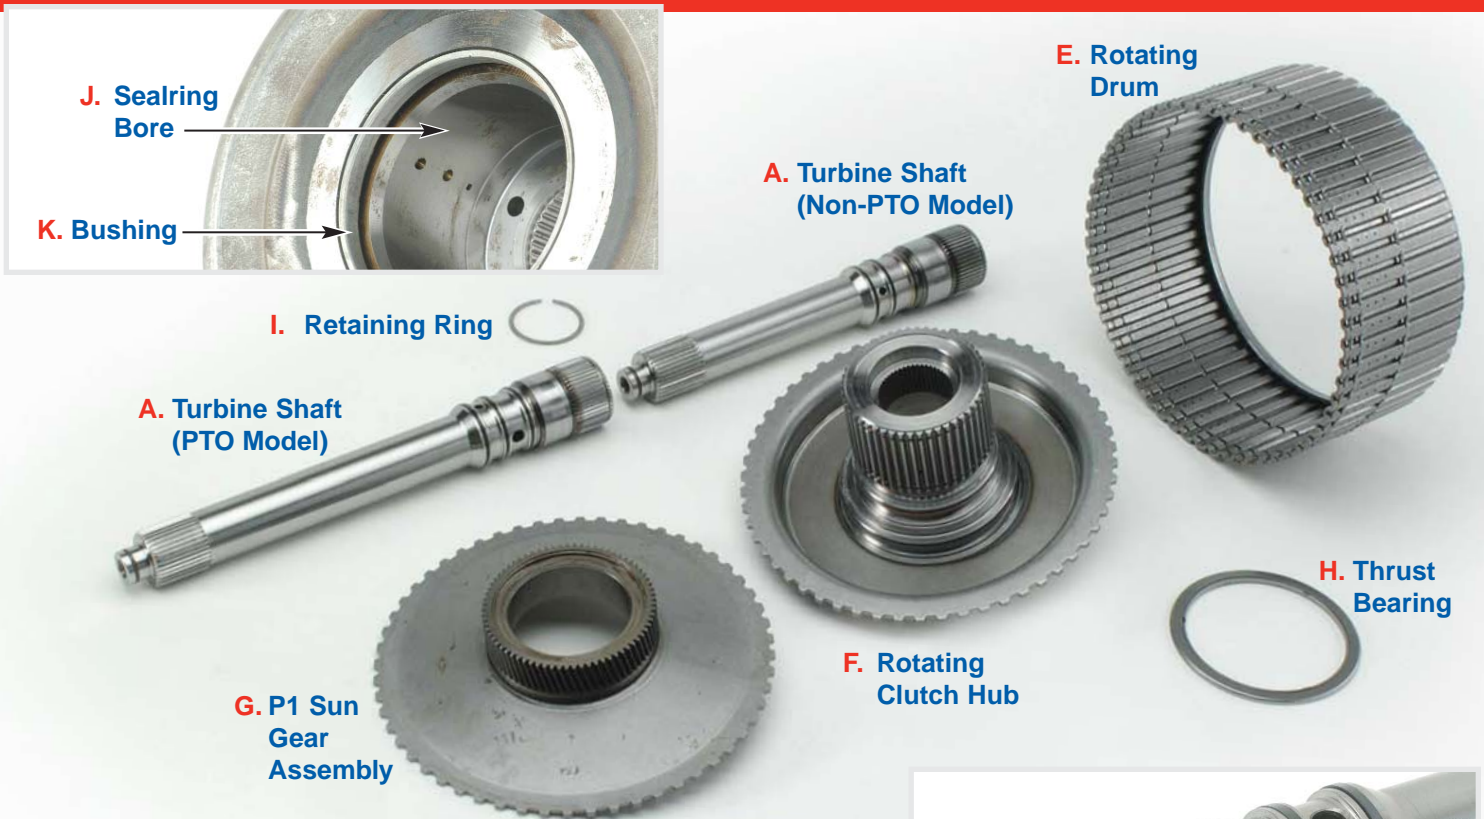
A. Inspect the turbine shaft following the “General Inspection Guidelines for Cast Parts and Machined Surfaces” section of this manual. Replace the turbine shaft if it fails any of these inspection procedures. Maximum allowable spline wear is 0.38 mm (0.015 inch).

B. Inspect the turbine shaft bushing following the “General Inspection Guidelines for Bushings” section of this manual. Replace the bushing if it fails any of these inspection procedures. Maximum allowable bushing inside diameter is 36.14 mm (1.423 inch).

D. Inspect the three sealring grooves for damage. Replace the turbine shaft if damage cannot be repaired with a light stone or crocus cloth. Install three new sealrings and check end gap. Minimum end gap allowed is 0.65 mm (0.026 inch). Replace turbine shaft if end gap is below minimum.

E. Inspect the rotating drum following the “General Inspection Guidelines for Cast Parts and

Machined Surfaces” and “General Inspection Guidelines for Splines” sections of this manual. Replace the drum if it fails any of these inspection procedures. Maximum allowable spline wear is 0.38 mm (0.015 inch).

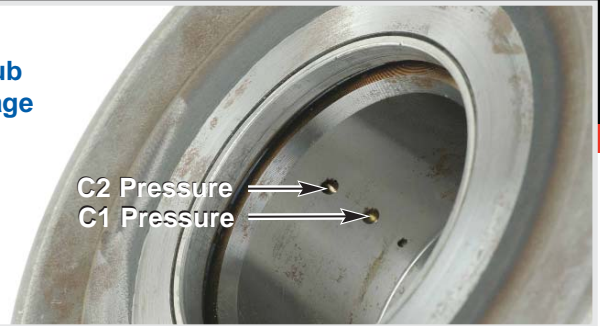
Rotating clutch hub oil passage detail.

C2 Pressure
C1 Pressure

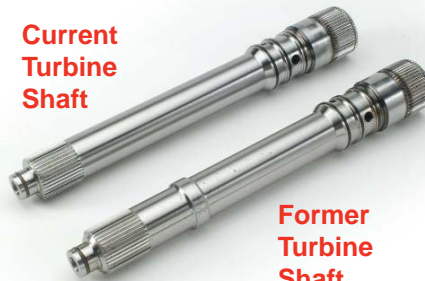
Turbine Shaft Update -
Reference SIL 19-WT-94
& 22-WT-94

Current Turbine Shaft

Former Turbine Shaft

Former turbine shafts include a raised area toward the torque converter end of the shaft.

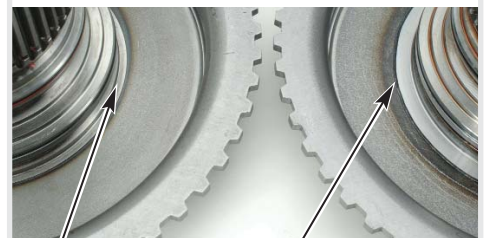
Rotating Clutch Hub Update -
Reference SIL 8-WT-99, Rev. A

Former (No Weld)

Current (Weld)

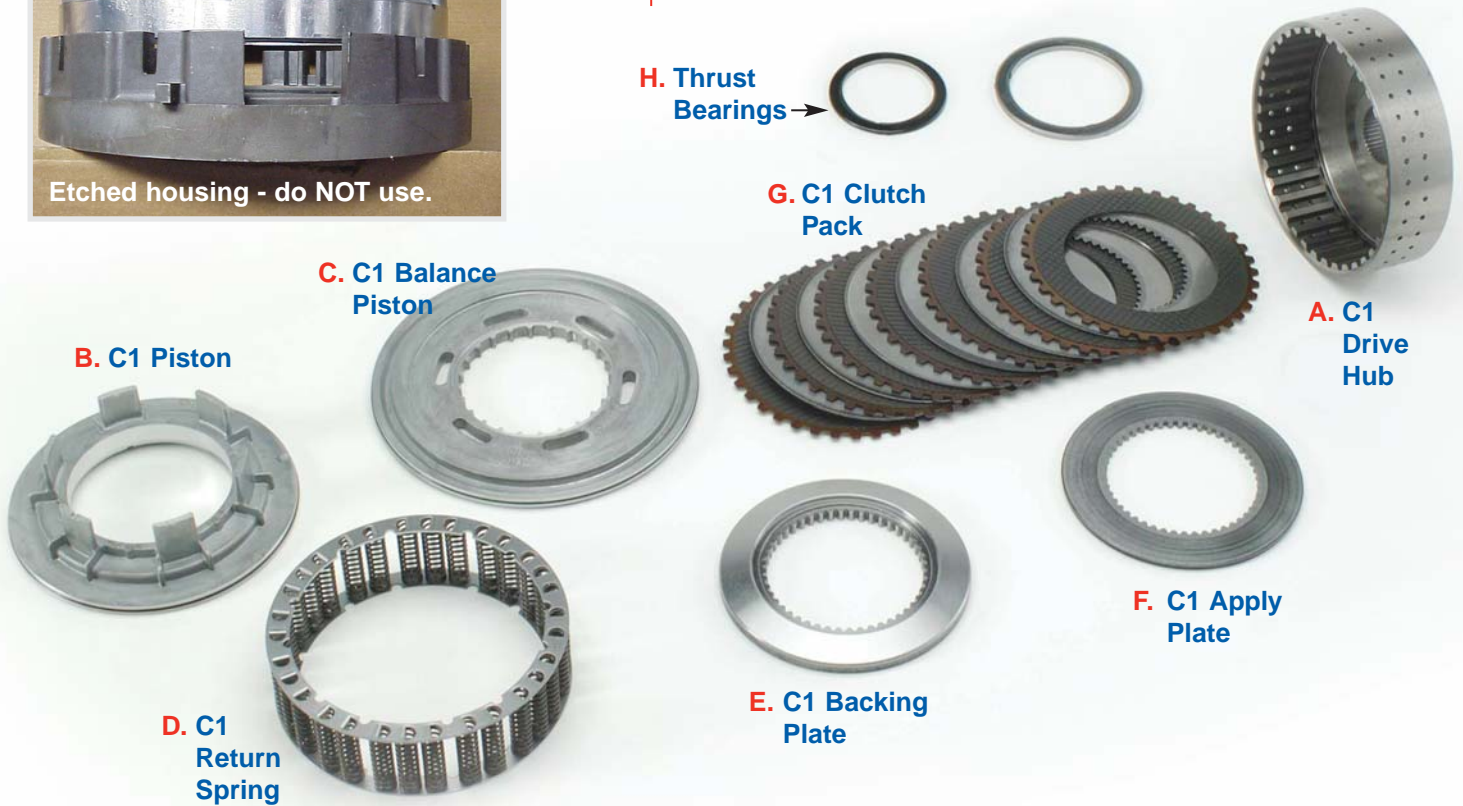
C1 Clutch Components

A. Inspect the C1 drive hub following the “General Inspection Guidelines for Cast Parts and Machined Surfaces” and the “General Inspection Guidelines for Splines” sections of this manual. Replace the hub if it fails any of these inspection procedures. Maximum allowable spline wear is 0.38 mm (0.015 inch).

B & C. Inspect the C1 clutch piston and C1 balance piston following the “General Inspection Guidelines for Cast Parts and Machined Surfaces” section of this manual. Replace any component if it fails any of these inspection procedures.

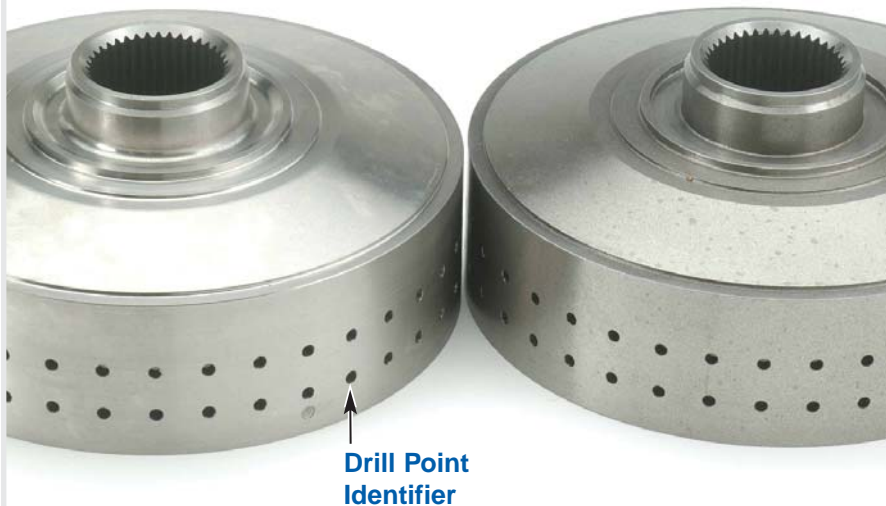
Current: C1 Drive Hub

Former: C1 Drive Hub

Drill point identifies the current hub which is backward compatible.

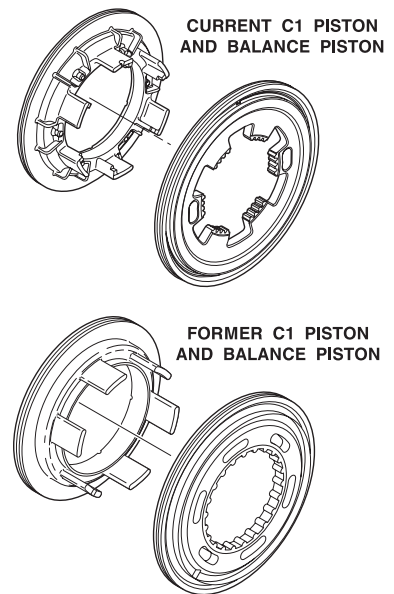
C1 Clutch Piston and Balance Piston Re-design - Reference SIL 30-WT-04

Former and current components can NOT be mixed.

NOTE: Transmissions built prior to S/N 6610032320 used two identical C1 pressure plates. Transmissions built after that used different plates. The current C1 apply pressure plate (next to the C1 piston) is approximately 2 mm thinner and has a different shape than the current C1 backplate (opposite end of the C1 clutch pack). When replacing the former pressure plates in a transmission with the current plate, both current plates must be used. Mixing former and current plates will result in C1 clutch failure.

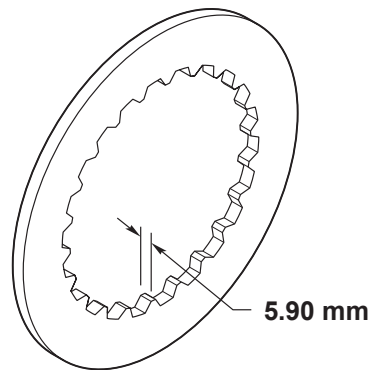
NEW STYLE APPLY PLATE

C1 Backing and Apply Plate Updates - Reference SIL 22-WT-98, Rev. A

Former and current components can NOT be mixed

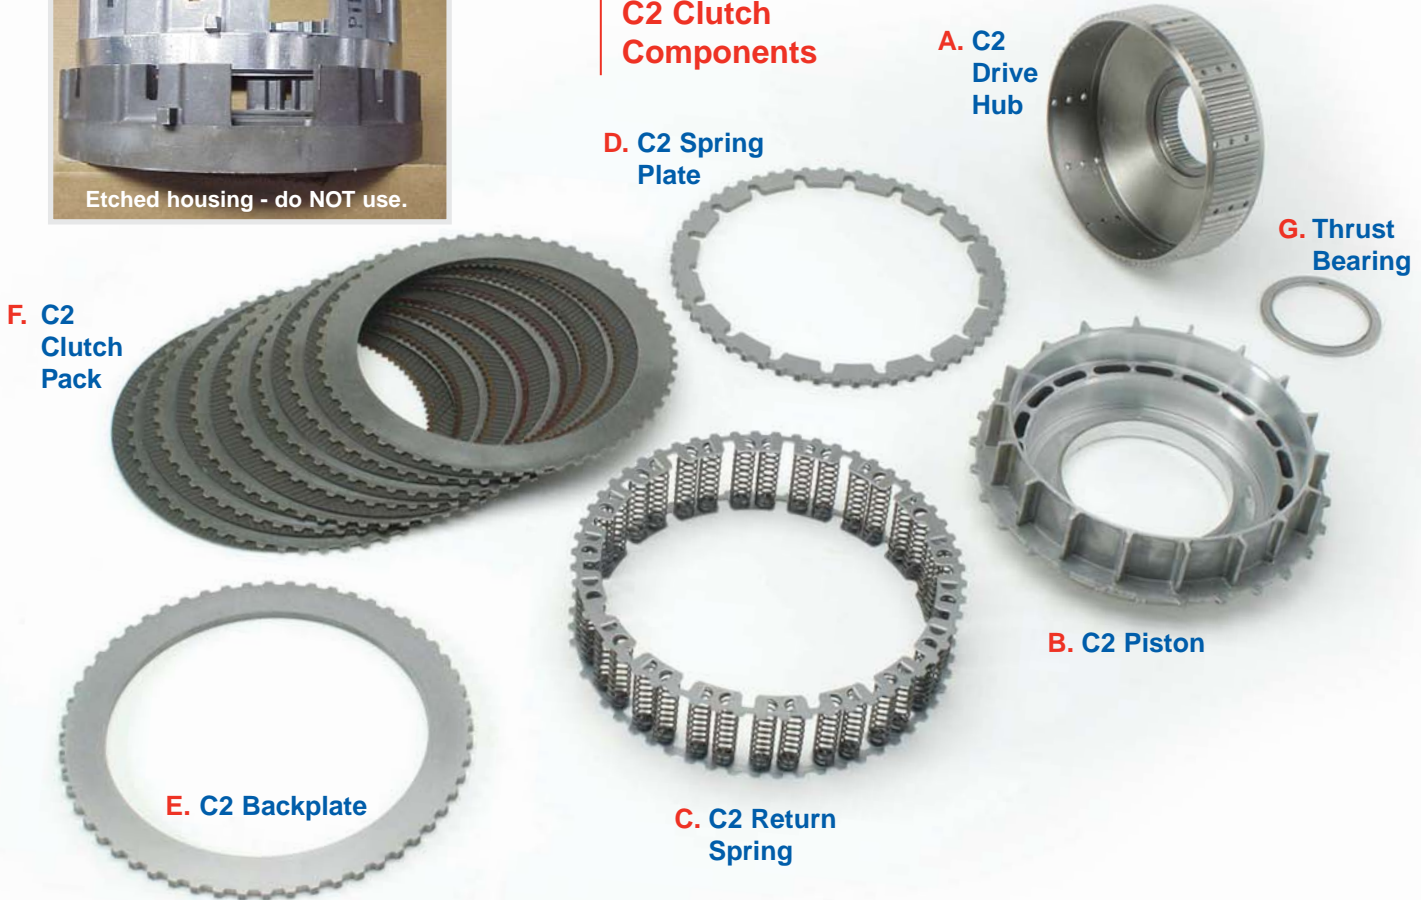
C2 Clutch Components

A. Inspect the C2 drive hub following the “General Inspection Guidelines for Cast Parts and Machined Surfaces” and the “General Inspection Guidelines for Splines” sections of this manual. Replace the hub if it fails any of these inspection procedures. Maximum allowable spline wear is 0.38 mm (0.015 inch).

B. Inspect the C2 clutch piston following the “General Inspection Guidelines for Cast Parts and Machined Surfaces” section of this manual. Replace the piston if it fails any of these inspection procedures.

C. Replace the C2 return spring assembly if it has permanent spring set, wear due to rubbing adjacent parts or if springs are cracked or broken in any way. Reference the

D. Replace the C2 spring plate if it is cracked, broken or showing any signs of distortion or wear.

E. Inspect the C2 backplate for damage. Replace the plate if damage cannot be removed using a soft stone or crocus cloth. C2 backplate minimum allowable thickness is 7.90 mm (0.311 inch) when measured at the backing plate wear area. Maximum allowable distortion from flat is 0.015 mm (0.006 inch).

F. Inspect the C2 clutch friction plates following the “General Inspection Guidelines for Friction Plates” section of this manual. Replace any plates failing these inspection procedures. Minimum allowable friction plate thickness is 2.92 mm (0.115 inch). Minimum allowable oil groove depth is 0.20 mm (0.008 inch). Maximum allowable plate coning is 0.25 mm (0.010 inch).

Inspect the C2 clutch reaction plates following the “General Inspection Guidelines for Reaction Plates” section of this manual. Replace any plates failing these inspection procedures. Minimum allowable reaction plate thickness is 2.41 mm (0.095 inch). Maximum allowable reaction plate coning is 0.25 mm (0.010 inch).

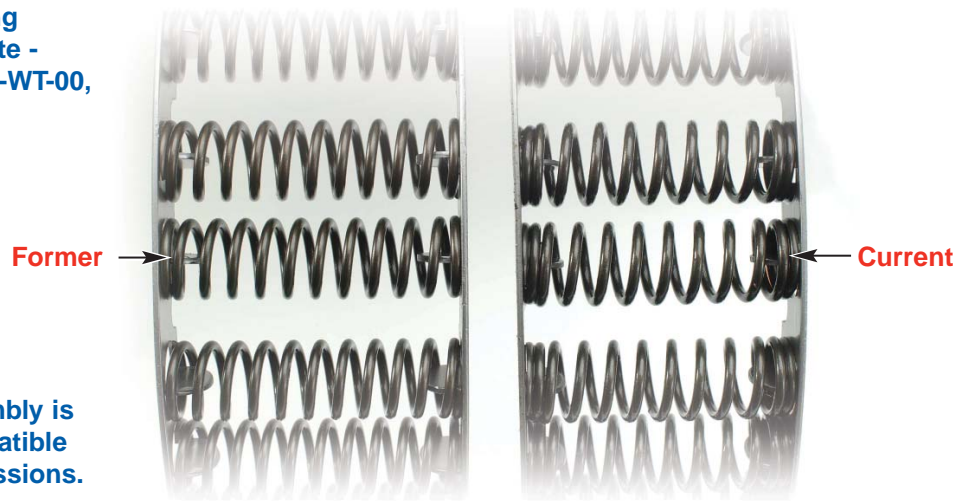
**C2 Return Spring
Assembly Update -
Reference SIL 4-WT-00,
Rev. B**

**Currently assembly is
backward compatible
with all transmissions.**

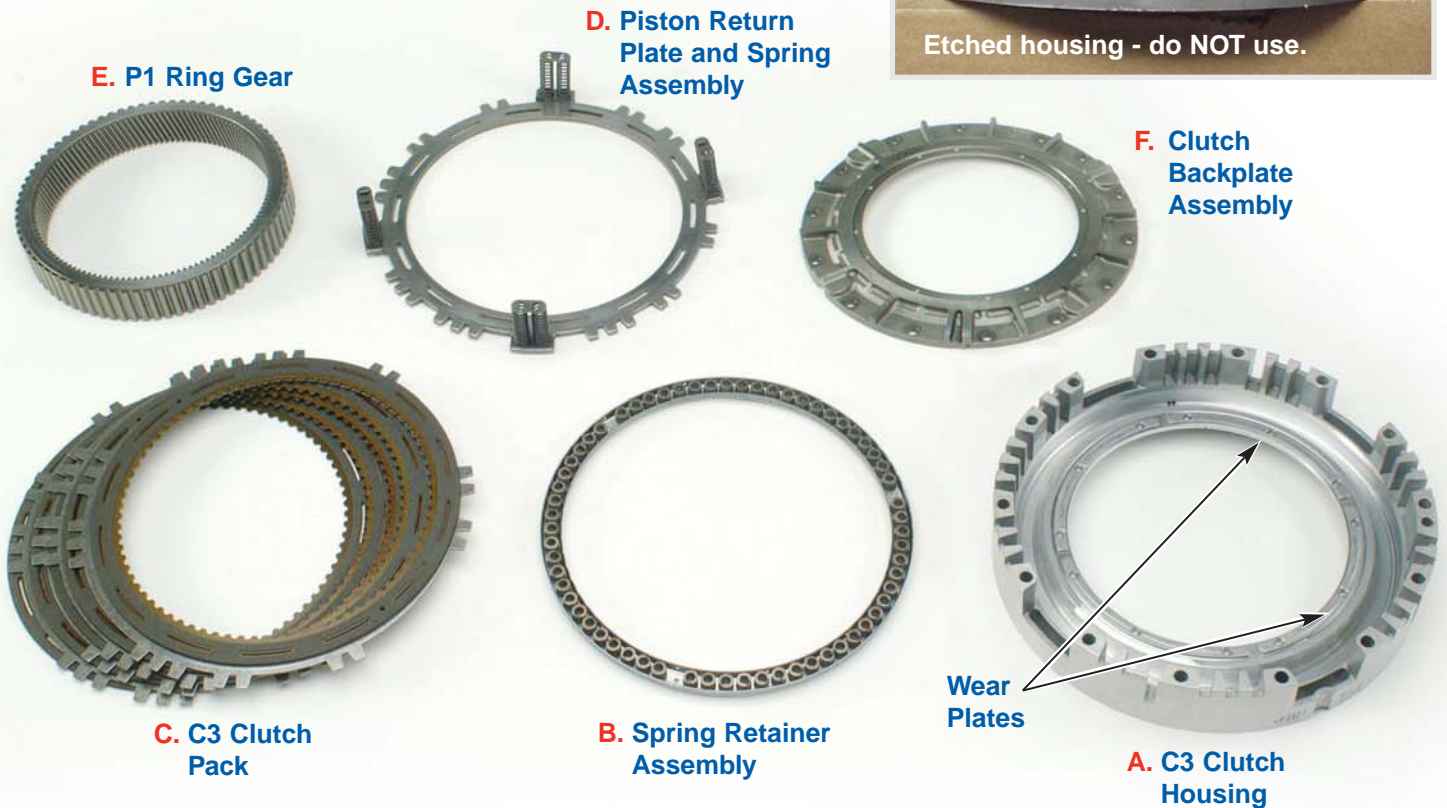
C3 Clutch Components

A. Inspect the C3 clutch housing following the “General Inspection Guidelines for Cast Parts and Machined Surfaces” section of this manual. Replace the housing if it fails any of these inspection procedures. Check for C3 housing spline wear. Maximum allowable spline wear is 1.15 mm (0.045 inch). Replace the C3 housing if excessive spline wear exists. Check the C3 housing wear plates for flatness. Maximum allowable distortion is 0.15 mm (0.006 inch). Minimum allowable wear plate thickness is 2.82 mm (0.111 inch).

B. Inspect the C3 spring retainer assembly following the “General Inspection Guidelines for Cast Parts and Machined Surfaces” section of this manual. Inspect the assembly for wear due to rubbing adjacent parts and cracked, broken or

C. Inspect the C3 clutch friction plates following the “General Inspection Guidelines for Friction Plates” section of this manual. Replace any plates failing these inspection procedures. Minimum allowable friction plate thickness is 3.485 mm (0.137 inch). Maximum allowable plate coning is 0.25 mm (0.010 inch).

Inspect the C3 clutch reaction plates following the “General Inspection Guidelines for Reaction Plates” section of this manual. Replace any plates failing these inspection procedures. Minimum allowable reaction plate thickness is 2.41 mm (0.010 inch). Maximum allowable reaction plate coning is 0.25 mm (0.010 inch). (continued)

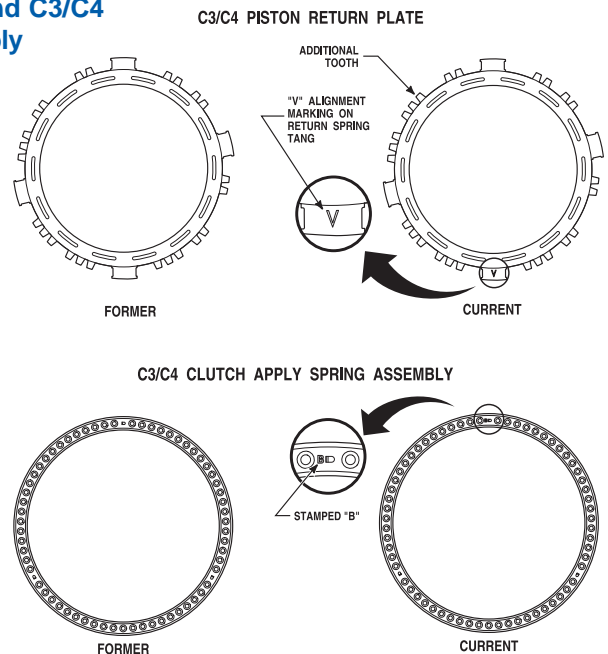
C3/C4 Return Plate and C3/C4 Apply Spring Assembly Update - SIL 9-WT-04

Former and current components can NOT be mixed in the same clutch pack.

NOTE: The C3/C4 spring retainer assemblies (sometimes referred to as clutch apply spring assemblies) and the C3/C4 piston return plate were updated starting with S/N 6610137389. Do not mix former and current parts in the same clutch pack. The identifier for the current return plate is a letter “V” stamped in the face with an additional external spline on the outside diameter. The identifier for the current apply spring assembly is the

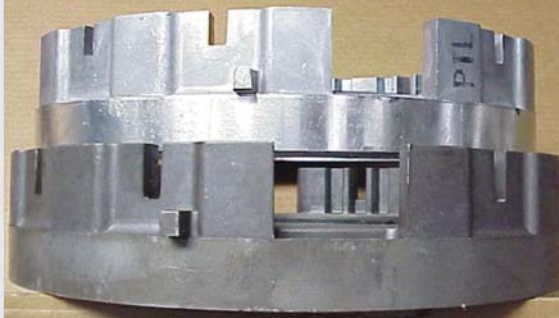
Housing in good condition - reuse.

Etched housing - do NOT use.

NOTE: Aluminum castings (like clutch housings) can be etched by caustic parts cleaners and solvents. Etched components are identified by a dull to dark gray color - not the bright finish of a normal machined aluminum part. Etched components are also identified by roughness in the piston seals to abrade and result in low clutch apply pressure and transmission damage. Replace etched or damaged components.

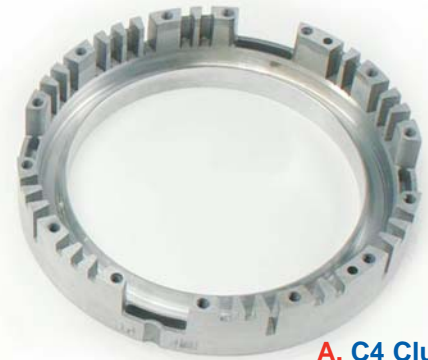
A. C4 Clutch Housing

A. Inspect the C4 clutch housing following the “General Inspection Guidelines for Cast Parts and Machined Surfaces” section of this manual. Replace the housing if it fails any of these inspection procedures. Check for C4 housing spline wear. Maximum allowable spline wear is 1.15 mm (0.045 inch). Replace the C4 housing if excessive spline wear exists.

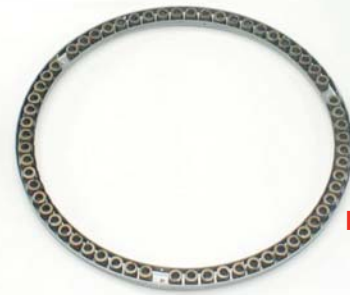
B. Spring Retainer Assembly

B. Inspect the C4 spring retainer assembly following the “General Inspection Guidelines for Cast Parts and Machined Surfaces” section of this manual. Inspect the assembly for wear due to rubbing adjacent parts and cracked, broken or permanently set springs. Reference the Spring Data Charts in the Service Manual for spring specifications and identification.

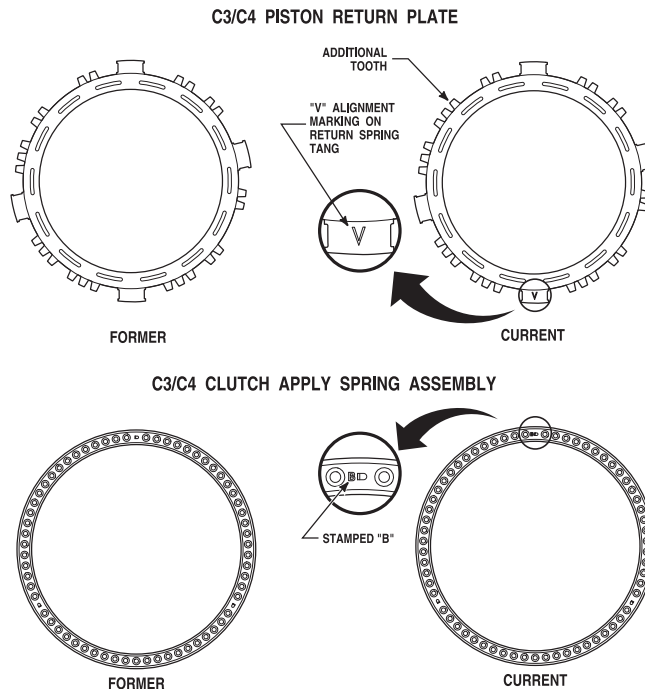
C3/C4 Return Plate and C3/C4 Clutch Apply Spring Assembly Update - SIL 9-WT-04

Former and current components can NOT be mixed in the same clutch pack.

NOTE: The C3/C4 spring retainer assemblies (sometimes referred to as clutch apply spring assemblies) and the C3/C4 piston return plate were updated starting with S/N 6610137389. Do not mix former and current parts in the same clutch pack. The identifier for the current return plate is a letter “V” stamped in the face with an additional external spline on the outside diameter. The identifier for the current apply spring assembly is the letter “B” stamped in the spring retainer. Reference SIL 9-WT-04.

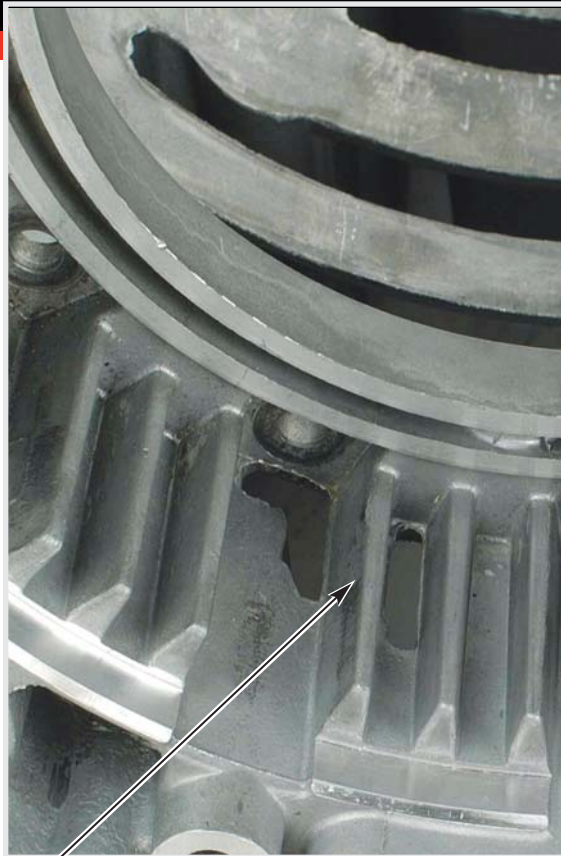
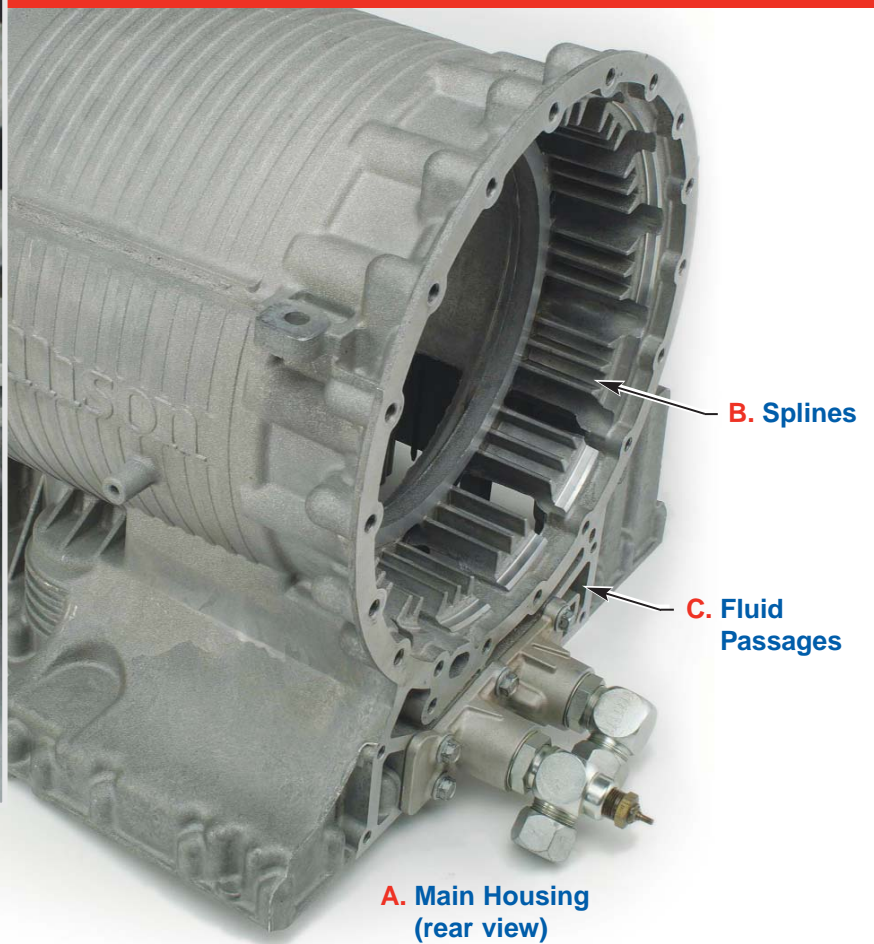
A. Main Housing
(rear view)

Check for spline wear.

B. Splines

B. Maximum C5 clutch spline wear is 1.15mm (0.045 inch).

C. Inspect all fluid passages for obstructions, porosity and cracks. Inspect bolt holes for stripped or damaged thread. Replace the housing if damage cannot be repaired.
