TECHNICIANS' GUIDE

INSPECTION AND ANALYSIS OF THE ALLISON 4000 & B 500 PRODUCT FAMILIES

INSPECTION AND ANALYSIS OF THE ALLISON 4000/B 500 PRODUCT FAMILIES

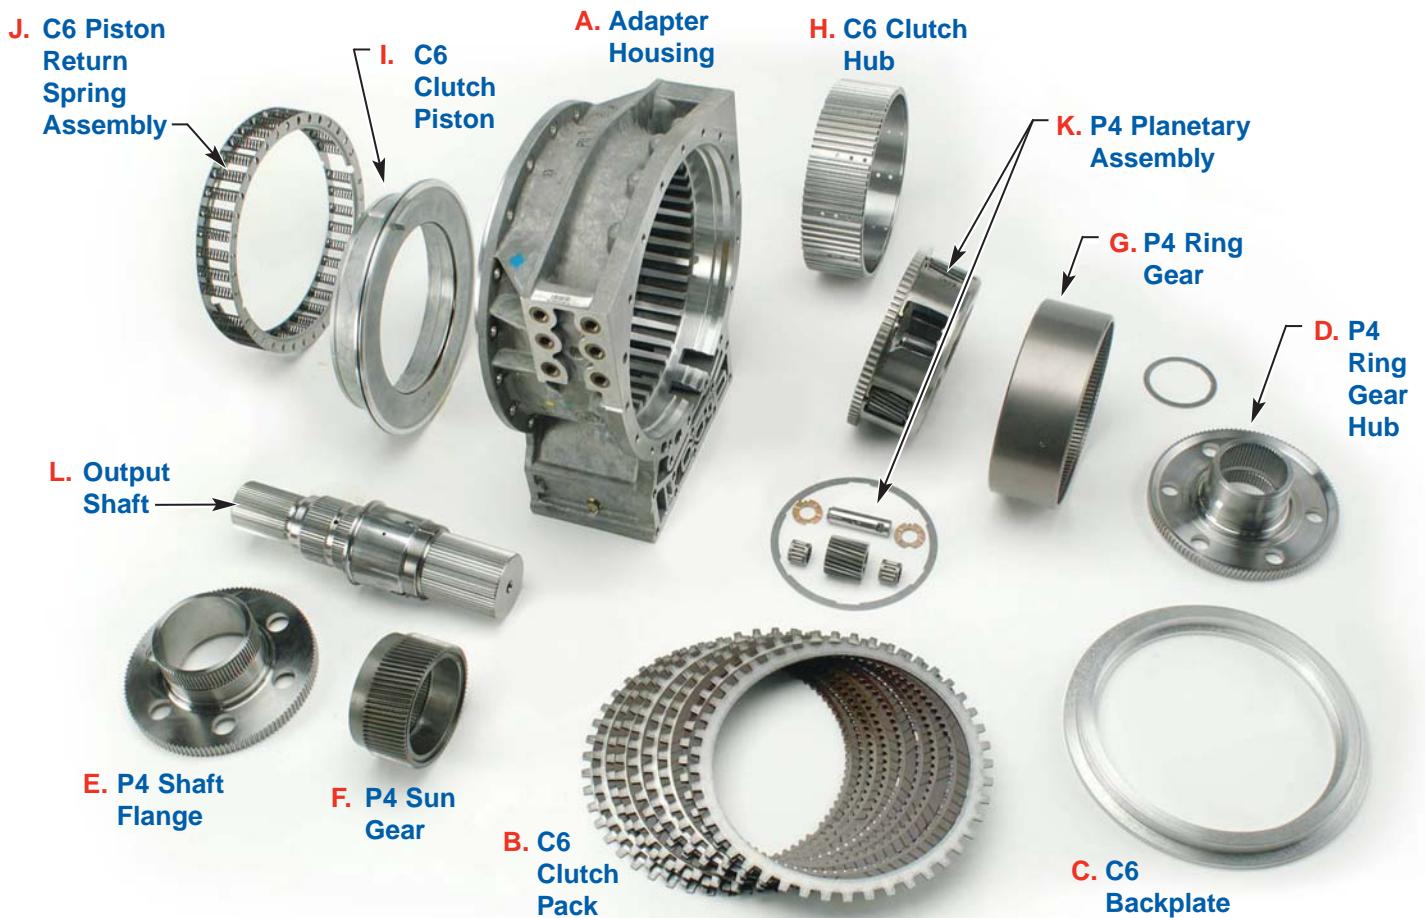
ALLISON 4000/B 500 PRODUCT FAMILIES C6 ADAPTER HOUSING MODULE

A. Inspect the adapter housing following the “General Inspection Guidelines for Cast Parts and Machined Surfaces” and “General Inspection Guidelines for Splines” section of this manual. Replace the housing if it fails any of these inspection procedures or if the damage cannot be repaired using a soft stone or crocus cloth. Maximum clutch spline wear is 1.15mm (0.045 inch). Inspect all fluid passages for obstructions, porosity and cracks. Inspect bolt holes for stripped or damaged threads. Replace the housing if damage cannot be repaired.

B. Inspect the C6 clutch friction plates following the “General Inspection Guidelines for Friction Plates” section of this manual. Replace any plates failing these inspection procedures. Minimum allowable friction plate thickness is 3.68 mm (0.145 inch). Maximum allowable plate coning is 0.25 mm (0.010 inch).

D. E. F. G. & H. Inspect the P4 ring gear hub, P4 shaft flange, P4 sun gear, P4 ring gear and C6 clutch hub following the “General Inspection Guidelines for Gears” and General Inspection Guidelines for Splines” sections of this manual. Replace any components failing any of these inspection procedures. Replace any components with damage which cannot be repaired using a soft stone or crocus cloth.

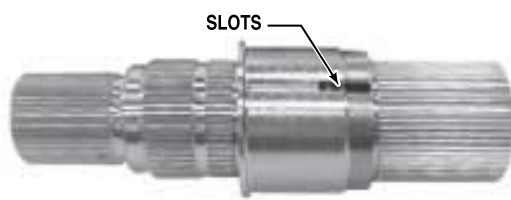
**Former 4070
Non-Retarder
Output Shaft**

**4070 Output Shaft Update -
Reference SIL 25-WT-01**

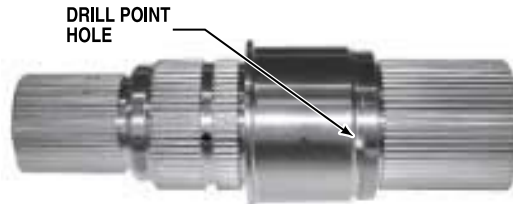
**Current 4070
Non-Retarder
Output Shaft**

**Current output shaft requires
current bearing retainer locknut
and Belleville washer.**

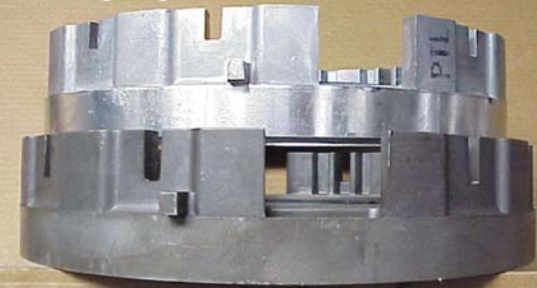
Housing in good condition - reuse.

Etched housing - do NOT use.

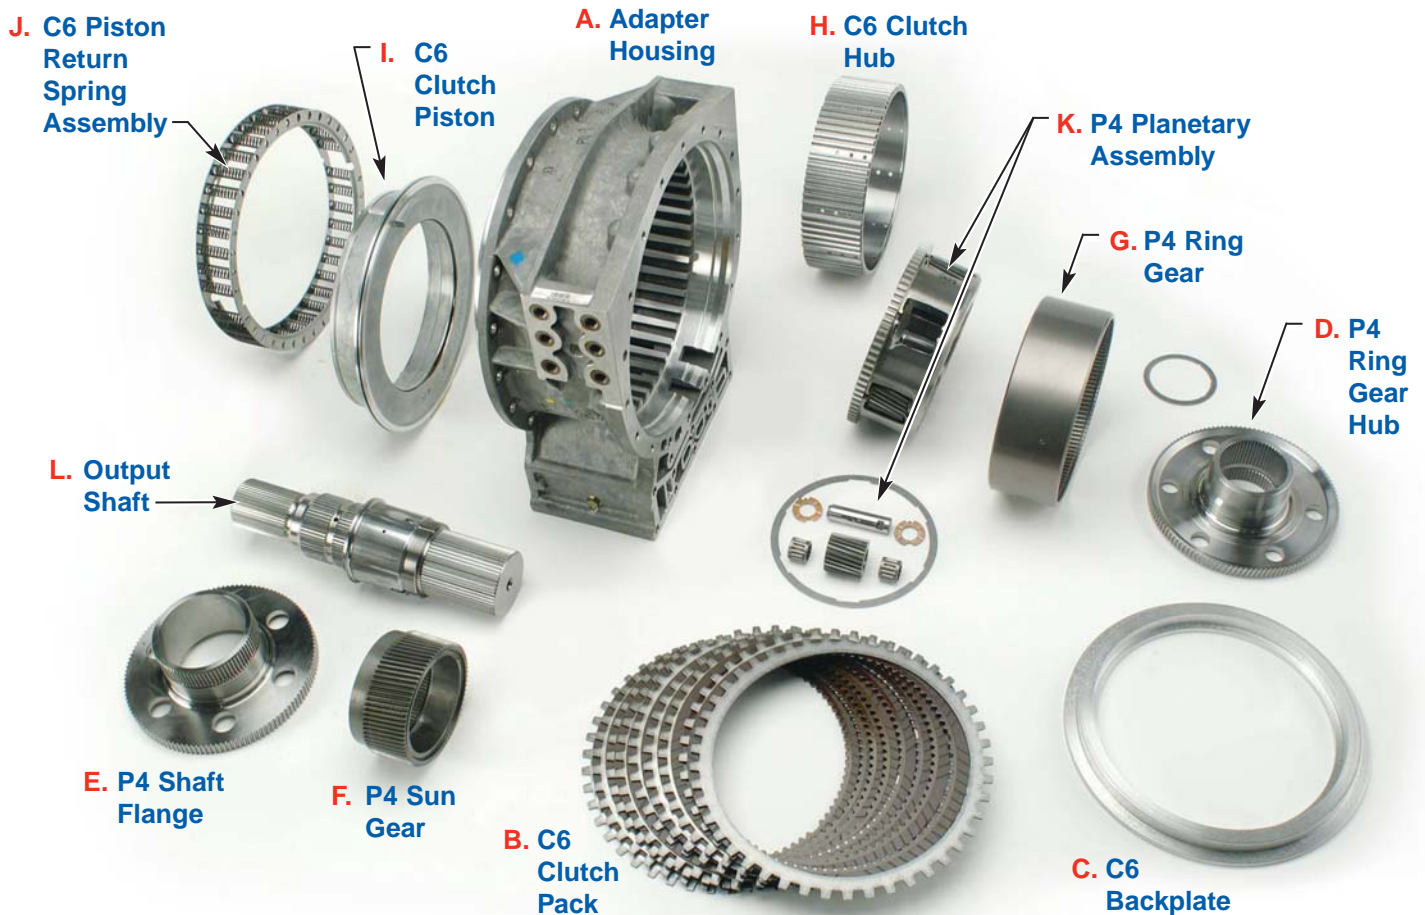
ALLISON 4000/B 500 PRODUCT FAMILIES (continued) C6 ADAPTER HOUSING MODULE

Inspect the P4 carrier indexing ring for wear and damage, especially where the spindles make contact with the ring. Replace the indexing ring if it shows signs of spindle battering or has damage which cannot be repaired using a light stone.

Replace the pinion gear thrust washers if they are damaged, distorted or showing signs of overheating. Minimum allowable thrust washer thickness is 1.40 mm (0.055 inch).
